Derby Diocesan Association of Church Bellringers Consultant's Report	Report DDACB 12/05
Church of Saint Martin Alfreton – Inspection of Bells	Issue Date 22/11/05

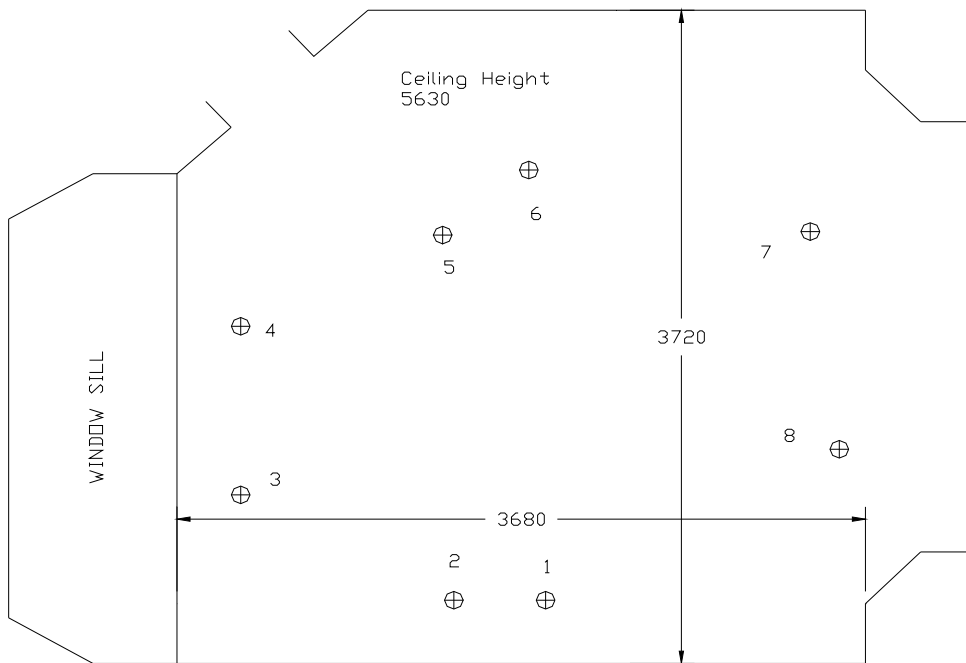
FIGURE 1
Ringing Room

The ringing room is reached via 15 steps up the spiral stairwell. It is clean, carpeted and well lit by natural light both through the large west window and also the glazed infill in the arch through to the nave. Electric lighting is good from two fluorescent tubes and one filament bulb.

The centre of the room is dominated by a wooden clock pendulum case which extends through the ceiling and finishes 2.26 metres above the floor. Although intrusive, the pendulum case does not seem to seriously affect rope sight.

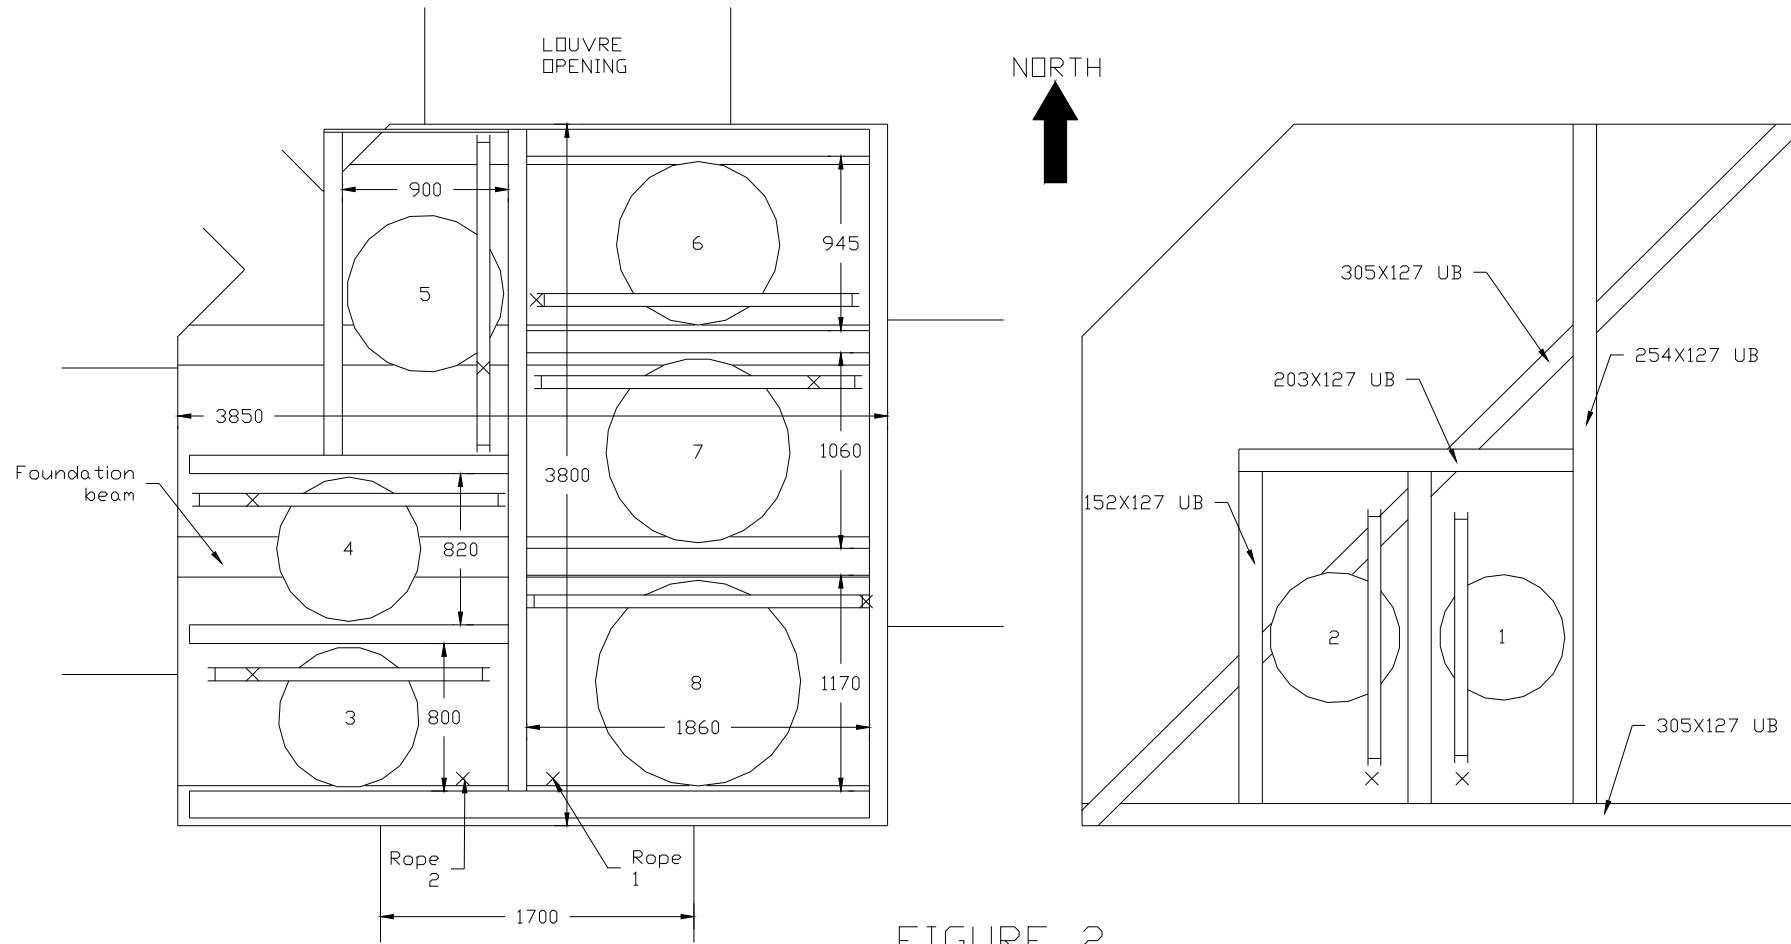
FIGURE 2
 Bell Chamber and Frames

The bell chamber is reached by a further 29 steps. There are four louvre openings, one to each aspect of the tower and both natural and artificial lighting are adequate. Although there is metal mesh over the louvre openings it is not adequate to exclude birds as evidenced by considerable quantities of bird debris on the bell frame and floor. This debris retains moisture and promotes favourable conditions for the onset of rot in adjacent timbers. (It is also a health hazard). The debris should be removed and the louvre openings covered in "Galebreaker" porous sheeting.

The upper steel frame carries bells 1 and 2 and is supported by a 305X127 steel universal beam set diagonally across the bell chamber. All of the steel work has considerable surface corrosion, although it appears to be structurally sound.

The bottom frame, carrying the other six bells, is a low-sided frame of wooden construction which appears to be in good condition. Since there is limited space for the bells and frame, the pits in which bells 3,4,6,7 and 8 swing have gallows ends and the whole frame is set above the tower offsets noted in section 5.0. The frame sits on four 350X200 wooden foundation beams, which are set east/west, and the top of the frame is roughly level with the louvre sills resulting in all bells being above the sill height. When heard from outside the church this results in some bells appearing louder than others dependent on which louvre is closest to the observer. (Ideally all bells should be below sill level to give an even sound at all compass points outside the church). None of the bells was rung to assess frame movement but it was considered that any movement would be acceptable given the good state of the frame. If any looseness were found in the frame, tightening of the metal frame ties would reduce it.
