| Derby Diocesan Association of Church Bellringers Consultant's Report | Report no. DDACB 01/004 |
| Inspection of New Six Bell Installation at Saint James, Bonsall | Issue date: 8/04/04 |

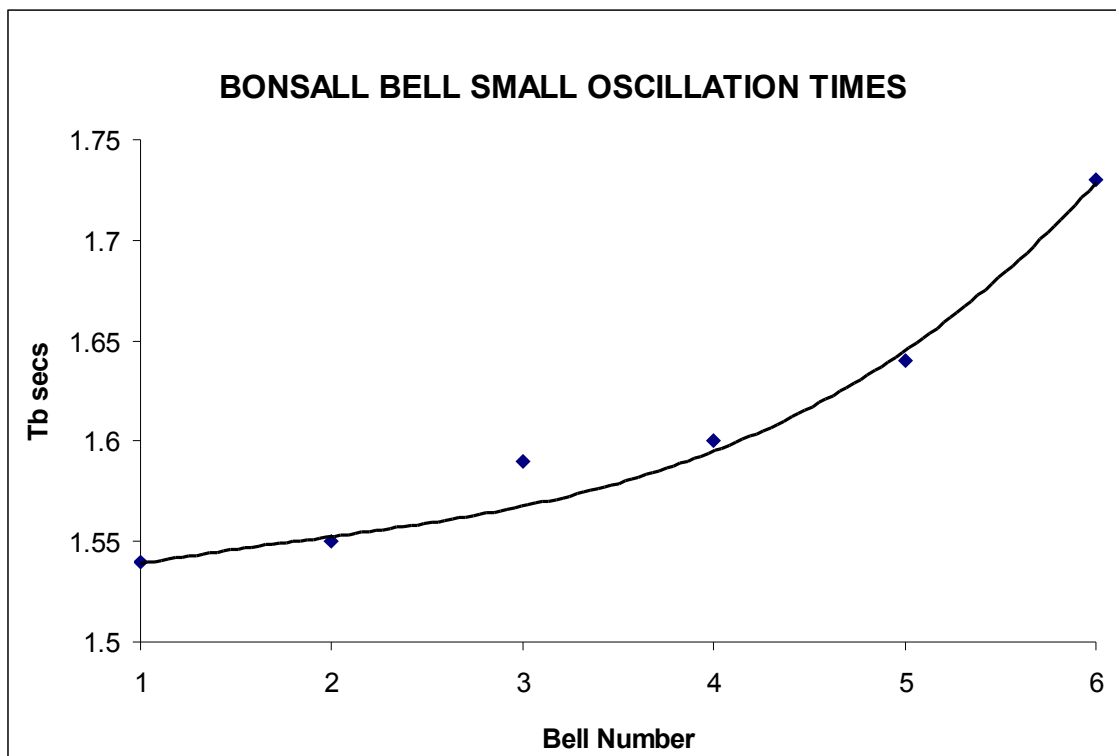
For ease of striking it is necessary for the oscillation times for each bell to lie on a smooth curve. It can be seen from the graph that bells 1,2,4,5 and 6 meet this requirement. Bell 3 is slow by about 1.3% from ideal which is outside the preferred tolerance of +/- 1%. Additional "pull down" testing was carried out on Bell 3 to establish the position of its centre of gravity and the value of its radius of gyration. This bell retains its canons and appears to have been hung with its centre of gravity displaced from its axis of rotation by a distance very close to the value of its radius of gyration. Under these conditions it is not possible to usefully speed the bell up any more by altering its hang and so it must be accepted.

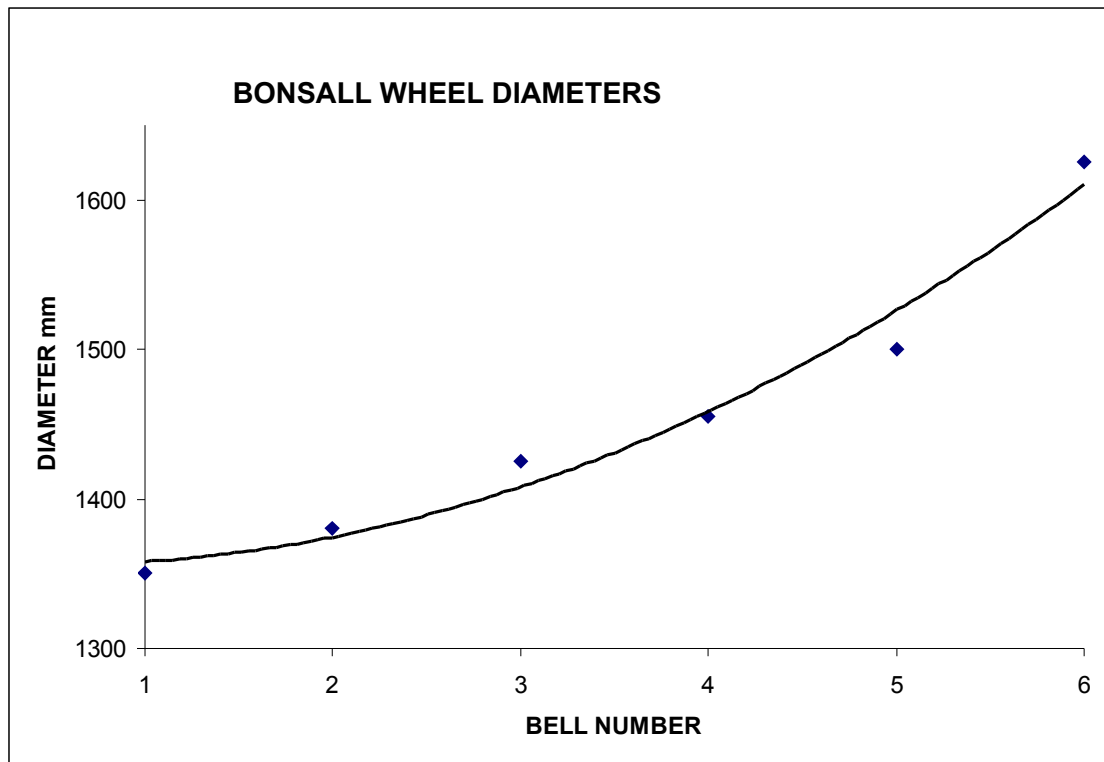
Referring to the graph it can be seen that the diameters fall more or less on a smooth curve which is acceptable.

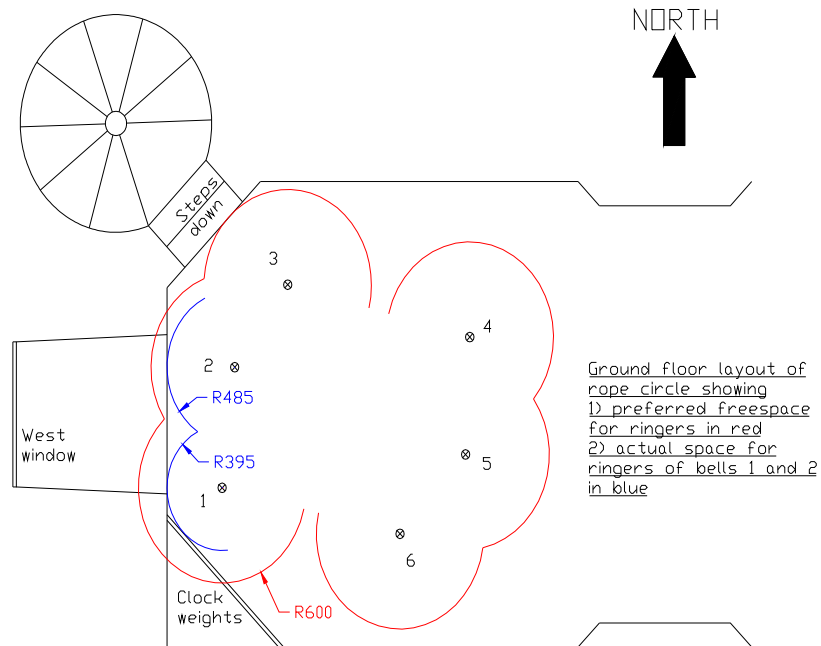
Referring to the drawing below, the ropes fall in an acceptable circle. However free space available behind the ringers of bells 1 and 2 is limited, particularly 1. Space is required to enable ringers to handle the ropes in a way which allows the rope to fall vertically in front of the ringer and which avoids interference with adjacent ringers. Adequate space is particularly important for inexperienced ringers since there must also be room for a tutor. The preferred free envelope around a ringer falls within a circle of 600 mm radius and this is shown in red in the drawing. The blue arcs show the actual clearance from the west wall which, at 485 and 395 mm, is well within 600 mm. A simple alteration to the tower clock case would have made it possible to move the treble rope further away from the west wall. Also if autowind is ever fitted to the clock in the future this would enable space currently occupied by the weight box to be relinquished to the treble ringer.

The local ringing band find they can ring these two bells without too much trouble and so for this reason the rope positions are accepted.
