**INSPECTION OF BELL INSTALLATION
AT ALL SAINTS, BRADBOURNE
2 December 1998**

The inspection was requested by Gordon Halls (Diocesan Bells Adviser) to provide a record of the installation following a recent major overhaul of the installation by John Cater and his team.

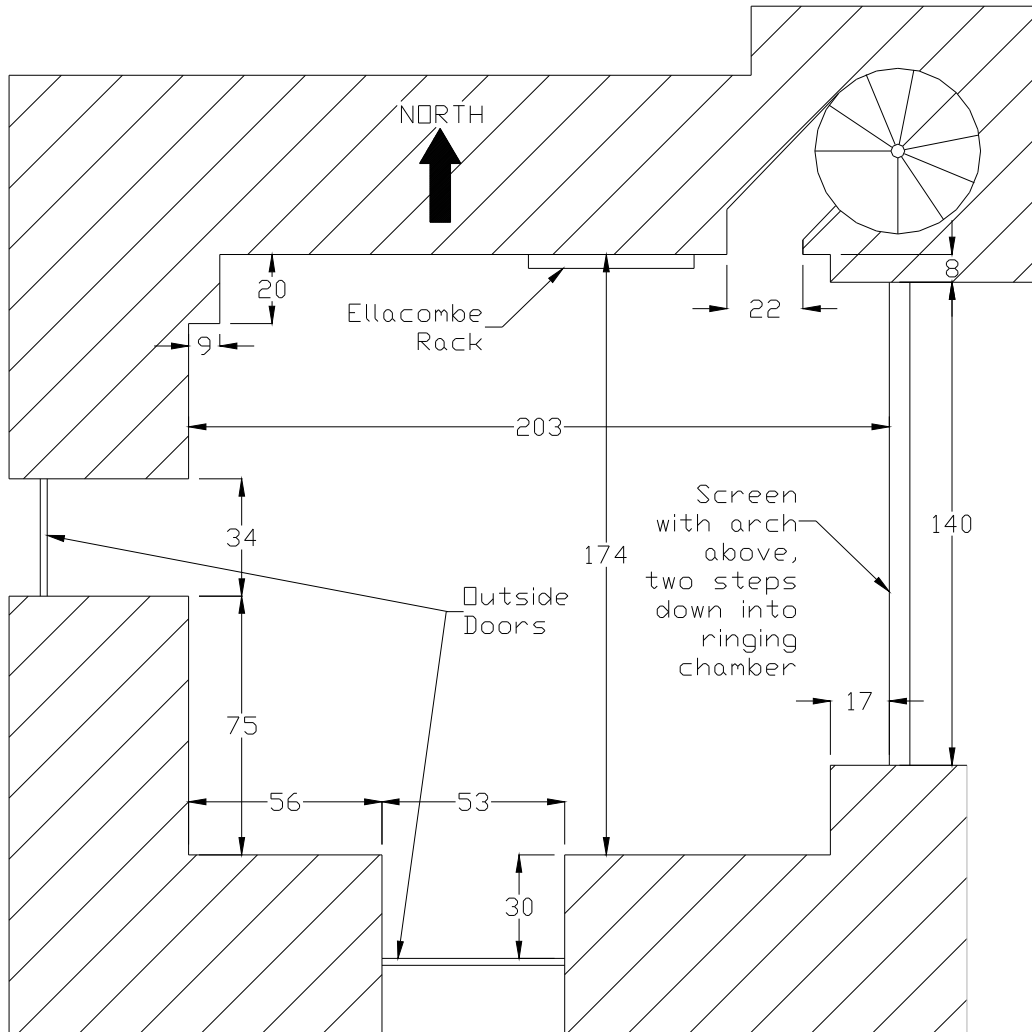
LOCATION ALL SAINTS Bradbourne
TITLE Ringing Chamber (GF)
DRAWN MDBanks 2 December 1998
DIMENSIONS inches

The tower is stone built, square in section and situated at the West end of the church. It is of substantial construction with walls approximately 52ins thick at the base. Primary access to the tower and ground floor ringing chamber is from the nave but there are also two doors giving direct outside access, one in the south wall, the other in the west wall (see attached diagram).

The ringing chamber has a high ceiling (294ins) and so is fitted with a rope guide frame set 164ins above the floor. The frame has been derusted and painted black. Situated on the north wall is an Ellacombe chime rack operating hammers on all 6 bells.

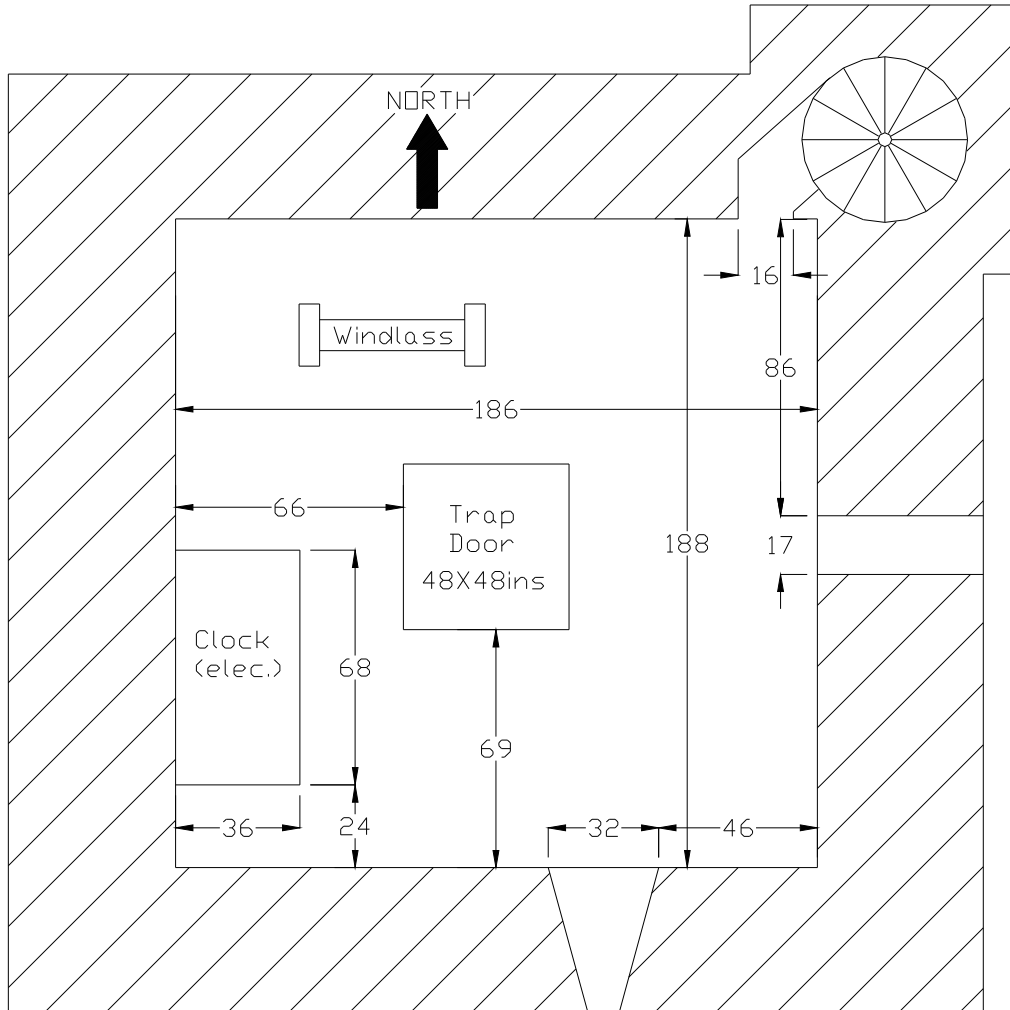
LOCATION ALL SAINTS Bradbourne
TITLE Intermediate Room
DRAWN MDBanks 2 December 1998
DIMENSIONS inches

Above the ringing chamber is an intermediate room which is reached by a spiral staircase (36 steps) entered through the ringing chamber north wall. This contains the clock mechanism, the remains of a very old windlass and a 48X48ins trap door in the floor (see attached diagram). The room is clean and has recently had part of the flooring replaced although the windlass has suffered from wood worm.

Seen from the intermediate room, its floor is supported by six beams running east/west (approx. 12X12ins in section) and these rest on two beams running north/south (approx. 16X10ins in section). The north/south beam on the East wall has been replaced but there is evidence of woodworm in some of the other beams. It is not known if the woodworm has been treated (but there was no evidence of wood powder on the intermediate room floor below). The steel bell frame is mounted directly in the walls and so is independent of these wooden floor beams (see later).

- 1) Six beams running E/W approx. 12X12ins supported by 2 beams running N/S approx. 16X10ins
- 2) N/S beam along east wall has been replaced
- 3) Evidence of wood worm in some beams and windlass
- 4) Height to ceiling 109ins
- 5) Clock case height 85ins
- 6) There are 13 steps to the bellchamber

No further work is required on the bell installation, however it would be advisable for the church authorities to assure themselves that the woodworm seen in the bell chamber floor beams and the windlass has been treated.

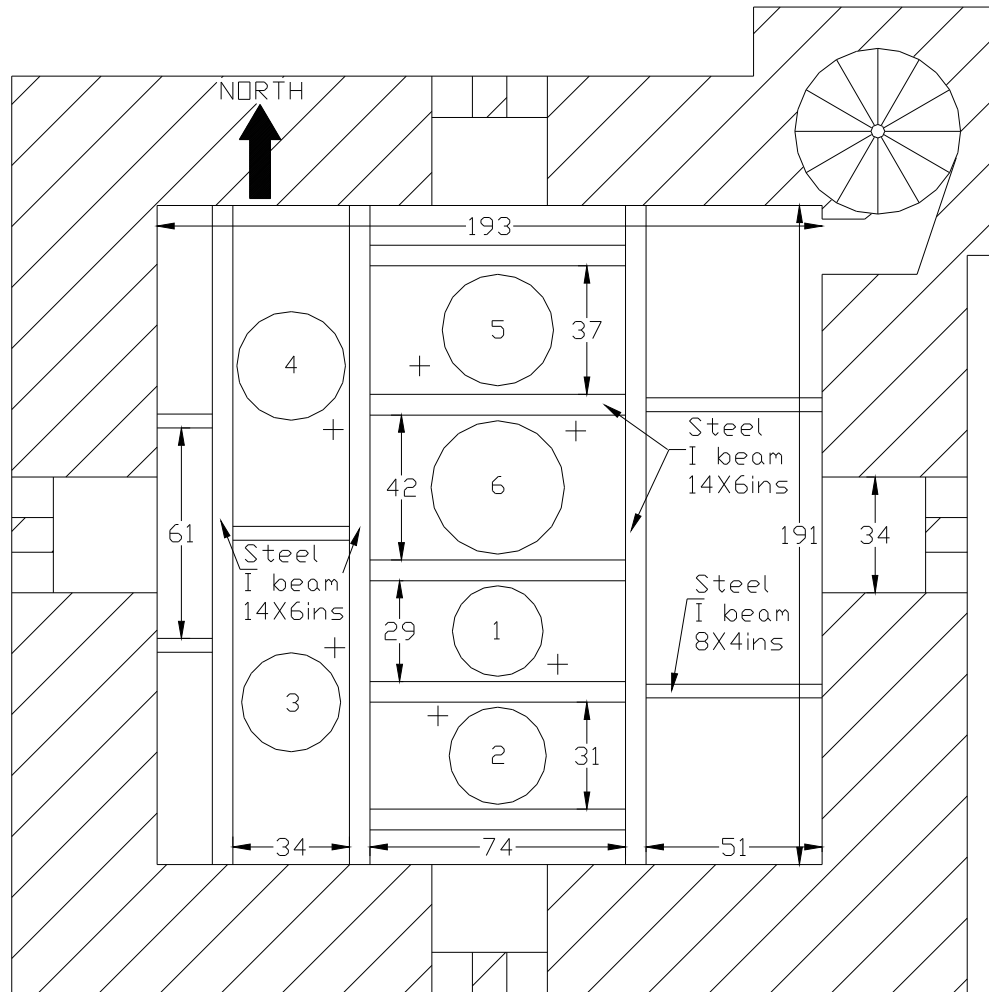
LOCATION ALL SAINTS Bradbourne
TITLE Bellchamber
DRAWN MDBanks 2 December 1998
DIMENSIONS inches

The bell frame is in a single plane and made from steel **I** section beams riveted together. It probably dates from 1895 when the treble was added and the No 2 recast. Three principal 14X6ins beams run north south fixed into the north and south walls. Two 8X4ins steady beams connect the frame to the east wall and there are two similar beams on the west side fixed to the west wall. There are six 8X6ins frame stretchers between the bells (see diagram).

All rust has been stripped and the steel work undercoated with red lead and then painted to a very good standard with two coats of Brolac blue gloss paint. The frame and its attachments to the wall are in excellent condition.
