<b>Derby Diocesan Association of Church Bellringers Consultant's Report</b>	<b>Report no. DDACB 10/003</b>
<b>All Saints', Brailsford Feasibility Study For Improvement of Rope Circle</b>	<b>Issue date: 25/07/003</b>

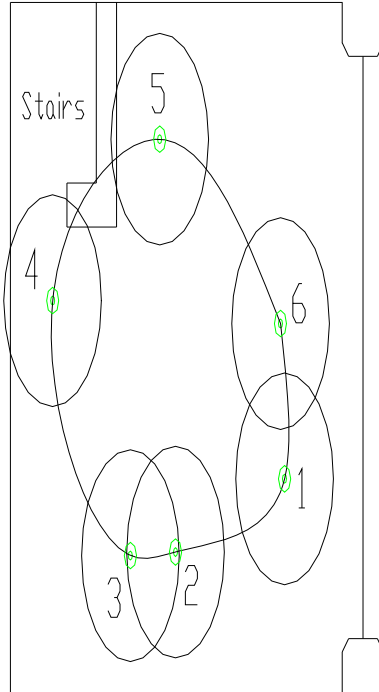
FIGURE 1  
RINGER'S GALLERY - EXISTING ROPE CIRCLE

- Figure 1 shows that removal of the rope guide has caused the ropes for bells 2 and 3 to fall too closely to each other. (The circles represent recommended safety zones of radius 600 mm around each rope, which should be largely clear of any obstructions. This allows space for personnel to ring safely (particularly when under tuition) without unduly interfering with neighbouring ringers).

- The ringer of bell 4 blocks entry to the gallery from the spiral staircase. This is dangerous for both the ringer and any newcomer attempting to gain entry when ringing is in progress.

- When ringing is in progress it is essential that each ringer has a clear view of the ropes of each of the other ringers. This is achieved by ensuring the ropes fall essentially in a circle, certainly avoiding any tendency for ropes to be in a straight line. Figure 1 shows that ropes 1, 2 and 3 are close to being in a line making rope sight difficult for ringers in these positions.

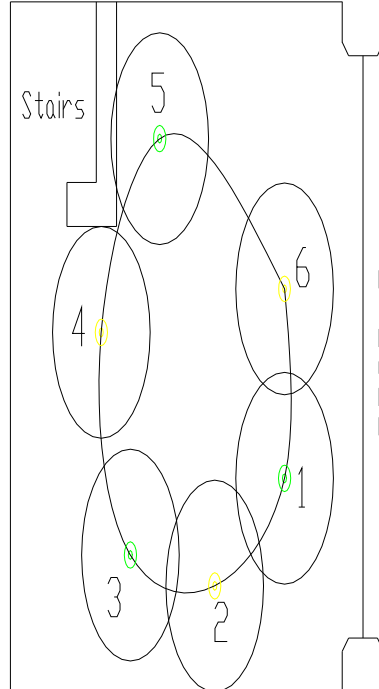
FIGURE 2  
RINGER'S GALLERY - PROPOSED NEW ROPE CIRCLE

Figure 2 shows that repositioning the ropes as follows will give an acceptable rope circle.

- Rope 2 is moved to a position which is equidistant from ropes 1 and 3 and also 600 mm from the south wall. (This removes the safety hazard and improves rope sight between positions 1, 2 and 3).
- Rope 4 is moved to a position which is equidistant from ropes 3 and 5 and also 600 mm from the spiral stair balustrade. (This removes the safety hazard and gives a more circular rope circle).
- Rope 6 is moved 200 mm northwards away from rope 1 (it appears that rope 6 does not fall truly vertical through the intermediate room and this movement will not only give less overlap of safety zones between ropes 1 and 6 but will also allow rope 6 to now fall vertically).
