Derby Diocesan Association of Church Bellringers Consultant's Report	Report DDACB 06/07
Church of All Saints', Breadsall Inspection of Bells	Issue Date 09/11/07

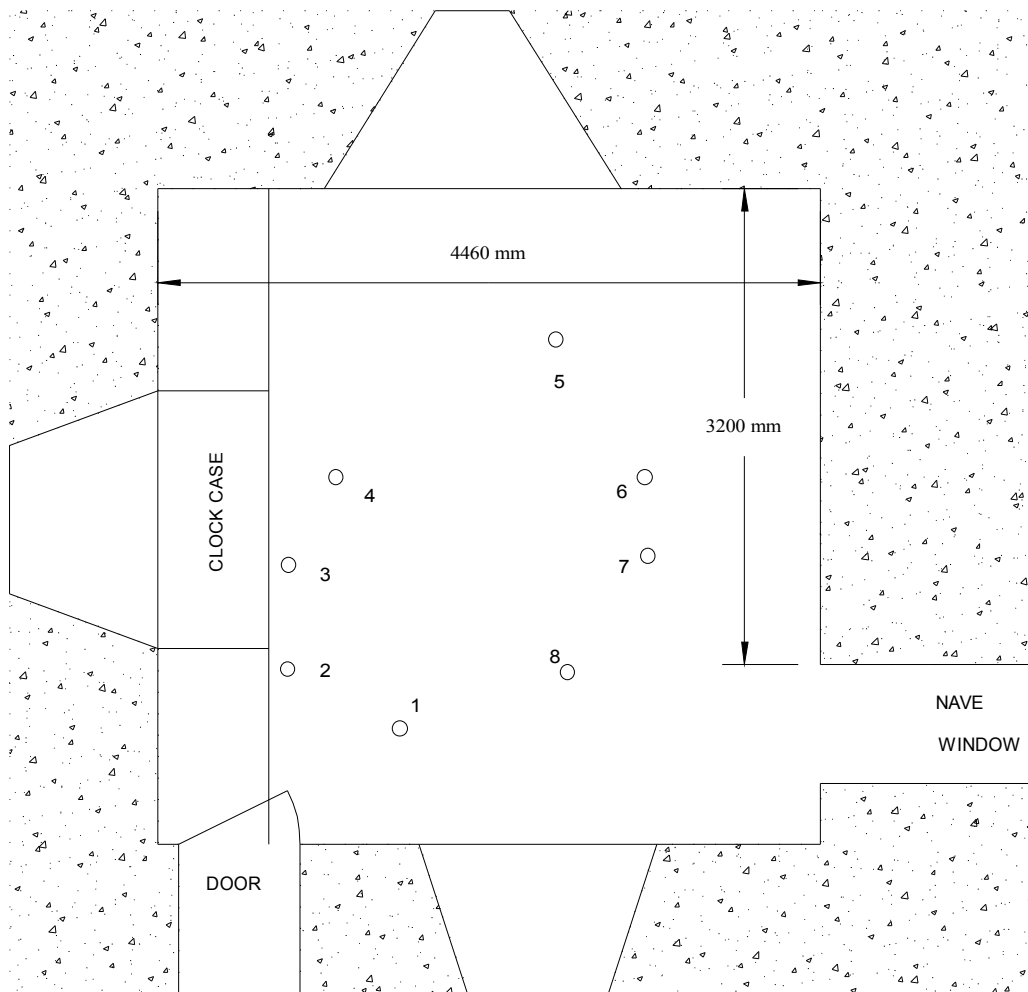
Figure 1

Reached by a spiral staircase. The 24 stone steps are in good repair and access to the door of the ringing room is on the left-hand side. The room, almost square in section is reasonably clean and illuminated by two separate fluorescent lights. The wooden floor is carpeted. Natural daylight enters the area through the windows on the North and South walls.

The clock case and mechanism is mounted on a Rolled Steel Joist (RSJ) which is tied into the North and South walls 750 mm. from the West wall. The bottom face of the RSJ is 2340 mm above the floor which in no way impedes the ringing of the eight bells, the ropes of which fall in an acceptable ringing circle. Bell 6 is the service bell and a hole is correctly positioned in the floor through which the extension rope passes freely.

The ceiling (of concrete construction) height is 4280 mm. which is safe in the event of a ringer being carried up following the breaking of a stay. In the centre of the ceiling is a large trapdoor through which the bells could be lowered.

The tower has a crack running from the top of the 'nave' window up the wall across the concrete ceiling to one side of the trapdoor opening and down the West Wall. There was no evidence of this crack continuing upwards in the bell chamber or below the ringing chamber floor level.

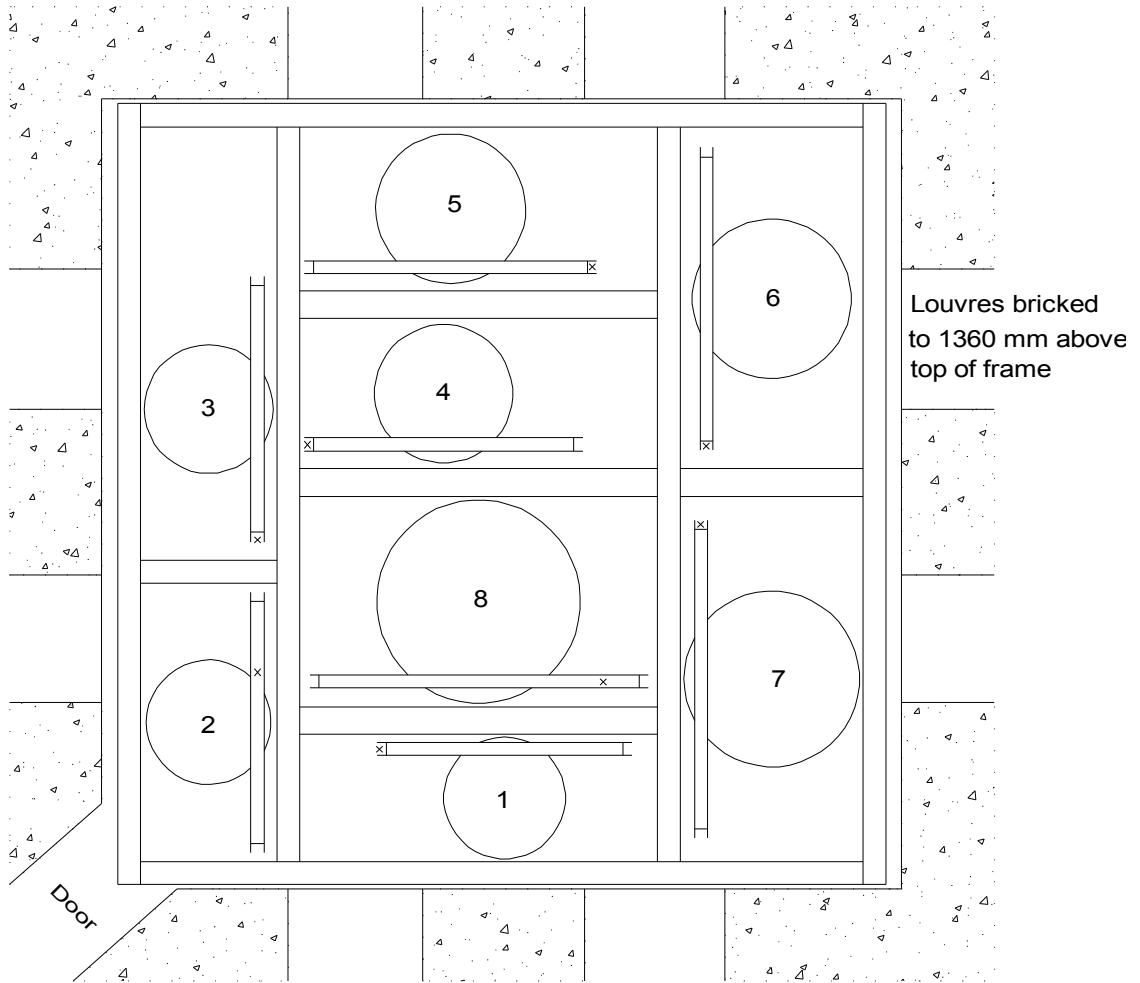
Figure 2

The Bell Chamber is reached by climbing a further 34 steps. Entry is through a wooden door which is normally locked, with a key kept in the ringing chamber. The area is illuminated by a single fluorescent light and a single incandescent lightbulb. The eight louvres (two on each aspect) have all been bricked up to a height of 1360 mm. above the top of the bell frame leaving an 'open' space of 1280mm. to the top of these louvres. All the louvres in the spire appeared to

be well protected by galvanised mesh and there was no sign of bird ingress. The small amount of bird droppings found appeared to have come from birds nesting higher up outside the octagonal spire.

The concrete floor and beams of substantial section appeared in good condition and there was no sign of the crack noticed in the ringing room ceiling. The wooden trap door is located under bells 4 and 8 and covered with a sheet of polythene. Wooden grillage beams rest on these concrete beams and are set into the walls of the tower on the North and South aspects. The mechanism for the South facing clockface is located on the floor under Bell 1 in a box of brick construction with a loose fitting wooden lid. The West facing clockface mechanism is located under Bell 3. The brickwork on this box is in need of attention as one corner has collapsed and the wooden lid is in danger of resting on the input shaft.

13. Carry out repairs to the brickwork box that houses the gearbox mechanism for the clock on the West face (located under bell 3).
14. Plane or chisel some wood from the support structure for the clock hammer on bell 4 to give clearance for full circle ringing of bell 8.
