Derby Diocesan Association of Church Bellringers Consultant's Report	Report no. DDACB 03/004
Inspection of Six Bell Installation at Christ Church, Burbage	Issue date: 20/09/04

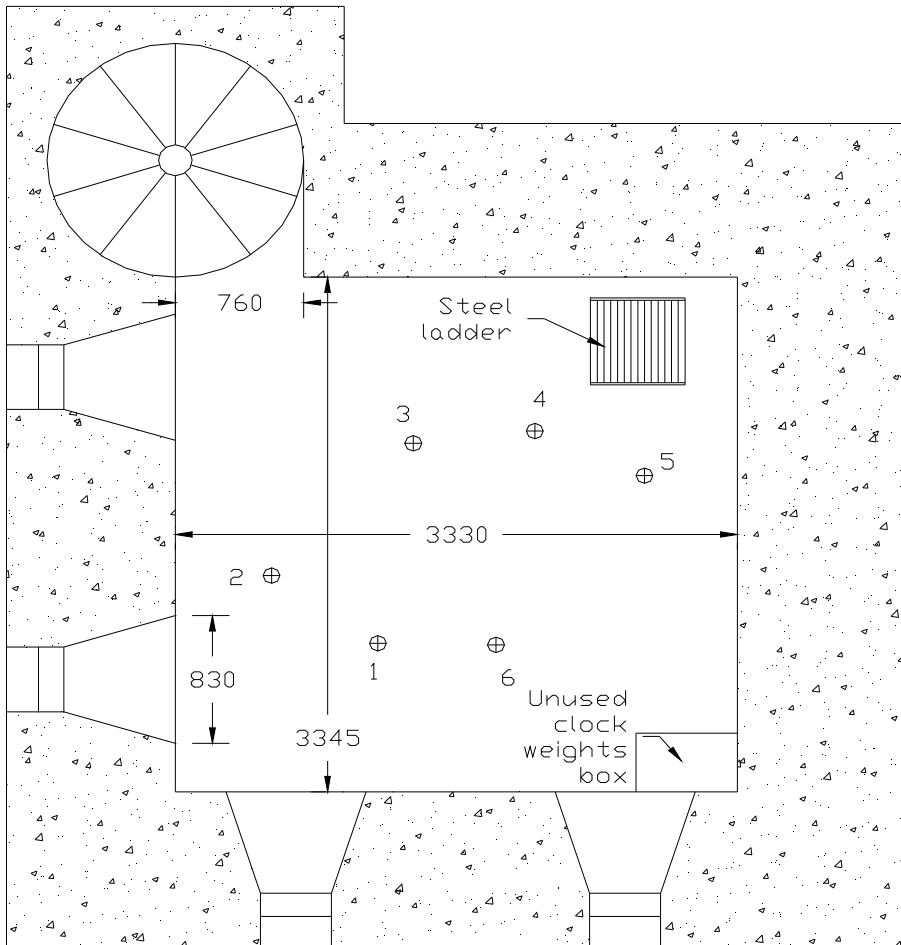
FIGURE 1 RINGING ROOM

The ringing room is reached via 14 steps up the spiral staircase. The entrance is closed by means of a curtain and the room is 3.3 metres square with a ceiling height of 3.2 metres. There is good natural light from four windows, two in the west wall and two in the south wall. Artificial light is also good from a single fluorescent tube, however for safety it is good practice to have a twin tube installation to guard against loss of light in event of a tube failure during night-time ringing.

There is no trap door in the ceiling for removal of the bells but the boarding shows evidence of an area which might be readily removed.

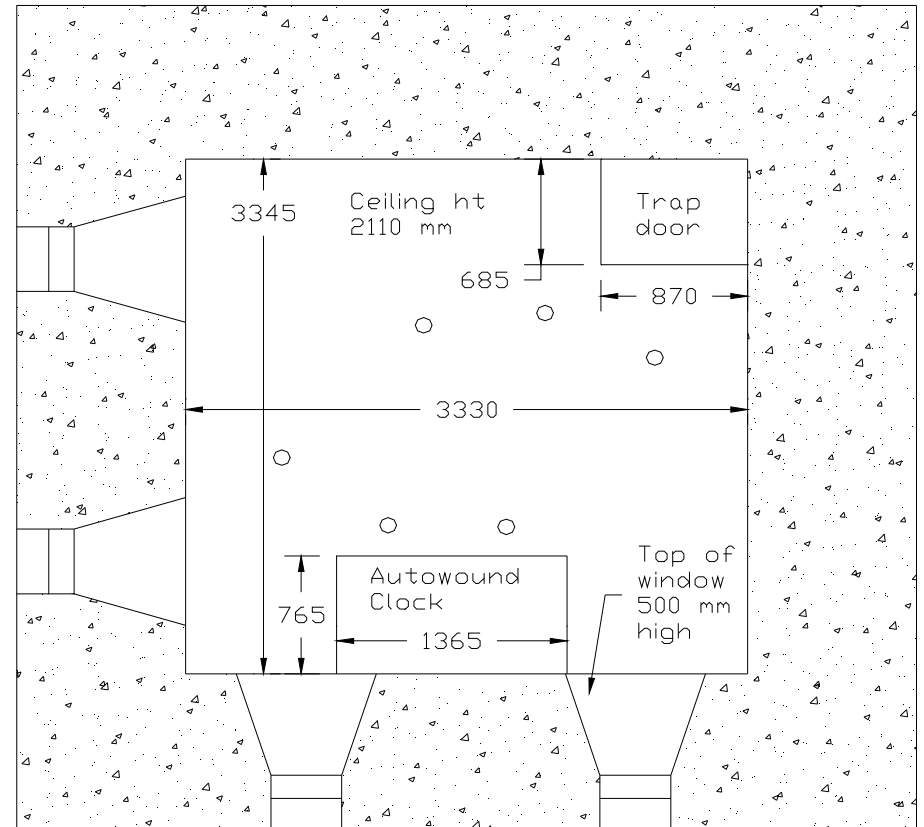
FIGURE 2 INTERMEDIATE / CLOCKROOM

The intermediate room is reached through a trap door via 14 rungs of an iron ladder. It has the same cross section as the ringing room but with a ceiling height of 2.1 metres. The tops of the ringing room windows protrude 500 mm above the floor surface and to reduce transmission of bell noise down to the ringing room, this floor protrudes into the window openings. Lighting is good from a single fluorescent tube and the room is clean.

There is an auto wound clock in a case on the south wall.

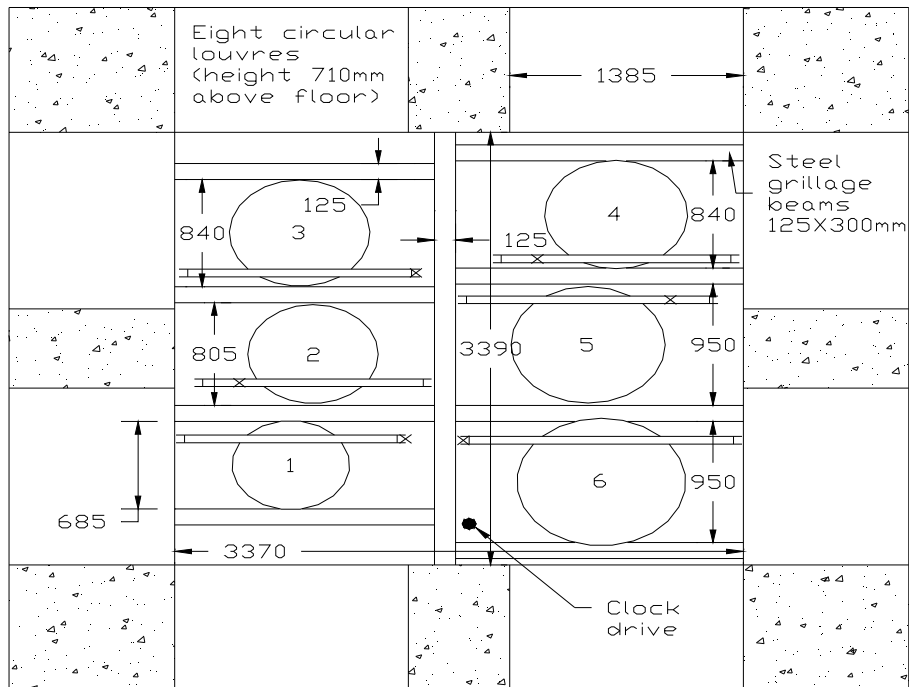
FIGURE 3 BELL CHAMBER -
 "H" FRAME LAYOUT SHOWING
 (FOR SIMPLICITY) ONLY
 GRILLAGE BEAMS

The frame is a high-sided "H" frame. Cast iron "H" frames support the bells and rest on steel grillage beams which are set into the walls of the tower. The top of the frame is attached to the centre of each wall for lateral stability.

Although structurally sound, there are areas of deep rusting in the frame particularly on the lower parts of the grillage beams. It is strongly recommended that the rust be removed and all metal surfaces painted (see recommendations).

- Using a wire cup brush in an angle grinder, remove all rust and scale from the bell frame metal surfaces. Of particular importance are the steel grillage beams but all other metal parts such as wheel fittings, headstocks, bell holding bolts, frame sides and upper steel framework

should be treated as well. Prime with red oxide paint and then apply an undercoat and a gloss topcoat. Alternatively two coats of Hammerite paint could be applied.
