**INSPECTION OF THE BELL INSTALLATION AT
ALL SAINTS CHURCH – FINDERN
30th AUGUST 2002**

The inspection was requested by Mrs. Nora Durricott on behalf of the PCC and was carried out by Mike Banks and John McCartney.

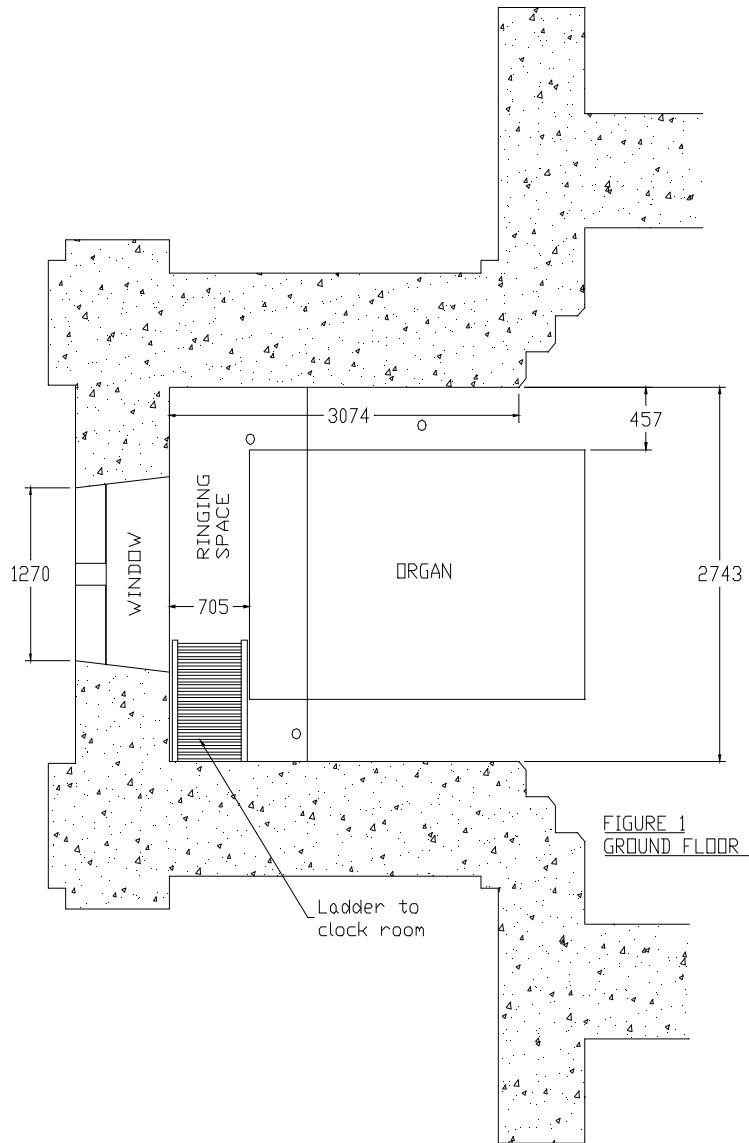
FIGURE 1
GROUND FLOOR LAYOUT

The ground floor of the tower is accessed from the nave though an arch however most of the ground floor area is occupied by the organ. Entry to the 'ringing room' is via very narrow passage to a raised floor at the rear of the organ adjacent to the West window. The area available is too restricted to allow safe full circle ringing of the bells, see figure #.

The bell ropes are drawn out of the vertical plane and pass through holes in the wooden ceiling. These holes do not feature rope bosses and as a result rope wear will occur even if the bells are only swing chimed.

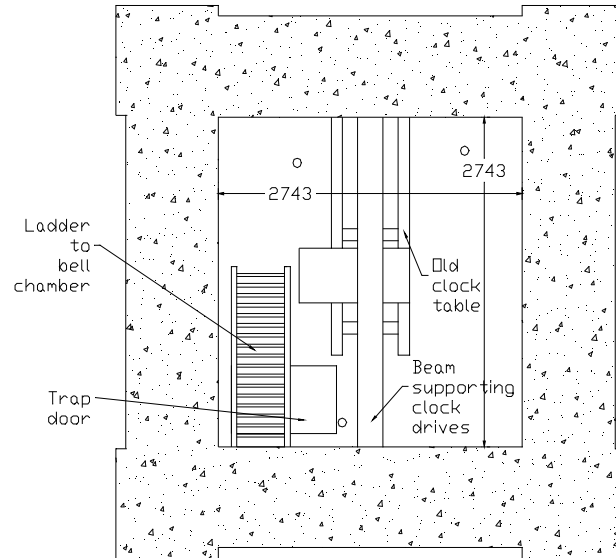
FIGURE 2
CLOCK ROOM
LAYOUT

The clock room is heavily contaminated with pigeon droppings as a result of bird entry though the only window in the South wall. The leaded window is damaged sufficient to allow bird entry and although the aperture has been covered with netting this has deteriorated leaving an unprotected area currently blocked by a paint tin. It is recommended that the window be repaired or at least the netting renewed.

The floor adjacent to the trapdoor is suspect and some rotting is suspected, a detailed examination was not possible because of the pigeon droppings.

In the centre of the room there is a timber frame, which once supported a mechanical clock this has been removed and replaced with an electric motor driving the rods through a gearbox to the two clock faces. Contamination of the clock motor and its control box is prevented by cardboard cartons however there is no similar protection for the gearbox.

For health reasons it is strongly recommended that after repair or netting of the window the clock room be cleaned of all bird debris the woodwork examined and any suspect areas replaced. All the wood should then be given a liberal coating of creosote.

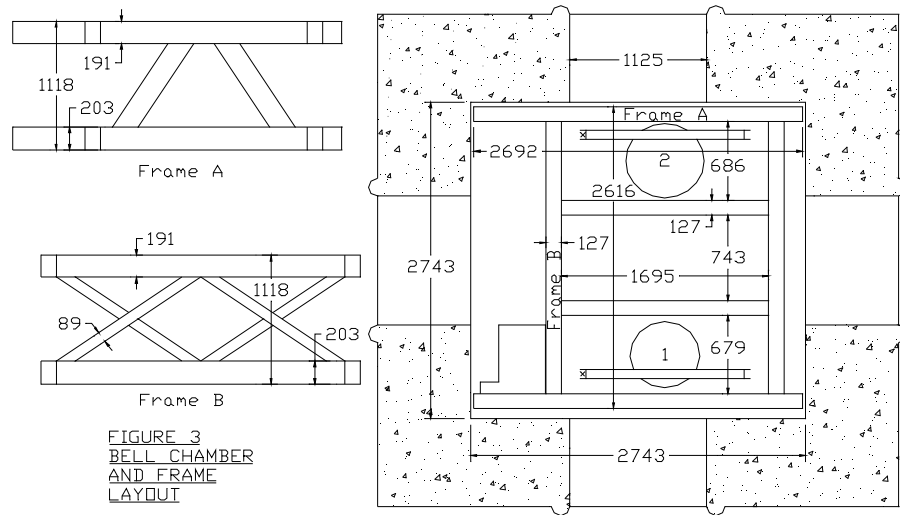
FIGURE 3
 BELL CHAMBER
 AND FRAME
 LAYOUT

The bell frame is a convention low sided 'A' frame design constructed of pine instead of the usual oak. It features three bell pits but only two are occupied, see figure #. Despite the neglect it appears to be in a satisfactory condition and will certainly carry the loads imposed by the bells when they are swing chimed. The top sills do show evidence of woodworm attack and softening of the wood indicating the onset of rot. This is predominately on the South facing side and will be the result of exposure to wind driven rain/snow through the open louvres.

The beams that carry the frame run East/West and will be grouted into the walls. Examination of the beam-ends was not possible due to the depth of the pigeon droppings covering them.

Even if restorative work on the bell installation is delayed urgent action is required to exclude the birds and wind driven rain, clean out the debris and examine and treat the bell frame.

It is recommended that the louvres be covered with 'Galebreaker', which is a tough, porous plastic material that should be stretched across the louvres and held in place with timber batons. This will prevent the entry of birds and wind driven rain whilst still allowing a free flow of air for ventilation. It is coloured black and cannot be seen from the outside and does not reduce the passage of sound from the bells. Approval from the church architect will be required before proceeding.

With all the bird droppings removed the frame supporting beams can be examined and if satisfactory they and the frame should be given a liberal coating of creosote.
