ALL SAINTS CHURCH, FINDERN -
FEASIBILITY STUDY INTO RESTORATION TO FULL CIRCLE RINGING
AND AUGMENTATION

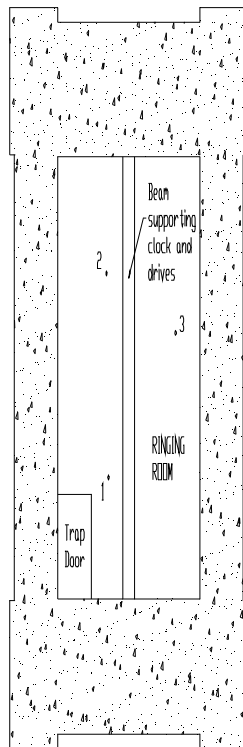
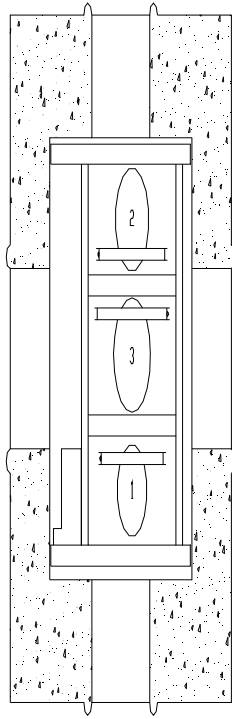
FIGURE 2 - OPTION (3.D)
THREE BELL INSTALLATION

3.1) Three Bells Rung Full Circle in Existing Wooden Frame (Figure 2)

The integrity of the existing wooden frame is unknown. What can be seen of it appears to be sound but critical parts such as the grillage beams (which support the frame and feed the bell dynamic loads into the tower) are buried in pigeon droppings which does not bode well for what appears to be a pine frame. The whole frame must be cleaned thoroughly to permit a detailed inspection. The Derby Diocesan Association of Church Bellringers Bell Consultants can then carry out limited remedial work on the bell fittings to permit frame movement to be measured with the bells rung full circle.

In this option a new bell augments the existing two bells and so represents the minimum recommended conversion to full circle ringing. The two old bells have their cast-in crown staples removed and are fitted with new independent crown staples and new clappers. Bell 1 has its canons (the loops on top) removed. After consultation with English Heritage the permissible degree of retuning for bell 2 is established and the other two bells tuned for minimum compromise with bell 2. New fittings for all three bells are provided (headstocks, wheels, ball bearings, stays, pulleys, sliders). Ringing takes place from the modified clock room as described in section (2).

This option can only be considered viable if the above inspections/tests indicate the frame to be sound.

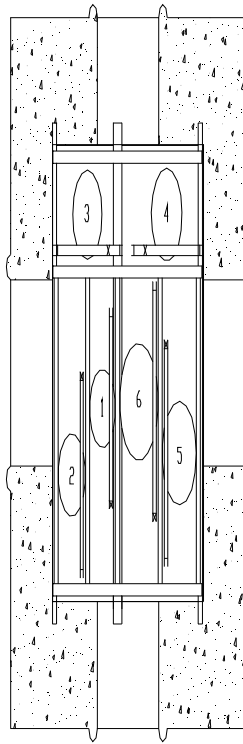
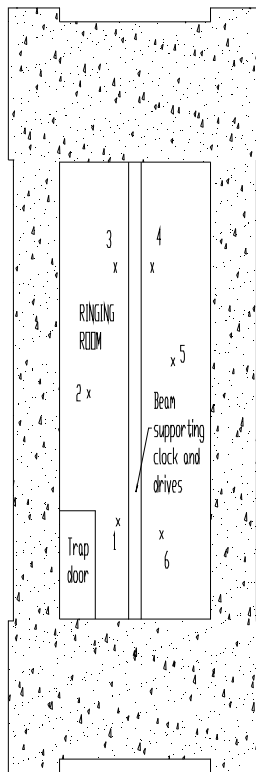
FIGURE 3 - OPTION (3,2)
NEW RING OF SIX BELLS

3.2) Install Six New Bells in a New Metal Frame (Figure 3)

The six new bells proposed are a close fit in the bell chamber and it would be beneficial for a stonemason to locally relieve the walls adjacent to the wheels and stays of the 3rd and 4th bells. Professional bell hangers may have better layouts.

This is the recommended option since it realises the full potential of the tower for full circle ringing. Fewer, larger bells are not possible since (with the organ in its current position) there is insufficient height in the tower to accommodate the rise and fall of the ropes on larger wheels. Option (3.1) commits to all the changes necessary to the clock room plus temporary removal of the west window. There is, therefore, a strong argument to be made for “doing the job only once” and installing the best option of six bells for the benefit of present and future generations.

This proposal removes the existing bells, wooden frame and bell chamber floor. (The two bells could be sold through the Keltec Trust to offset the cost of the new installation). A new metal frame is installed carrying six new bells with new fittings. A new bell chamber floor is installed below the frame.
