<b>Derby Diocesan Association of Church Bellringers Consultant's Report</b>	<b>Report DDACB 0806</b>
<b>Church of St Giles at Great Longstone Comments on Bell Improvement Proposal</b>	<b>Issue Date 18/12/06</b>

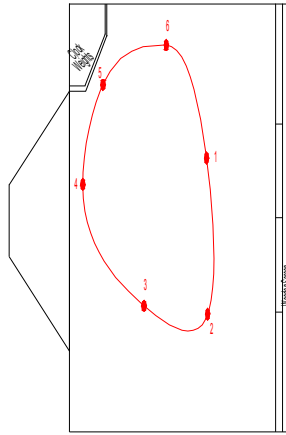
FIGURE 1 EXISTING RINGING CIRCLE

Figure 1 shows the shape of the existing rope circle and illustrates the deficiencies needing correction.

- As already noted, ropes 4 and 5 are too close to the tower walls.
- Ropes 2,3 and 4 almost lie in a straight line.

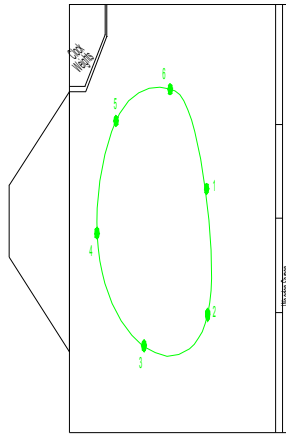
FIGURE 2 PROPOSED RINGING CIRCLE

Figure 2 shows the proposed optimised rope circle and it can be seen that the new circle is much improved, being more nearly round and with the ropes more evenly spaced. Also free space around each rope is considerably improved giving the following approximate radial clearances:

Rope	Approximate Clear Radial Space Around Rope (mm)
1	>600
2	600
3	450
4	400
5	400
6	450

Given the small cross section of the tower these clearances are acceptable and will enable training of new ringers to be performed in much greater safety.

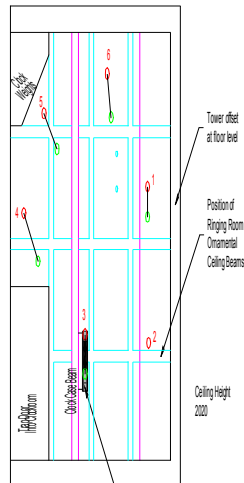
FIGURE 3  
CLOCK ROOM LAYOUT

The internal dimensions of the tower were measured in the ringing room and clock room. Also the position of each rope was established by measuring its co-ordinates in relation to two datum walls in the ringing room. Since the ropes fall vertically, these positions could also be translated to the points at which the ropes pass through the clock room floor. Figure 3 shows a plan view of the clock room with the underlying beam positions shown in blue (taken from the proposal). The red circles show the existing rope penetrations of the floor and the green circles show the proposed new positions.

The proposed use of additional pulleys to bring about these rope offsets appears to be acceptable, but with one proviso. In the proposal, offset of rope 3 is achieved by means of a pulley built around the right hand winding shaft of the clock. As stated in section 2.0 the clock must not be compromised and so the pulley box should be attached to the inside of the clock case at the position shown in figure 3. Care should be taken to keep the rope, rope channel and pulley box outside the swept volume of the clock-winding key. A corresponding ceiling pulley will have to be fitted to the clock case roof.

It is probable that drawing of rope 5 will interfere with the opening of the existing clock case door. This will require further thought.
