Derby Diocesan Association of Church Bellringers Consultant's Report	Report DDACB 04/06
Church of St Michael & All Angels, Hathersage - Inspection of Bells	Issue Date 06/08/06

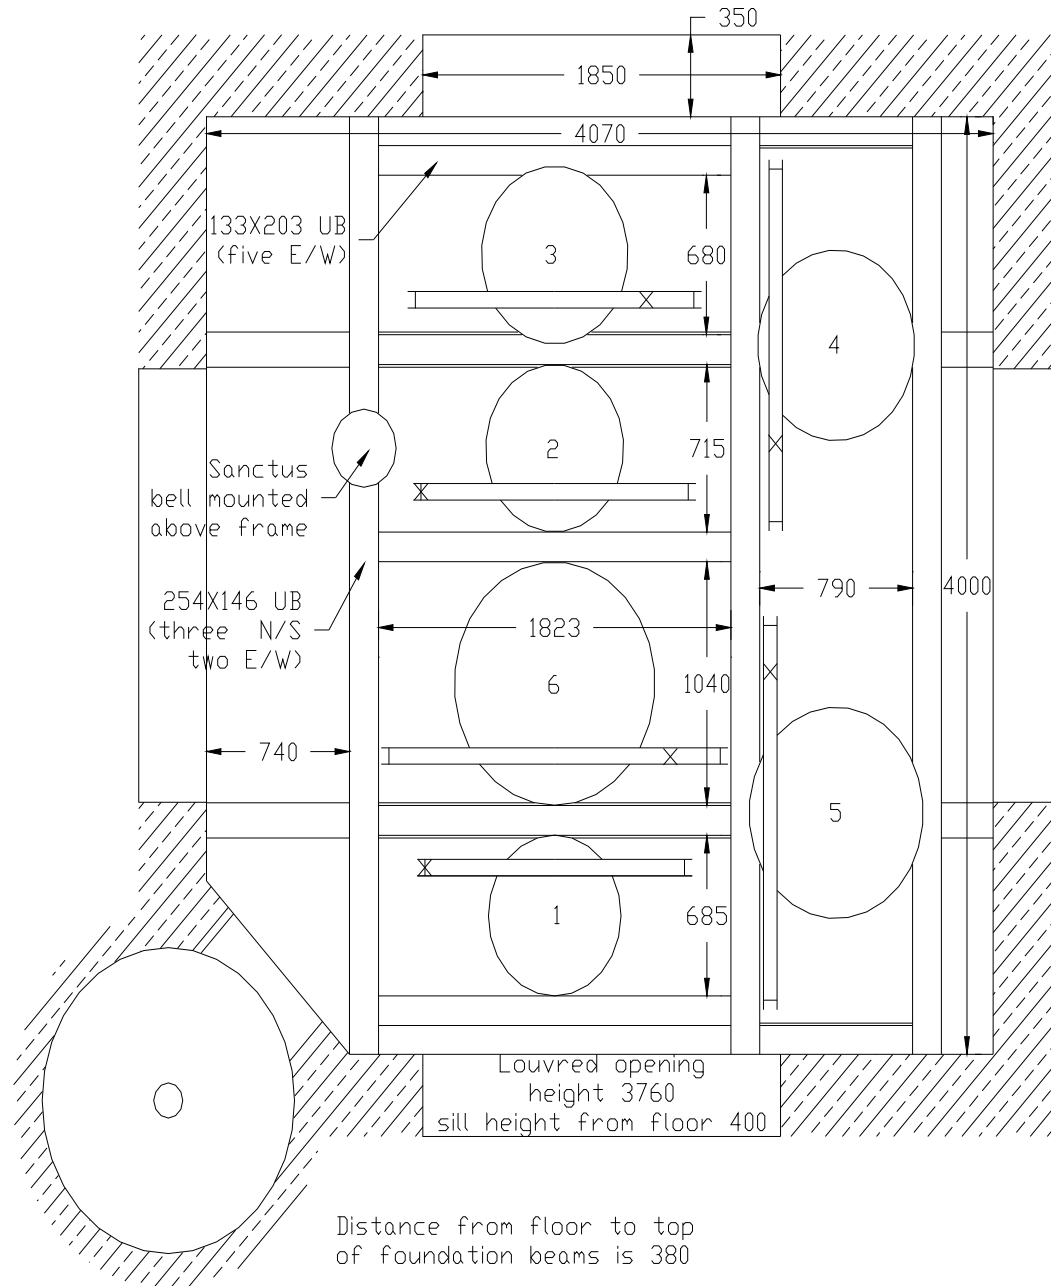
FIGURE 1
BELL CHAMBER

The area is illuminated by one floodlight and one incandescent bulb, which give adequate lighting for everyday use. On the North and South walls immediately above the apex of the louvres two cracks extending upwards were observed. There was some bird debris, the situation probably being made worse by the repair work that had been carried out on the South louvre to the supports and fitting of new slates. The wooden floor appeared sound and was fitted within the section of the foundation beams. Some thought had been given to soundproofing the louvres as when being rung full circle the open throat of the bells is above the lower level of the louvres.

11. Remove bird debris from bell chamber and complete repointing of the louvres.
12. During the next quinquennial inspection, seek the church architect's opinion on the cracks in the stonework on the North and South walls immediately above the apex of the louvres in the Bell Chamber.

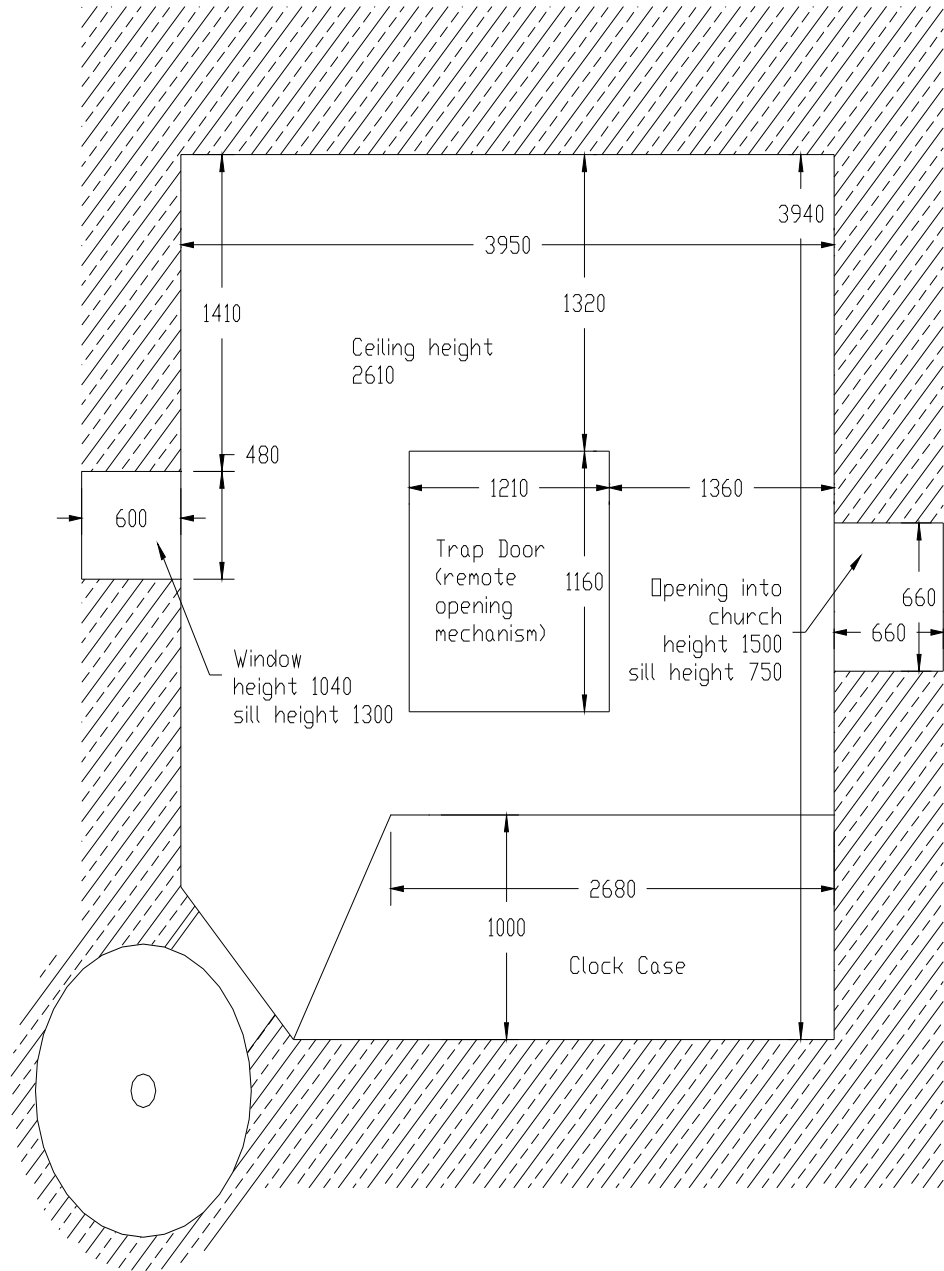
FIGURE 2
CLOCK ROOM

The clock room is reached by climbing 29 stone steps of the spiral staircase in the South West corner of the tower. The area almost square in section is illuminated by a single incandescent light bulb. A small window is fitted in the West wall and there is an opening into the church on the East Wall. The sill height to this opening is 0.75 metres and the wall thickness was measured at 660mm. Running down the entire length of the South wall is the wooden clock case. The floor of wooden construction contains a trap door measuring 1210mm

x 1160mm which can be raised and lowered from the Ringers' Gallery. The wooden ceiling is 2.610 metres above the floor. Running East - West are the lower sections of the two 'I' section foundation beams. All ends are keyed into the walls. Running East – West against the North Wall is another 'I' metal beam of smaller section which supports part of the wooden belfry floor.

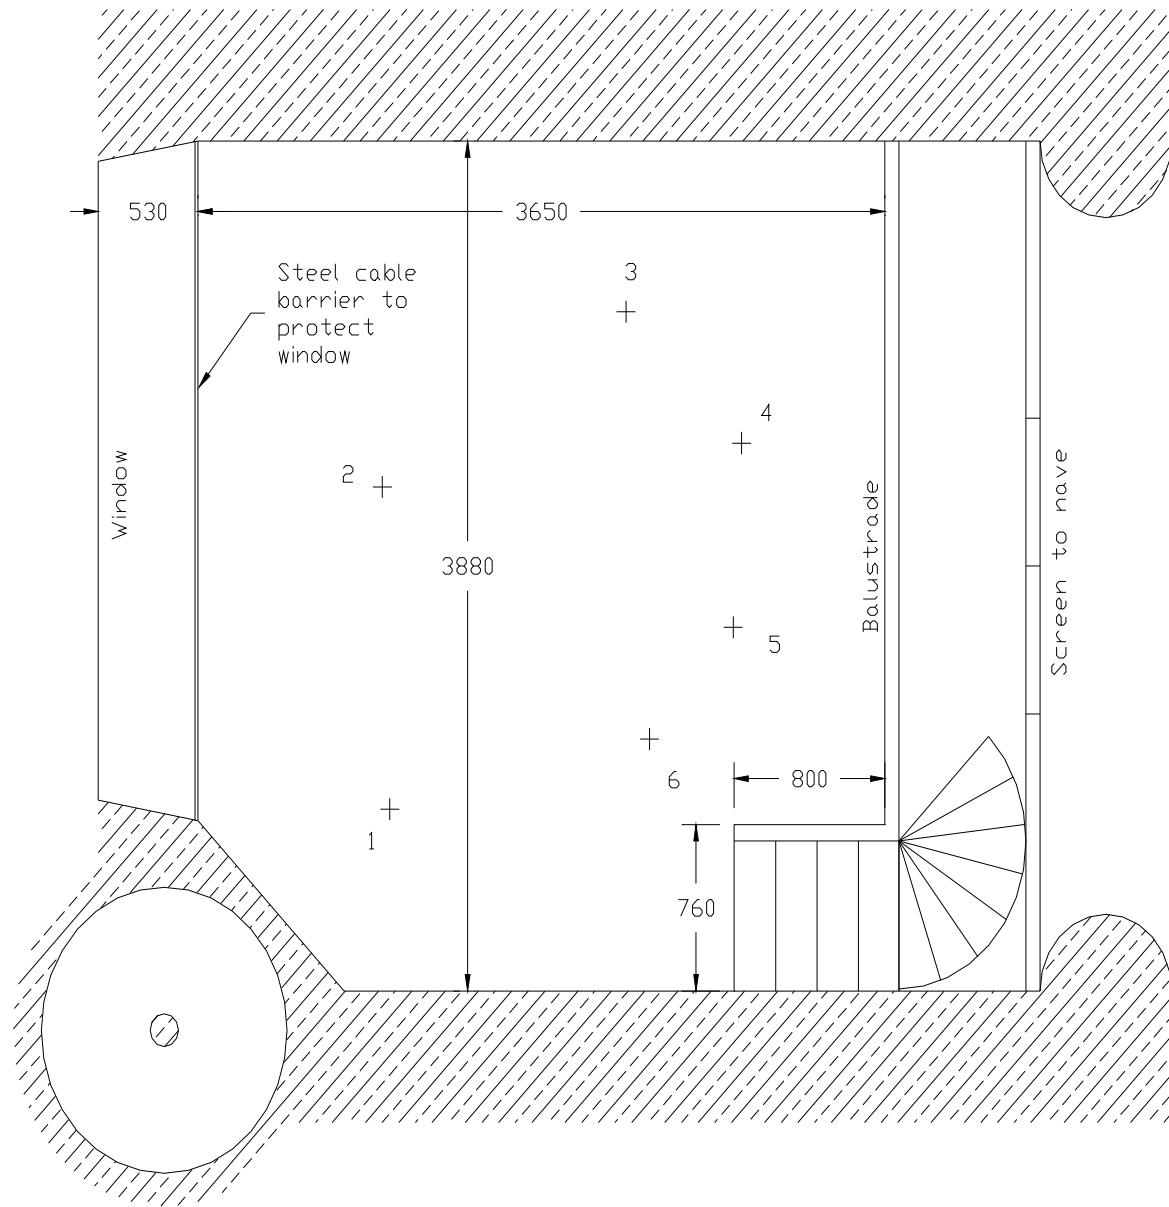
FIGURE 3
RINGERS' GALLERY

The ringers' gallery is reached by climbing the 11 steps of the metal fabricated spiral staircase. The area, almost square in section, is clean, carpeted and illuminated by four floodlights fitted high up in each corner. The lights in the South West and North West are at present working. The ones fitted in the South East and North East corners were not functional at the time of the inspection.

The six ropes fall in an acceptable circle and a rope guide rail is fitted 4.1 metres from the gallery floor level. The ceiling height was measured at 5.2 metres, located in which is a trapdoor which can be remotely opened by a rope and pulley system fitted on the South wall of the gallery. A large stained glass window is recessed into the West Wall. The floor of the Ringers' Gallery ends 530 mm. short of the window supports and this potentially dangerous gap is well protected by steel cable wires that run across the entire width of the window wall. The sanctus bell rope falls between the steel cable barrier and the window to the ground floor area.

The East end of the gallery is open to the main body of the church. A balustrade, of acceptable height and constructed of glass and steel, runs North – South across the entire width and forms one side of the spiral staircase.

10. The fault in the floodlights fitted in the South East and North East corners of the Ringers' Gallery should be rectified. If it can happen to these two lights there is no reason why it cannot happen to the other two. With the dark evenings approaching the natural light from the window will be reduced and any natural light from the nave of the church will be minimal.
