Derby Diocesan Association of Church Bellringers Consultant's Report	Report no. DDACB 02/003
Inspection of Bell Installation at All Saints, Heath	Issue date: 4/03/003

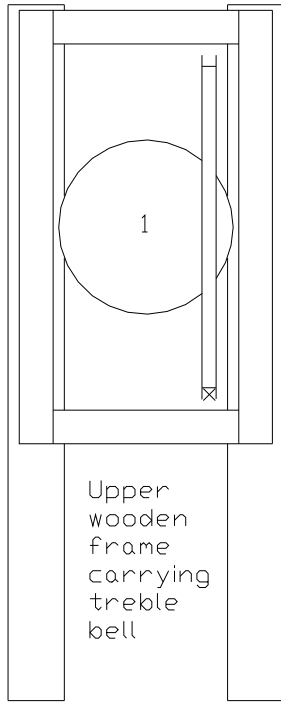
FIGURE 1 BELL
FRAME LAYOUT
AT ALL SAINTS
HEATH

4.2 Frames (see figure 1)

Bells 2,3,4 and 5 are supported in a low sided composite frame sitting on foundation beams which are obscured by the bell chamber floor boards. This frame is largely constructed from wood and cast iron and is a tight fit in the tower. Bells 2,4 and 5 are supported by cast iron frame sections on their wall side and wooden frame sections on their inside. Wooden frame members support Bell 3 on both sides. Use of cast iron has provided more space to enable larger bells to be installed than would be possible with an all-wood construction.

Bell 1, the treble bell, is supported in its own wooden frame above bells 2 and 5.

Visually the frames appear to be structurally sound. There are no signs of rot in any of the wooden sections and the metal sections appear not to be compromised by rusting. To be more certain of the integrity of the frames, a dial gauge was used to measure frame movement whilst each bell was rung. (It is difficult to quantify movement by eye and use of sensitive measuring equipment is the only sure way to assess movement). Figure 2 shows the points at which measurements were taken, all being in the horizontal direction. In his quotation, Fred Pembleton casts doubt on the strength of the cast iron frames supporting bells 5 and 4 and so measurements at "A" and "B" address this concern. He also doubts the integrity of the upper frame foundation beam wall fixings and so measurements at "D" and "E" were taken to address this concern. In addition measurements were taken at station "C" since movement in the wooden frame set between bells 2 and 3 will impose an unwanted side load on the bearings of bell 5. The table below gives the results.

Direct attachment of the frame to the wall at point "C" contributes to the small movements observed here and removes any tendency for applying significant side loads to the tenor bearings. The section of wooden frame between bells 3 and 4 is attached in an identical manner. It is not good practice to stiffen a frame in this way but the job appears to have been done some time ago in a competent manner with no sign of subsequent distress to the adjacent stonework.

- Check tightening of all screwed fittings including all tie bars in the wooden frames.
- Removing all rust from the metal frame sections and metal fittings with a wire brush and then painting with a coat of red oxide, a coat of primer and a top gloss coat of paint.
- Give the wooden frame sections a coat of Cuprinol wood preservative (or creosote)

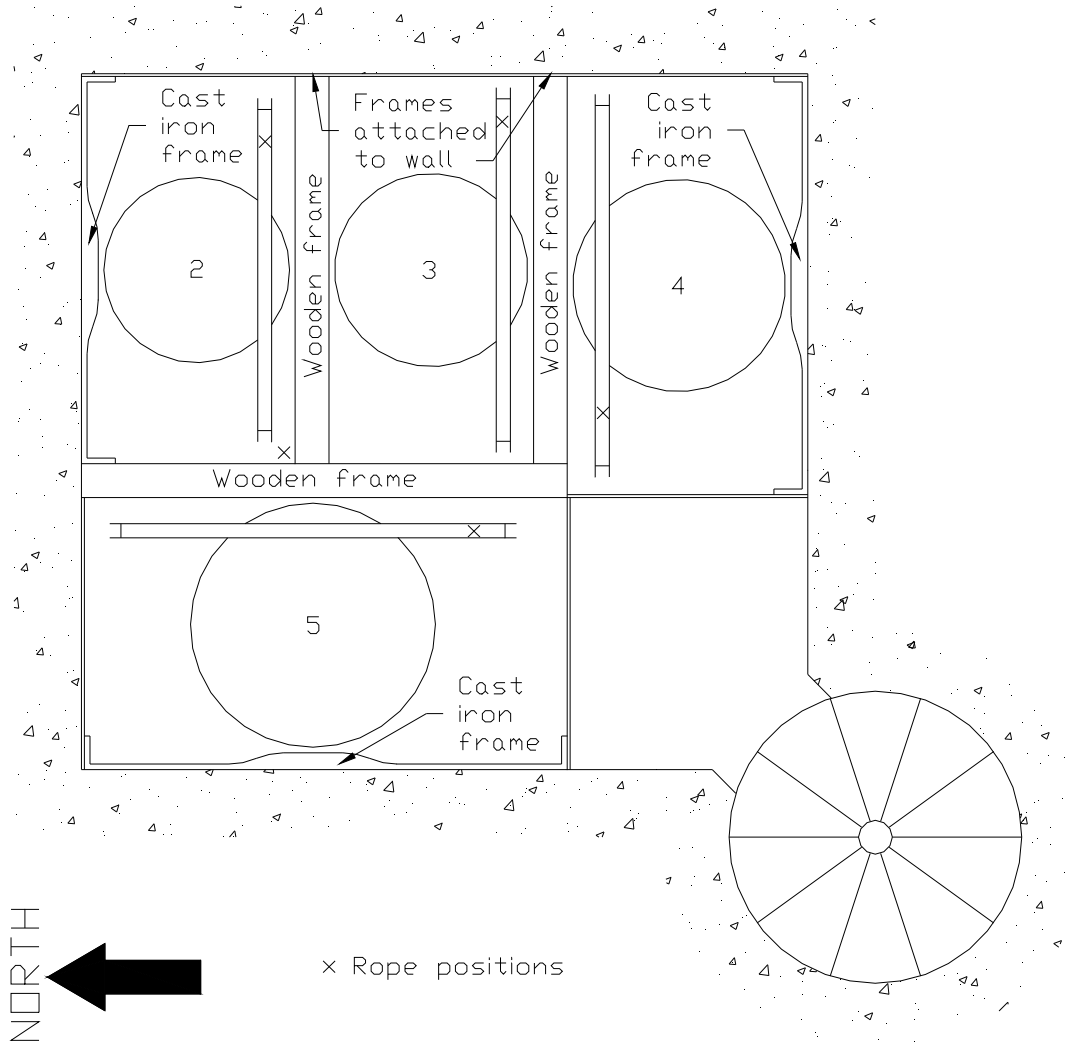
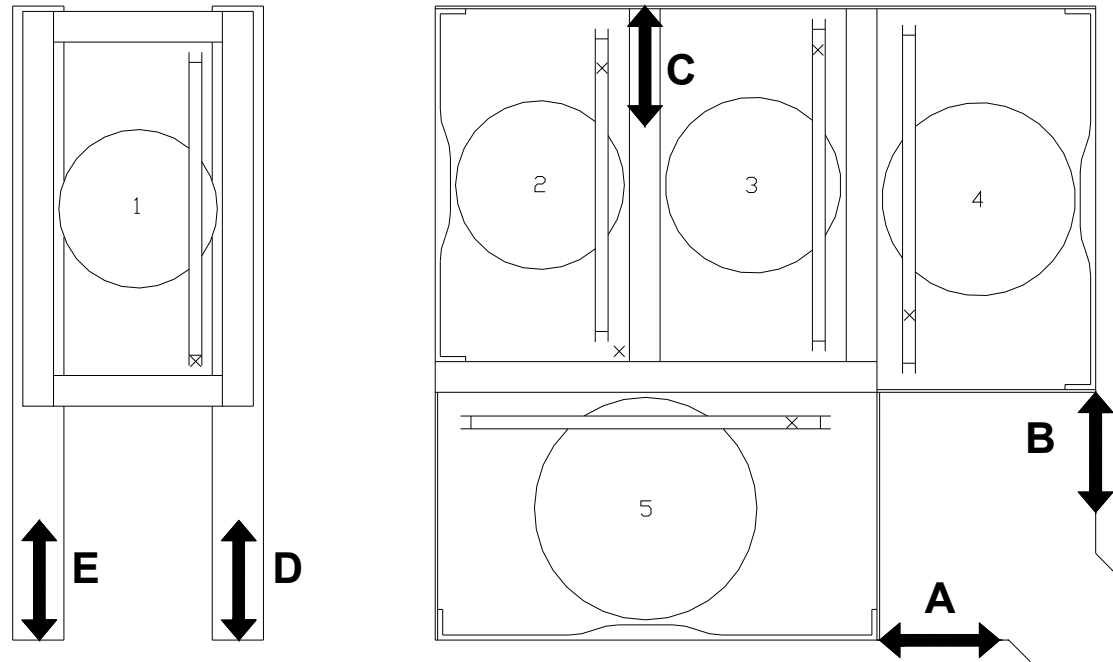
FIGURE 2 FRAME MOVEMENT MEASURING STATIONS

Bell Being Rung	Measuring Station	Movement (mm)
5	A	+/-0.3
4	B	+/-0.2
3	C	+/-0.15
2	C	+/-0.075
1	D	+/-0.02
1	E	+/-0.02

These results are commendably small and show the frames are very stable at the key points measured.
