**INSPECTION OF BELL INSTALLATION  
ST CLEMENT, HORSLEY  
9 December 1998**

The inspection was requested by Gordon Halls (Diocesan Bells Adviser) to provide a record following a recent overhaul of the installation by the local band and John Cater and his team.

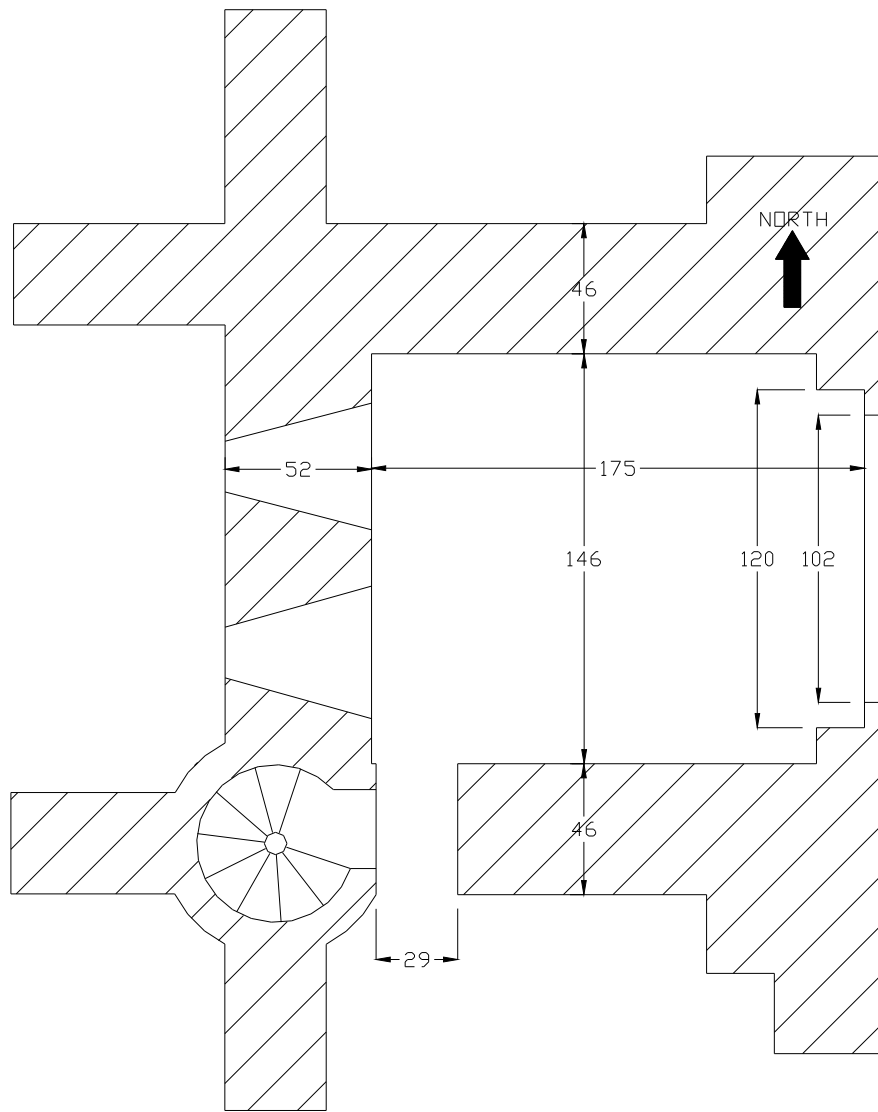
LOCATION ST CLEMENT Horsley
TITLE Ringing Chamber (GF)
DRAWN MDBanks 9 December 1998
DIMENSIONS inches

The ceiling of the ringing chamber is 246 ins high and so a rope guide frame is installed 168 ins above the floor. Principal floor dimensions are 175 ins east/west and 145.5 ins north/south. There are two windows in the west wall which are 76HX45Wins. Lighting from two flood lights is good.

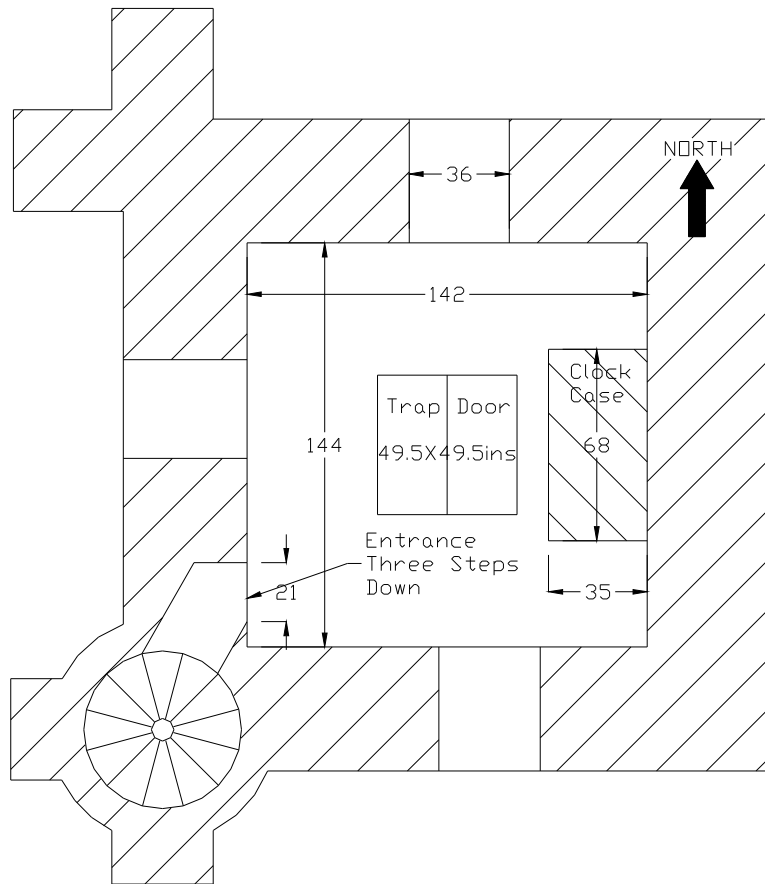
LOCATION ST CLEMENT Horsley
TITLE Intermediate Chamber
DRAWN MDBanks 9 December 1998
DIMENSIONS inches

Three wooden steps drop the 36ins into the intermediate room which is clean and used for storage. The auto wound clock is housed in a case on the east wall. There are windows on the west/north/south walls and a trap door (49.5X49.5ins) in the centre of the floor with three of the six ropes passing through. Ceiling height is 106ins. and the principal floor dimensions 142.5X142ins.

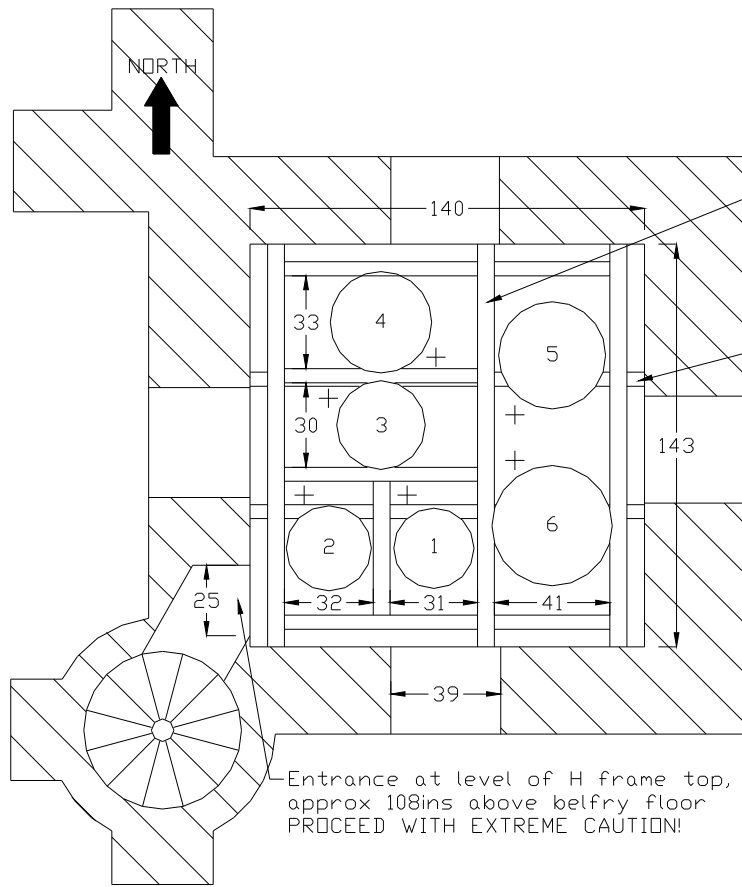
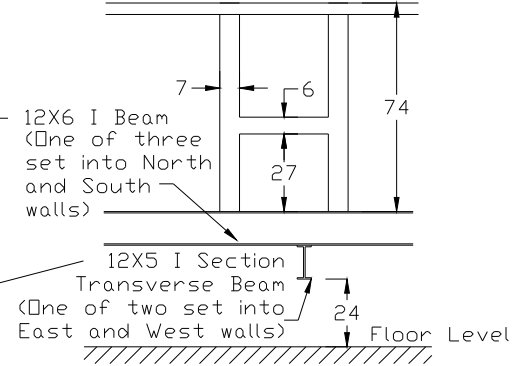
LOCATION ST CLEMENT Horsley
TITLE Bell Chamber
DRAWN MDBanks 9 December 1998
DIMENSIONS inches

Entry is at approximately 108ins above the floor level, and 11 ins below the top level of the steel H frame. Access to the ladder down to the floor and also the ladder to the steeple is by way of the top of the bell frame which offered neither a safe foothold nor handhold. At the time of inspection the frame was dripping with condensation and extremely slippery presenting a considerable hazard.

There is a louvre in the centre of each wall (39WX99Hins) fully protected against bird entry. (The louvre sills are positioned at the same height as the entrance door sill). Weather protection is inadequate with a small piece of perspex sheet in the south louvre. Full protection is essential in both the south and west louvres, the direction of the main prevailing winds which cause wind driven rain to come through the louvres.

The bell frame is of cast iron H frame construction mounted on three 12X6ins RSJs set into the north and south walls which rest on two transverse 12X5ins RSJs set into the east and west walls. (Framing connecting the upper edges of the H sections is not set into the walls). Details of sizes and layout are shown in the appended diagram.

Following the recent refurbishment the frame is in excellent condition with all rust stripped and the metal repainted.

1) Install weather proofing to the west and south louvres to exclude driving rain from the bell chamber. Use of thin wood (suitably treated against rot) or plastic material filling the full louvre area is suitable since this will not significantly attenuate the outside sound of the bells.

- consider installation of handrails and secure footways to access the frame ladder and steeple ladder from the entrance door
- install proper lighting to appropriate approved standards.
