Derby Diocesan Association of Church Bellringers Consultant's Report	Report DDACB 10/05
Inspection of Bell Installation at the Church of St. James the Great Idridgehay	Issue Date 14/10/05

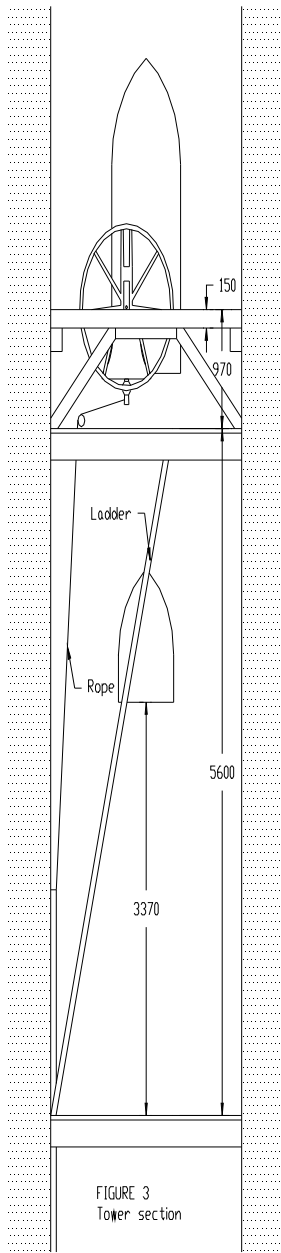
FIGURE 3
Tower section

The single bell is housed in a tower at the North East corner of the church which has a broach spire. There are four spire lights near the top of the spire, four large louvered openings, at bell chamber level, to each aspect near the top of the main body of the tower and a further two louvred windows on the North and East aspects at a lower level. Although all the openings appeared to be well protected by plastic mesh, fitted internally, there were signs of bird ingress. The tower appears to be of sound stone construction with no obvious signs of structural weakness. The single bell, hung for full circle ringing, is now only chimed. This is carried out from the vestry which is situated immediately below the intermediate room.

The bell is supported on two wooden beams running North - South supported on stone corbels at each end. Cross beams are fitted running East- West at either end. The rigidity of the frame is further enhanced, on each side, by wooden support beams, keyed into the angle where the floor meets the wall at one end and spaced apart by a distance piece fitted under the main beam. There was no sign of woodworm or rot in any part of the frame.

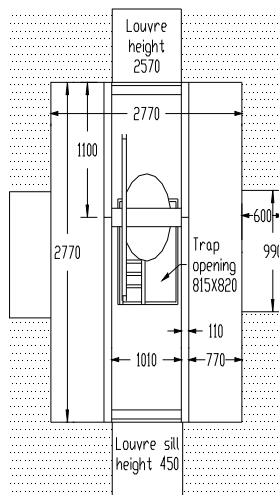
FIGURE 1
Bell Chamber

The bell chamber is square in section and well lit by natural light. It is thought unlikely that anybody would require access to the area in the dark and the installation of artificial light is of low priority.

There is a clearance of about 400mm between the floor and bell which hangs above the access hatch. Although not impeding entry to the bell chamber care should be taken to avoid head contact with the lip of the bell. The trapdoor was in the chamber but had obviously not been used for a some time.

The area has no artificial light but has good natural daylight from the louvres on each aspect. Each louvre was well protected from bird ingress by plastic mesh which appears to have been fitted several years ago. It was noted, however, that two of the slate slats in the South louvre and two in the East louvre were in danger of sliding out onto the roof of the church.

In the wooden floor there are signs of rot in the North West corner. The louvres and the floor would benefit from a good sweeping.

Special attention should be given to the area where the bell frame and wooden support beams meet the stonework. The chamber was dry and there were no signs of water ingress despite the hard rain that had fallen the previous day.

7.3 The debris should be removed from the bell chamber taking special care to remove that which is lodged between the wooden frame and the stonework.

7.4 Repair rotted section of bell chamber floor.

7.5 All the metalwork in the bell chamber should be wire brushed, bolts checked for tightness, and then painted with red oxide paint followed by an undercoat and topcoat.

7.6 The wooden frame should be given a good wire brushing and then treated with Cuprinol wood preservative or creosote to maintain the timbers in good condition.

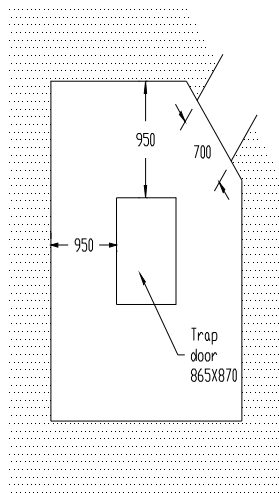
FIGURE 2
Intermediate room

This is reached by an external door which is kept padlocked. A spiral staircase (18 steps) leads to a tall, square, unlit room, Natural light enters through the louvred windows on the North and East aspects. The quantity of natural light actually entering the room through these windows is diminished by the accumulation of nesting material and bird debris on the ledges. There is also an accumulation of dirt and sundry items on the wooden floor and on the stone spiral staircase. The cleaning up of the whole area should be made the focus of a working party. There appears to be an electric supply to the room and the installation of a double fluorescent light should be seriously considered. This extra illumination would greatly assist in the cleaning of the area. The floor is of wood construction with a trapdoor neatly inset in a central position which is immediately over the vestry. The chiming rope hangs in the North West corner and passes through a single rope guide before passing through the floor into the vestry. The ceiling is of substantial wooden construction with the bell chamber floor being supported on seven joists running North - South. Access to the bell chamber is by a free standing wooden ladder, which although of sound construction, was not secured at either end.

7.2 Fit a double fluorescent fitting in the intermediate room.

7.8 Clean the intermediate room and spiral staircase of any accumulated rubbish. Although all the louvres appear to be well covered there has definitely been some bird ingress over the years.

7.9 Secure the free standing wooden ladder

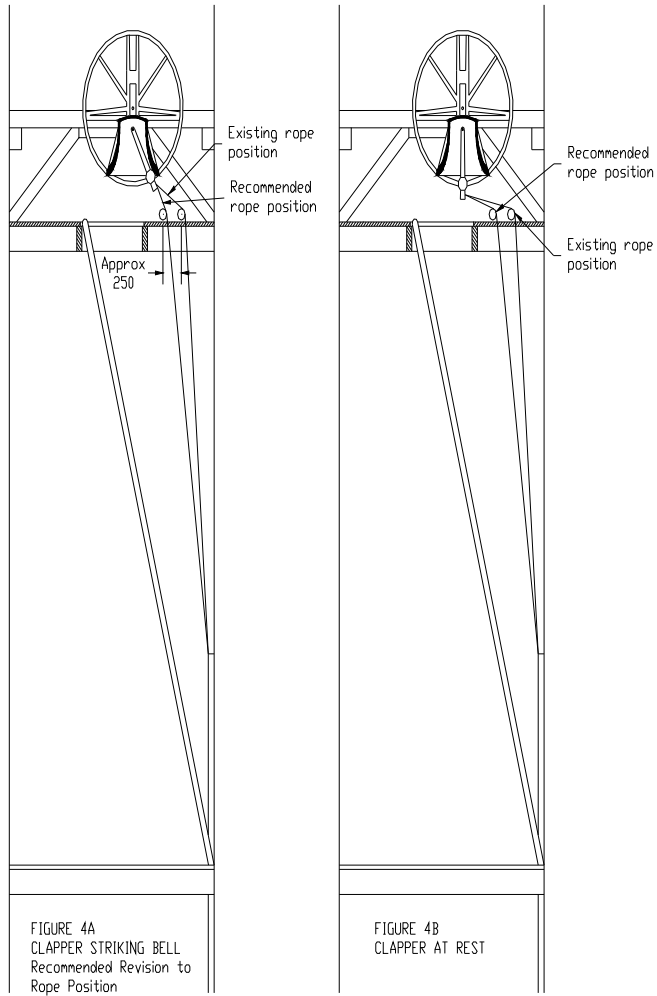
7.1 See figures 4A and 4B

understood that this has been fitted by local labour. The chiming rope was fitted round the clapper and then over a pulley and down through the intermediate room to the vestry. One of the dangers of chiming a bell is the danger of cracking the bell if the clapper remains in contact with the strike face of the bell after the initial impact. Bell metal is very brittle and the bell needs to return to its normal 'silent' state without any 'foreign' object (e.g. clapper) being in contact with it. (see 7.1 under Recommendations)

If the bell was cracked it would have to be removed from the tower for a repair to be undertaken and this would be a difficult and expensive undertaking.

By altering the pulley position as shown in Figure 4A the possibility of cracking the bell by chiming is reduced significantly. The pulley should be positioned so that when you actually pull on the rope the momentum of the clapper will carry it to hit the bell but then it will fall away from the surface and allow the bell to return to its normal 'silent' state. The 250 mm is, as stated, an approximate dimension and the exact position should be found by trial and error.
