Derby Diocesan Association of Church Bellringers Consultant's Report	Report DDACB 04/08
Church of St. Giles, Killamarsh Inspection of Bells	Issue Date 13/06/08

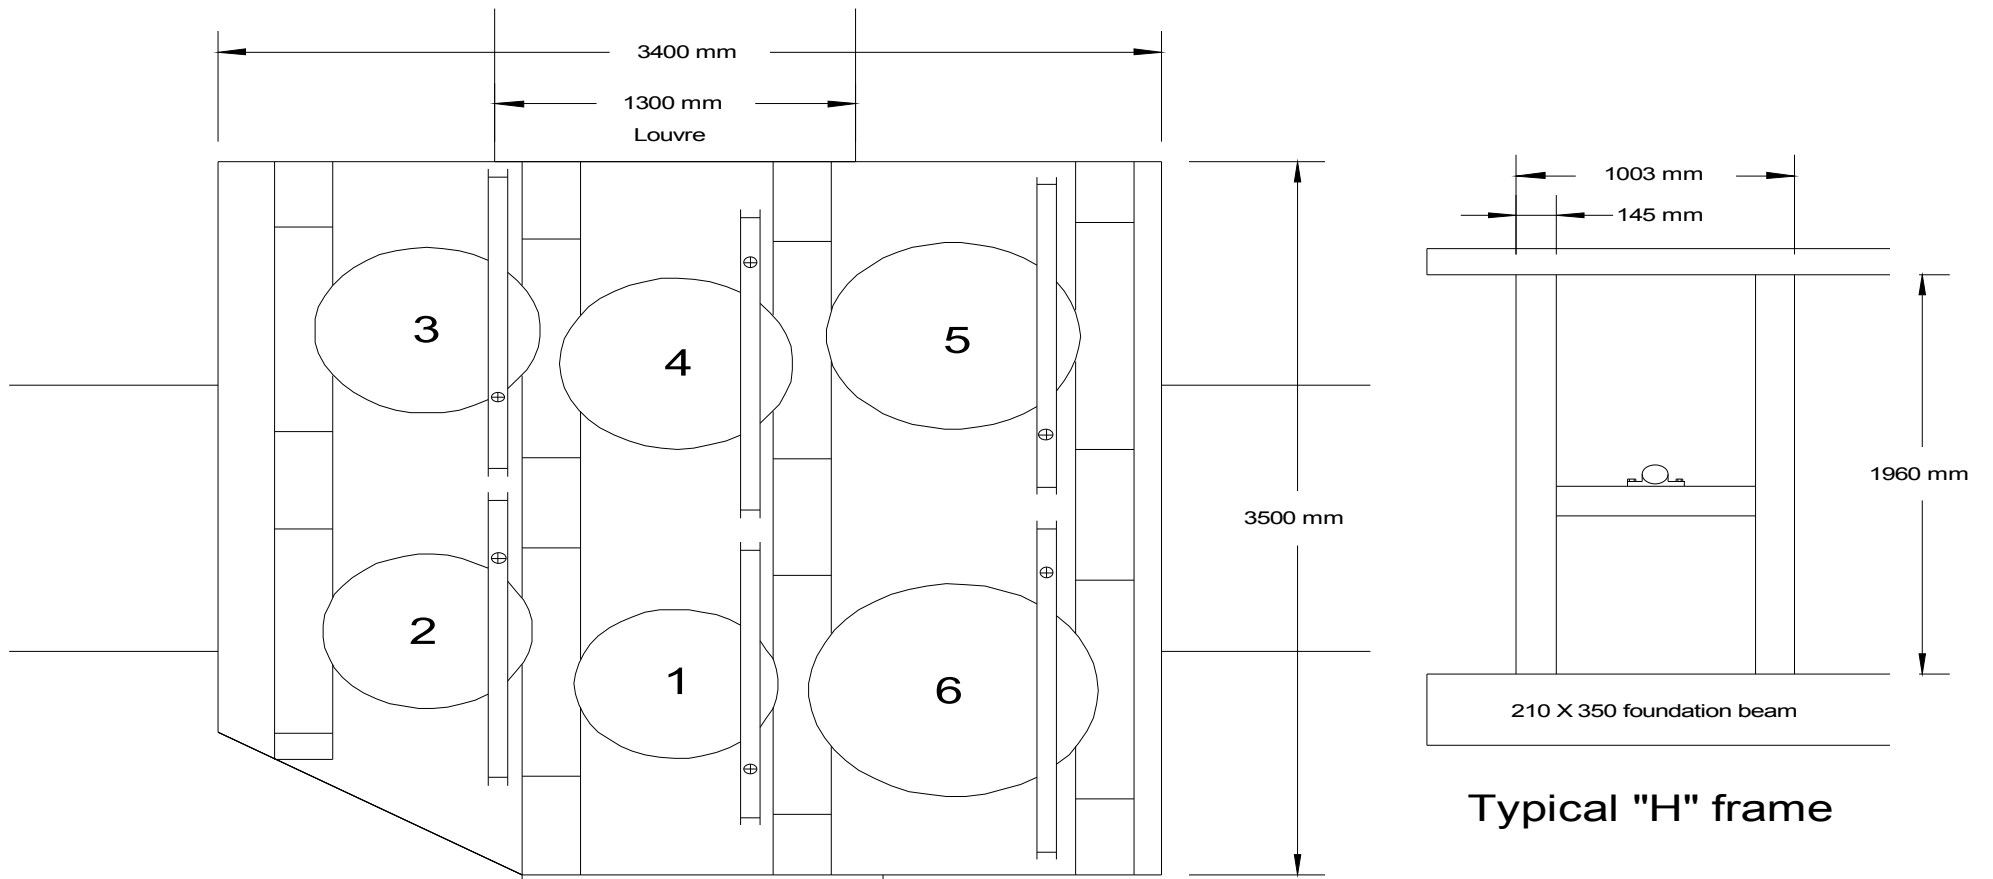
FIG1 BELL CHAMBER LAYOUT

The bell chamber is reached by climbing a further 14 steps. Entry is through a doorway, where once was fitted a wooden door. This now lies against the South wall but does not interfere with the clock mechanism or ringing of the bells full circle. There is no artificial lighting fitted to the area and natural light enters through the louvres which all have wooden slat type fittings over the bottom halves. This allows birds to fly in and nest in the area. One bird was present during our inspection. Nesting material and bird droppings were noted between the walls and the foundation beams and on the screeded concrete floor. This debris retains moisture and promotes favourable conditions for the onset of rot in adjacent timbers. (It is also a health hazard). The debris should be removed and the louver openings covered in "Galebreaker" porous sheeting. This would cut down on the natural light into the area and artificial lighting would be required for fitting of muffles and any required maintenance work to be carried out safely. The wooden roof appeared to be in good condition with no sign of water ingress.

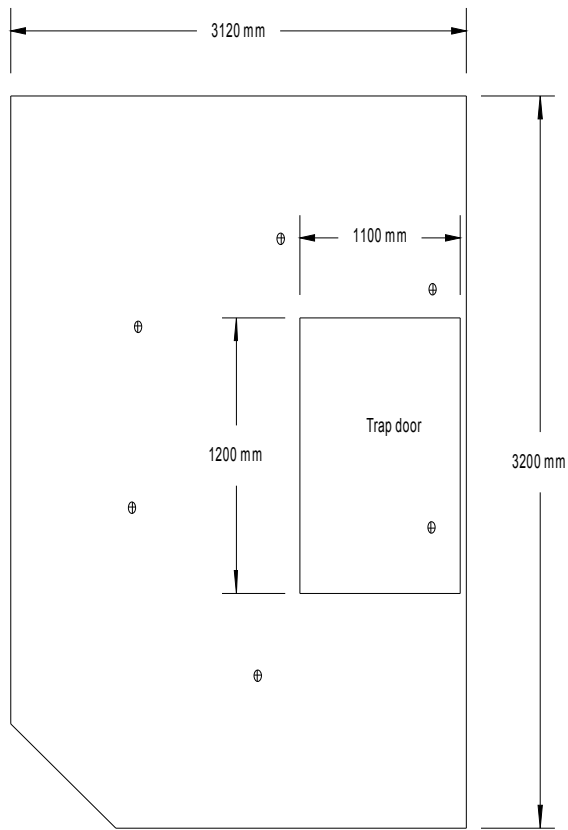
FIG 2 CLOCK ROOM

Reached by climbing 30 steps of the spiral staircase located in the South West corner. The Potts clock mechanism is well fitted and in no way interferes with any of the rope falls. The area is lit by a single incandescent bulb which gives an acceptable level of light to the area. The floor of wooden construction has a trapdoor fitted and the ceiling of wooden construction is 2450mm above the floor level. The ropes on bells 1,4, & 5 are 'drawn' and the floor pulleys

appeared to be in good condition. Bell 6 is 'drawn' slightly without the need for a pulley. The area was clean.

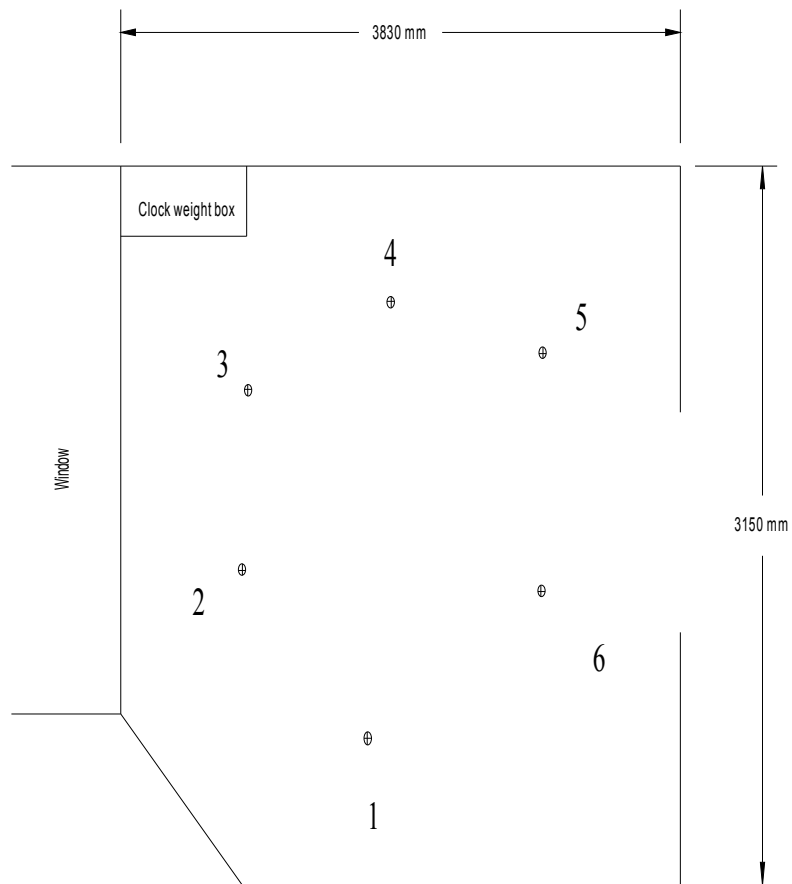
FIG 3 RINGING ROOM

The main door to the church is located on the South wall and the ringing area is located at the West end of the church behind a wood and glass screen. The area is used for storage but this in no way affects the ringing of the six bells, the ropes of which fall in an acceptable ringing circle. Good natural light enters the area through the large window in the West wall. The wooden ceiling is 6 metres above the floor level. A rope guide frame, to which is fitted a single fluorescent light, is positioned 1500mm below the ceiling. This height is safe in the event of a ringer being carried up following the breaking of a stay. Clock hammers are fitted to strike bell numbers 1,2,3 and 6 and the hold off mechanisms are located on the North and South walls and very positive.

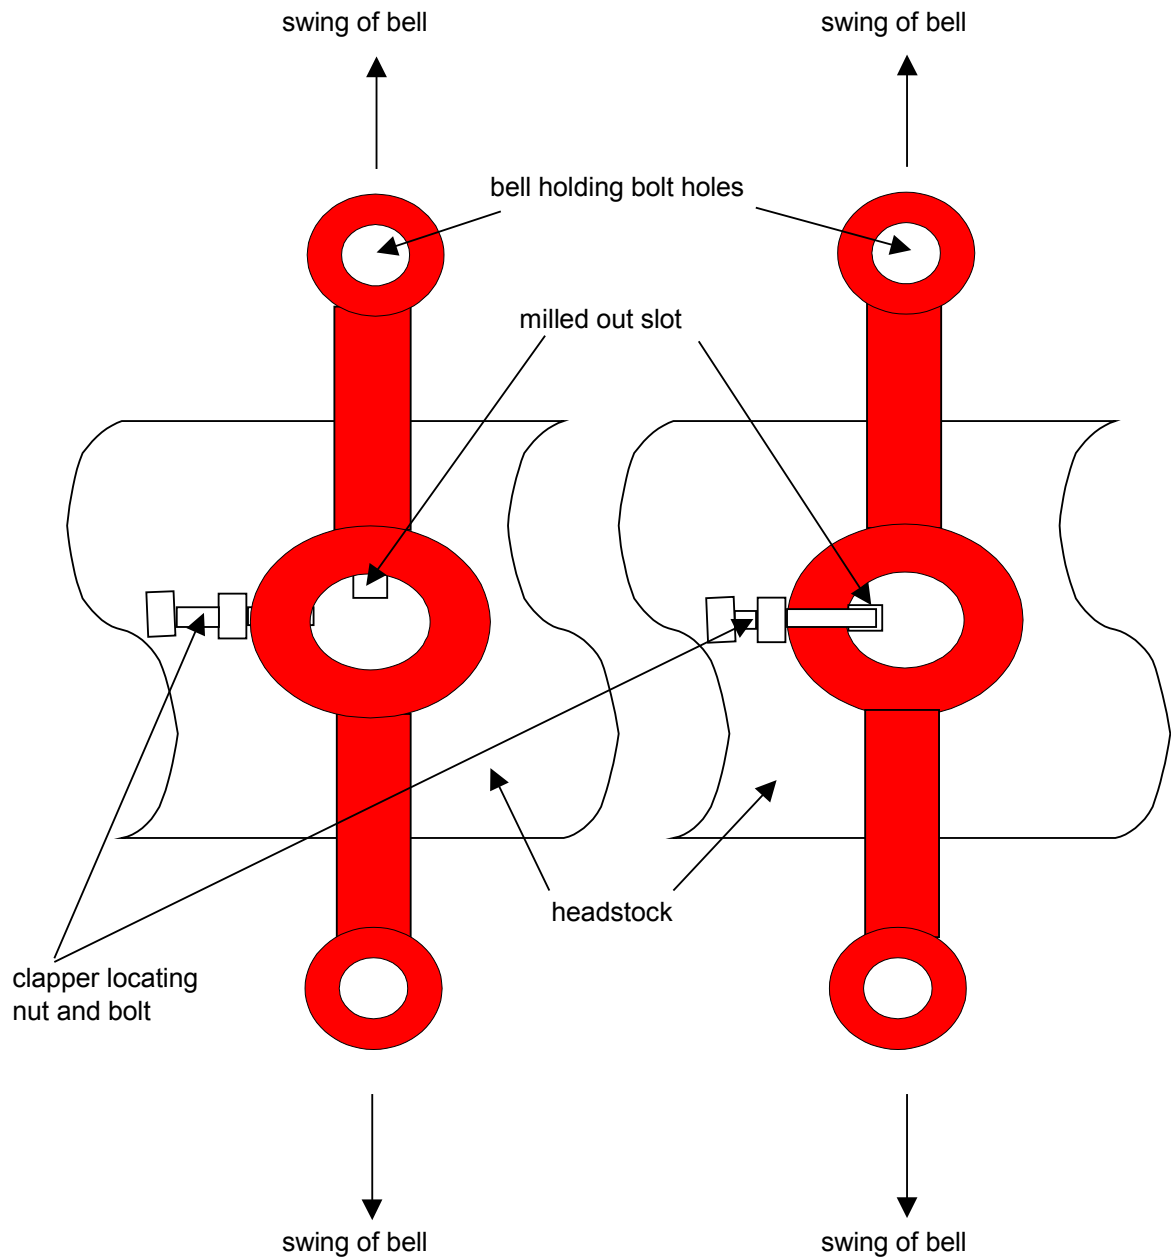
DIAGRAM 1
 NOT TO SCALE

It was however possible to 'rotate' the clappers on bells 1,2,3, and 4 through 360 degrees. Even though all the clappers appeared to be swinging in the correct line (at 90 degrees to a line drawn through the centre line of both bearings) this situation is unacceptable and all the clappers should be removed and refurbished. It is thought that initially when the bells were rehung the leather washer fitted between the clapper assembly and the head of the bell created enough friction to stop this happening. Over the years the leather washers have deteriorated and dropped out leaving the clapper free to swing over a wider arc. There appears to have been a manufacturing problem as the clapper locating nut and bolt is tightening down onto the round section of the crown staple and not locating in the milled out section designed for the purpose of stopping the clapper rotating. (see diagram 1).

LEFT HAND SHOWS SET UP AS AT PRESENT which is **WRONG**
 clapper assembly location is only held in place by end of locating bolt on threaded section of crown staple.

RIGHT HAND SHOWS CORRECT INSTALLATION
 clapper assembly cannot rotate due to being 'held in place' by locating bolt

1. All the clappers should be removed and new crown staples fitted with the clapper locating groove milled in the same plane as the clapper locating nut and bolt.
