INSPECTION OF THE BELLS AT ST MARY AND ST BARLOK AT NORBURY ON 8 JULY 1999

Report prepared by M D Banks

Approved by G A Halls
Diocesan Bell Advisor

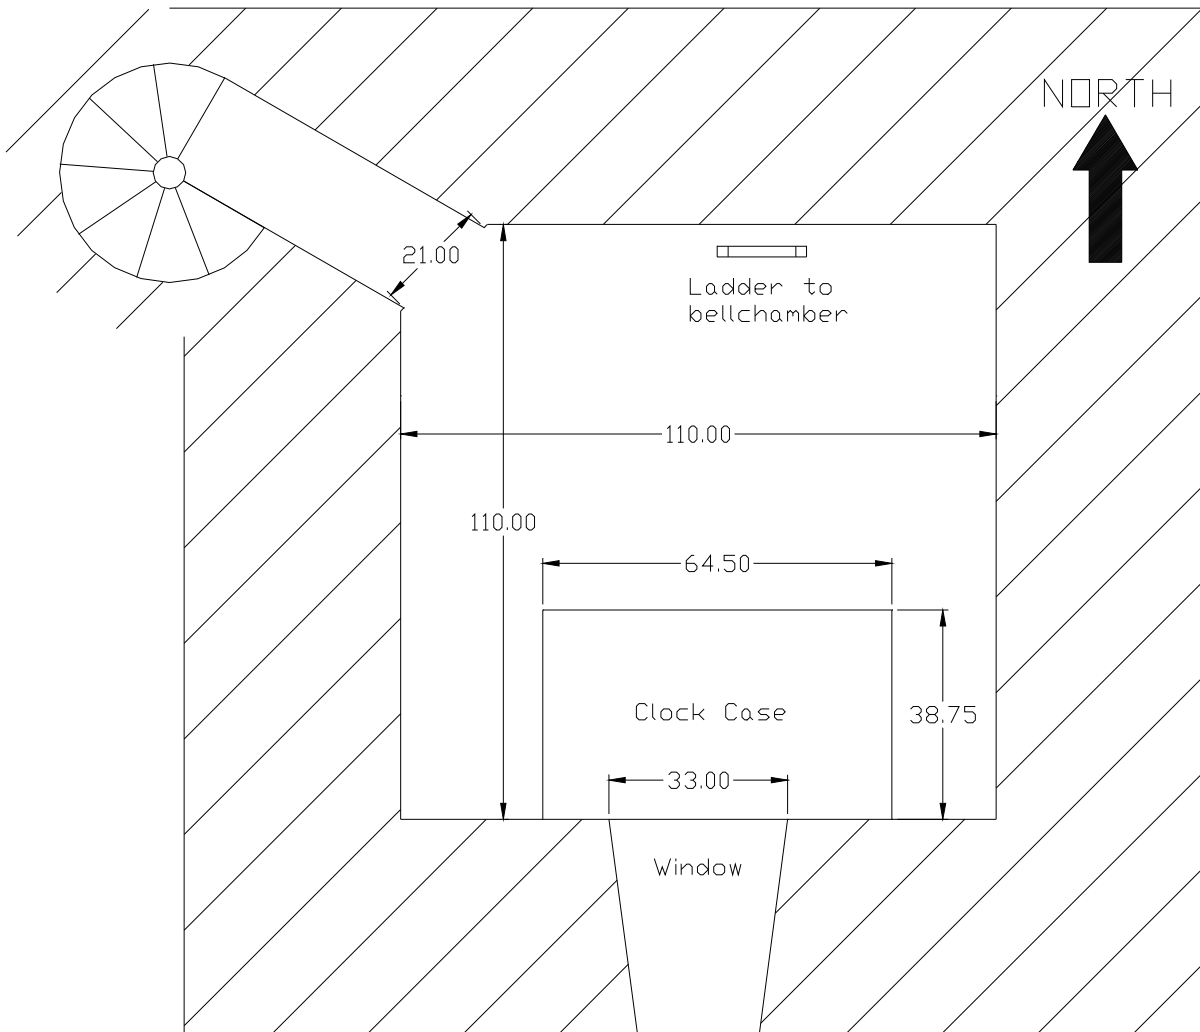
Fig 2 CLOCKROOM LAYOUT

Figure 2 shows the layout of the clock room. The clock room is reached via 28 steps up the spiral staircase, each step rising approximately 8ins. The hand wound Smiths clock is housed in a case on the south wall and its weights fall in the southeast corner of the

tower. Behind the clock is the only window in the clock room, measuring 41ins high X 33ins wide. Ceiling height is 109.5ins. Access to the bell chamber is via a vertical ladder on the north wall and a 15 X 21.5ins trap door in the ceiling.

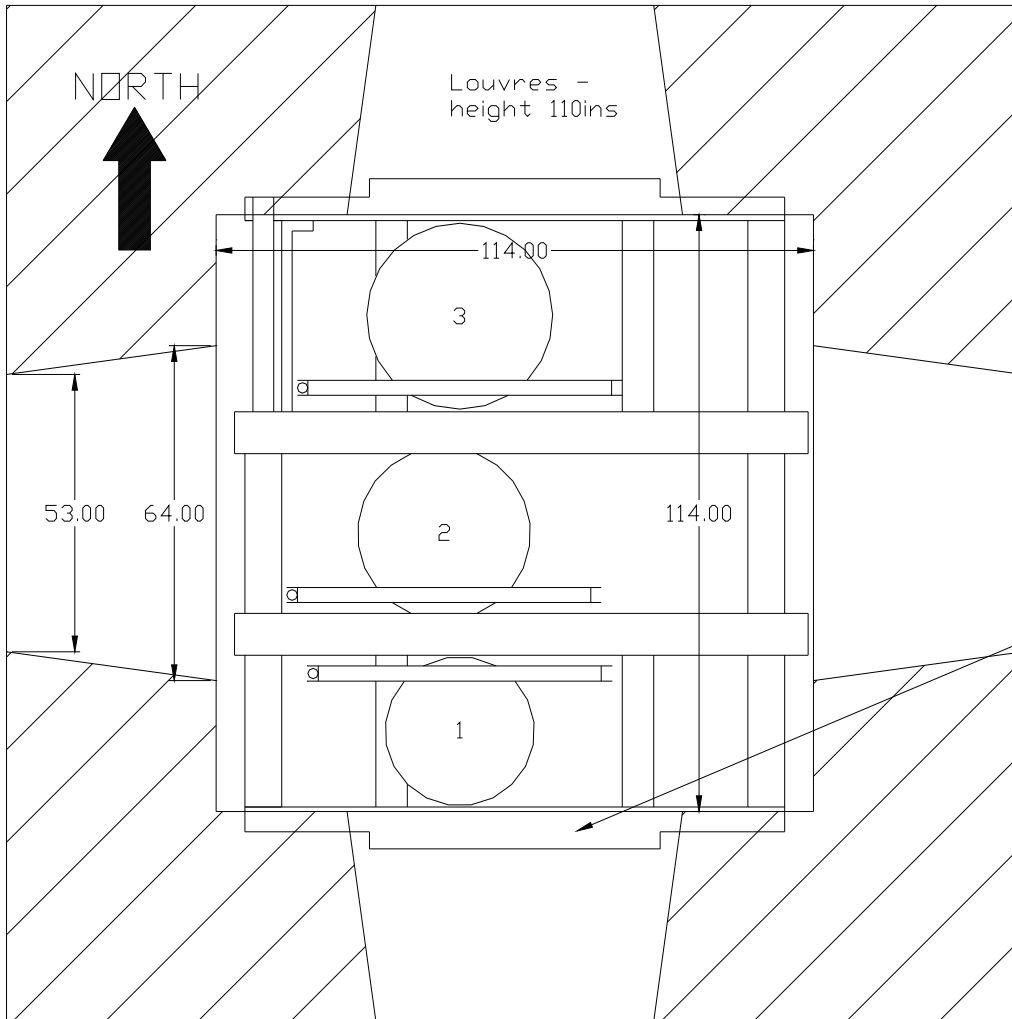
Fig 3 BELL CHAMBER LAYOUT

Figure 3 shows the layout of the bell chamber. Entry is gained through a trap door under the tenor bell.

The floor (and much of the bell frame) is supported on three 16 X 5.5ins oak beams running east/west which in turn rest on two 9 X 7ins beams running north/south. The bell chamber is free from birds but has obviously suffered in the past since there is nesting material particularly on the east louvre sill. There is general debris elsewhere. One of the wire netting grills over the louvre on the north side is not fixed properly.

The predominant directions for driving rain is from the south and east and there is no protection for this in the south and west louvres. Use of plastic sheeting held in place by wooden battens is recommended.

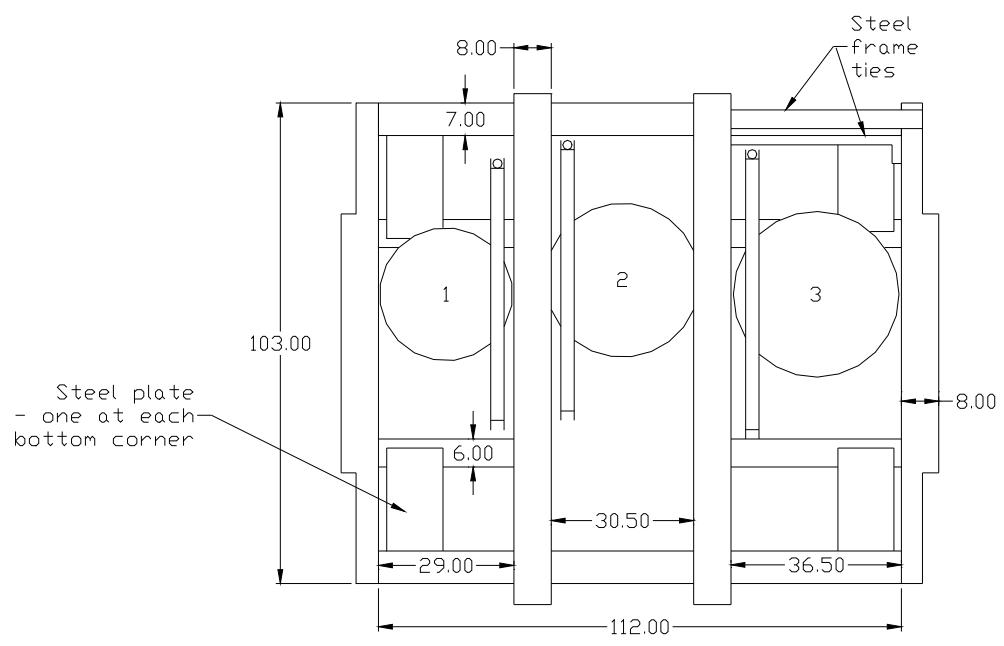
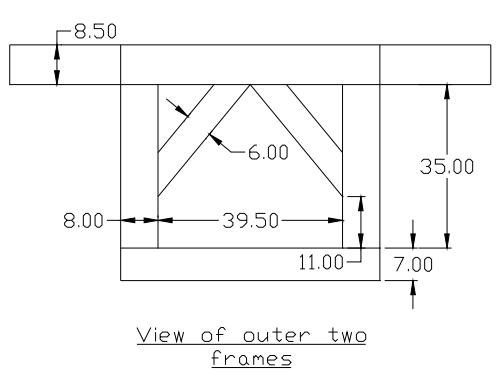
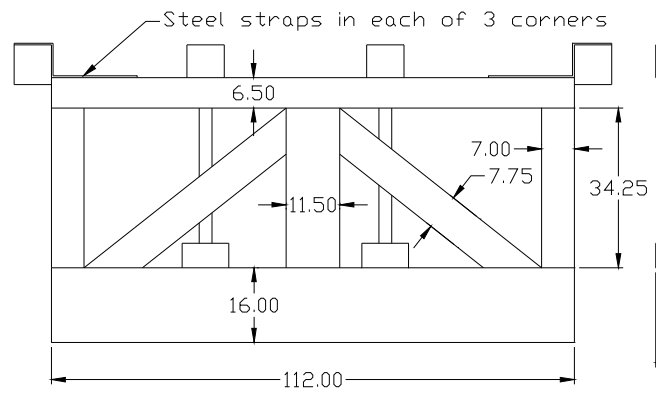
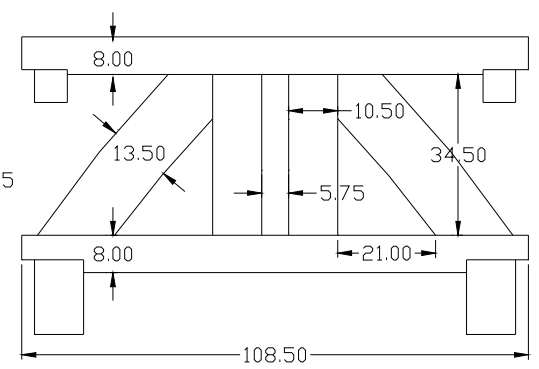
Fig 4 GENERAL ARRANGEMENT OF FRAME

A general arrangement drawing of the wooden frame is shown in figure 4. The bells are set in line along a north/south axis, swinging east/west. The two centre transverse frame elements are of queen post design and rest on two substantial foundation beams (16 X 7ins). The two outer transverse frame elements rest respectively on the north and south louvre sills with their top beams set into, but not attached to, the adjacent walls.

These outer transverse frame elements have a high degree of independence of movement relative to the rest of the frame since they have only a narrow footprint on the louvre sills and the load path to the foundation beams is tenuous. The lack of rigidity means that when the bells are rung full circle, movement of the outer frame elements is controlled (to about 2mm) by impact with the tower stonework. The structural integrity of the tower can be degraded by exposure to hammer blows of this type although there is no evidence that damage has occurred to date. There have been attempts in the past to improve the load path by use of steel straps at three of the top corners and by the use of flat steel plates between the foundation beams and short 6ins beams which span the base of pits 1 and 3. It is considered safe to continue ringing, but it is recommended that further thought should be directed at determining ways to improve the frame rigidity.

Each of the transverse top beams has been extensively relieved to allow clearance for the bells to swing. Theoretically the treble and tenor bells would be expected to require only slight relief of their frames since their pit widths are roughly equal to the respective bell diameters. However the poor load path to the foundation beams of the outer transverse frame members means that the treble and tenor bells yaw when rung full circle. This

requires greater than expected relief of the frame. When the treble was test rung full circle it was found to be hitting the frame hard enough to lift its bearing on the north side! Remedial work with a hammer and chisel restored adequate clearance. (It would appear that prior to 1890 the bells might have been hung at a larger radius since there are also clearance slots at a radius beyond the current bell swing path. Reducing the hang of the bells would have eased an even worse yaw problem).

A severe attack of rot is evident in the bottom beam of the north transverse frame. Being in the centre of the beam this is not critical to ringing of the bells but does further reduce the stiffness of the frame. It should be treated, although ideally the beam should be replaced. The north louvre should be made weather proof to prevent ingress of rain on to the frame. There is also woodworm in the wooden inserts under each of the bearings which should be treated.

End frames rest on louvre sills with upper cross beam recessed into wall. Inefficient load path to grillage beams results in movement at cross beam ends limited to 2mm by impact with the tower.

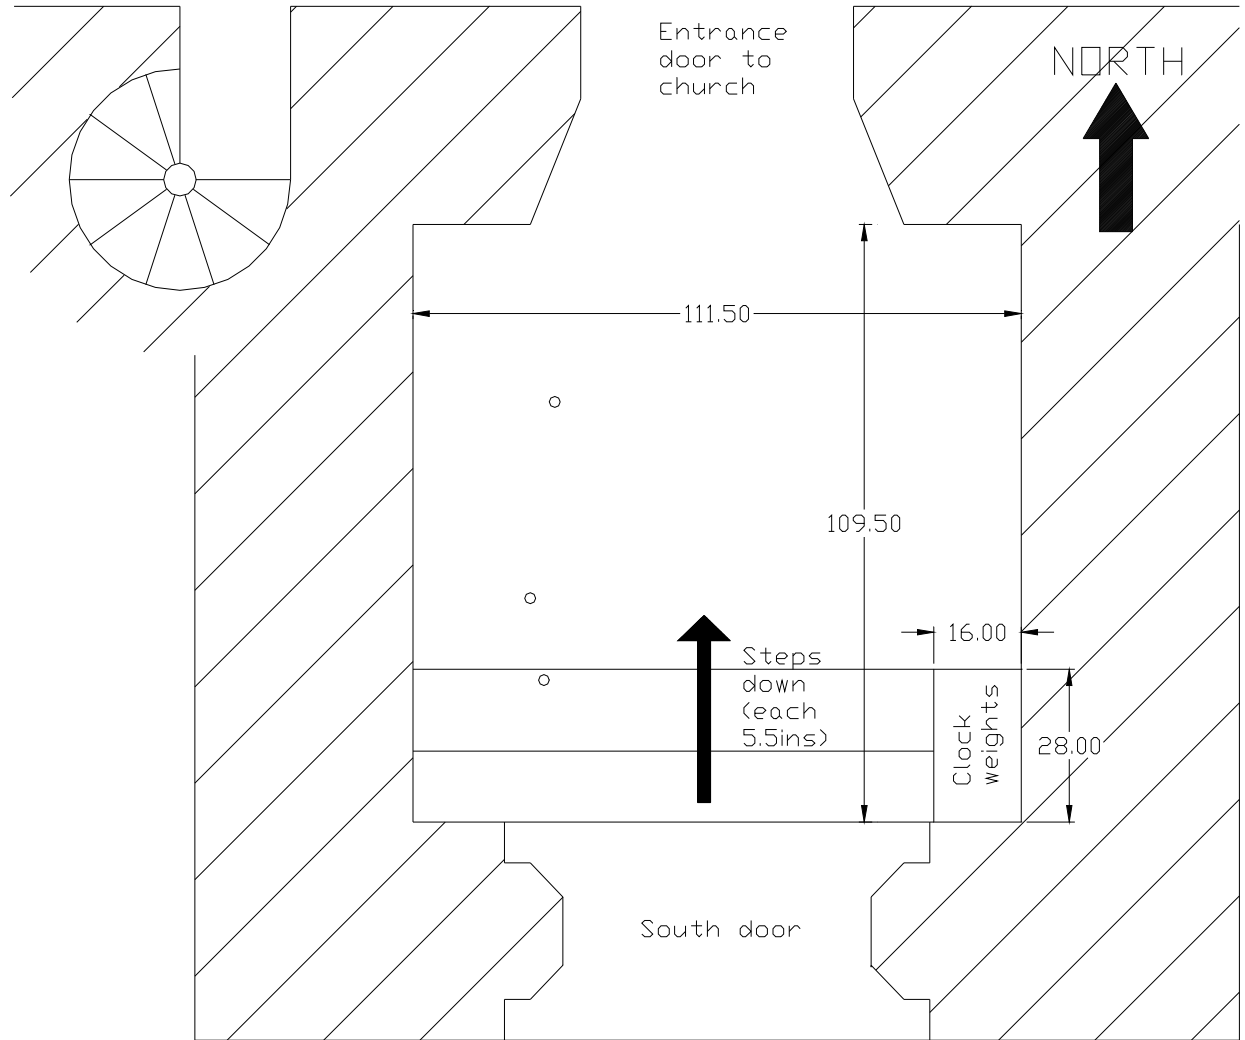
Fig 1 GROUND FLOOR LAYOUT

Figure 1 shows the layout of the ground floor ringing area where it can be seen that the three ropes fall in a near straight line at a distance of about 24ins from the west wall. Ceiling height is 228ins and there is evidence that an intermediate (ringing?) floor once existed at a height of 149ins. (If this was a ringing floor then the ceiling height would have been only 79ins which is too low for safe ringing).
