Derby Diocesan Association of Church Bellringers Consultant's Report	Report DDACB 09/05
Church of Saints Peter and Paul Old Brampton – Inspection of Bells	Issue Date 29/08/05

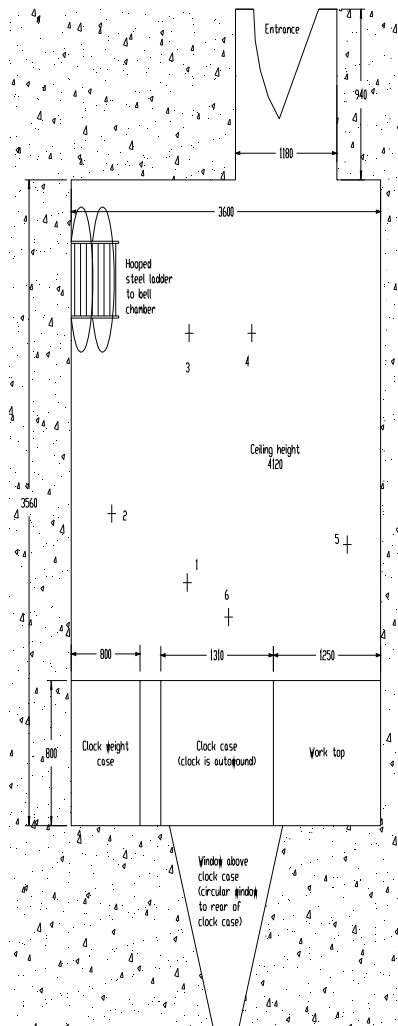
FIGURE 1
RINGING ROOM

The ringing room is roughly 3,6 metres square and is well lit artificially by two fluorescent tubes supplemented by daylight from a window above the clock case and a small round window below. The clock is driven by auto-wound weights positioned in the original weight shaft which extends through the ceiling into the bell chamber immediately above.

The ringing circle is not good; the ropes to bells 6,1 and 2 lie in a straight line (making rope sight difficult) and the ropes for bells 6 and 1 are too close together. In an ideal world there should be a clear space around each rope of 600mm, particularly on the heavier bells, but rope 6 is too close to the clock case and rope 5 is too close to the east wall.

The ceiling comprises tongue and groove boarding fixed to the underside of the bell chamber floor joists and has a total thickness of about 220mm. A hooped iron ladder gives access to the bell chamber via a trap door in the northwest corner. Since there is no intermediate room between the ringing chamber and the bell chamber, the bell sound levels in the ringing room are higher than desirable. Sound levels were measured at 77 - 82 dB(A) as shown in the table.

To maintain satisfactory voice communication between ringers and remain within legislative guidelines on sound levels, 80 dB(A) is the absolute maximum that is considered tolerable in ringing rooms for general ringing. The target is 10 dB(A) less than this, specifically to achieve ringing room sound levels for each bell of between 68 and 72 dB(A) with ideally no more than 3 dB(A) spread between all bells. Much of the sound comes through the large ceiling bosses and the unsealed trap door. Also the old weight shaft acts as a

sound conduit. Wall to wall carpeting reduces reverberation in the ringing room and so is already helping with sound control.

The ceiling height is 4120mm which is good. A minimum ceiling height of 3700mm is considered to be necessary from a safety point of view since should an inexperienced ringer break the stay on a bell he/she should have time to let go of the rope before being lifted to the ceiling!

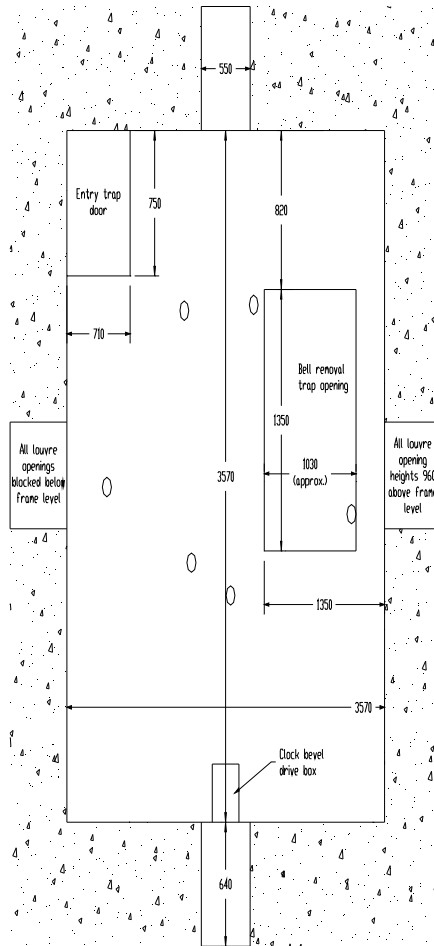
FIGURE 2
BELL CHAMBER

The bell chamber is well lit by electric lights both below and above the bell frame. There is a clearance of about 700mm between the floor and the underside of a steel beam which shores up the bell frame foundation beams. This is an obstacle to accessing the bells for maintenance work and regular sweeping of the floor would make this task more pleasant! The top of the frame is 2230mm above the floor and is reached via a short wooden ladder in the pit of bell 2. This ladder is missing one rung, making it unsafe, and should be repaired as soon as possible. The confined space of this pit makes negotiation of the ladder a challenge in any case!

The floor boss for the rope from bell 2 comprises a short box section. One side of the box has become detached and is fouling the rope. This must be rectified as soon as possible.

The bell chamber floor has suffered for many years from dampness resulting from ingress of rainwater. Although ingress of rainwater is now resolved, it is probable that the joist ends in the west wall have rotted to the point where they cannot safely transmit the floor weight into the wall. A 152 X 76mm rolled steel joist, set north/south in the ringing room walls, supports this side of the floor. There is serious rot evident in the tongue and groove boarding in the centre of the floor and a lack of support for the floor under the tenor bell. It seems likely that some joists may have partly succumbed to dry rot at mid span and it is recommended that the boards should be lifted to enable a structural survey to be carried out.

- 8.1.1 Replace the slider pivot block under bell 1 - do not ring bell 1 again until this work is completed!
- 8.1.2 Replace the missing rim segment on the wheel of bell 2. It is recommended that this be glued and screwed in place.
- 8.1.3 Retie rope 5 higher to move the worn section of rope above the garter hole.
- 8.1.4 Repair the floor boss for the rope of bell 2.
- 8.1.5 Replace the missing rung in the ladder giving access to the top of frame.
- 8.1.6 Carry out a structural survey of the bell chamber floor.

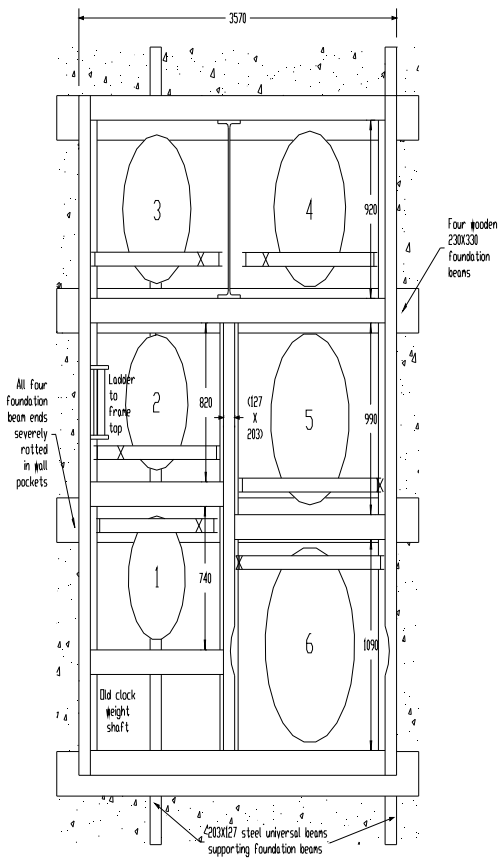
FIGURE 3
BELL FRAME

The frame is a conventional low-sided wooden (pine?) frame installed in 1887 and rests on four large foundation beams set east/west in the tower. It is well braced by tie rods and metal plates. Viewed from the underside, two of the tie rods on the truss between bells 5 and 6 appear to be loose and ought to be tightened.

Wind blown rain comes predominantly from the southwest and the frame has suffered in the past from the ingress of water, particularly on the west side.

The foundation beam-ends in the west wall have been severely damaged by dry rot to the point where some are no longer able to transfer frame loads into this wall. An alternative load path has been provided by installation of two 203 X 127mm universal steel beams set north/south under these wooden foundation beams. One of these steel beams is set against the east wall and the other set as far west as the clock weight pit would allow. Distortion of one of the two centre wooden foundation beams means that it provides no support to the west side of the frame under the treble and second bells. This does not seem to be a problem since there is very little frame movement when any of the bells is rung. However this beam is heavily affected by dry rot not only at its beam-ends but also on top under the treble bell and it is this which has caused the beam to distort away from the frame. It is also this considerable rot which has infested the wooden slider pivot block as described in section 4.8. It is strongly recommended that when repairing the slider this dry rot should be killed before it spreads further.

Having noted the effects of rot on the installation it is a good moment to point out that loose debris/sand should be cleaned from the frame and floor on an annual basis. In particular remove any accumulations between the frame and the walls since this acts like blotting paper, attracting damp, preventing air circulation and so creating ideal conditions for rot to continue unnoticed in the wooden frame.

- 8.2.2 Replace the wooden location wedges on the south-side bearing housings 1 and 2.
- 8.2.3 Tighten the bolts in stays 1,3,4,and 5.
- 8.2.4 Check tighten the holding bolts on bell 5.
- 8.2.5 Tighten the tie rods in the frame truss between pits 5 and 6.
- 8.2.6 Attend to the rot on top of the foundation beam between bells 1 and 2 – this may require expert advice.
- 8.2.7 Remove dust and dirt from the bell chamber floor and bell frame, paying particular attention to spaces between the bell frame and tower walls.
- 8.2.8 Replace the Perspex sheets in the south and west bell chamber louvres with Galebreaker sheet. (Leave the spire lights as they are).

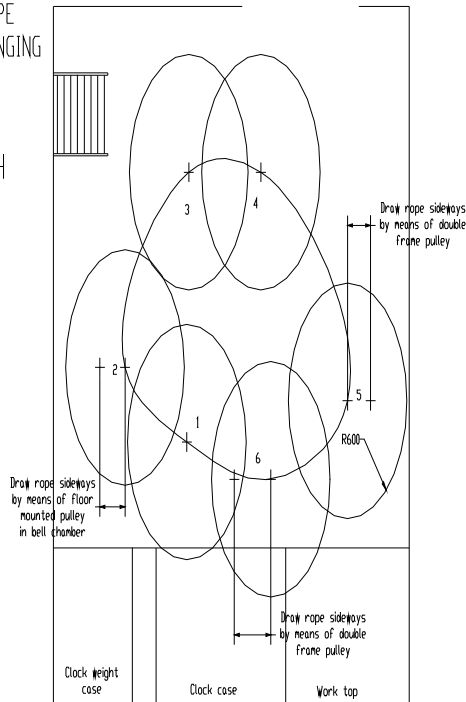
FIGURE A2
IMPROVED ROPE
CIRCLE IN RINGING
ROOM

The major problems with the existing rope circle are:

- ropes 2,1 and 6 are in a straight line making rope sight difficult,
- ropes 2 and 5 are too close to the walls,
- rope 6 is too close to rope 1 and too close to the clock case.

In an ideal situation there should be a clear space of 600mm around each rope to allow for loss of rope control by a learner and to give space for an

instructor to stand with the ringer. Since the bells are relatively close to the ringing room ceiling, the opportunity to alter rope positions really only occurs along the axis of swing of the bells. The biggest opportunity is to replace the single frame pulleys on bells 5 and 6 with double pulleys which enable their ropes to be drawn sideways. (All other bells are already fitted with double pulleys). With the ceiling height reduced to 3,7 metres, the sallies of bells 4,5 and 6 will pass completely through the new floor at backstroke. For this reason it is preferable that these ropes fall vertically from their frame pulleys. Also the rope from the treble passes through one of the foundation beams making it difficult to reposition. However since the sally from bell 2 will not pass completely through the new floor, this rope can be drawn sideways by means of a floor-mounted pulley.
