Derby Diocesan Association of Church Bellringers Consultant's Report	Report no 05/003
Inspection of Bell Installation at St Paul's Church, Quarndon	Issue date 09/04/03

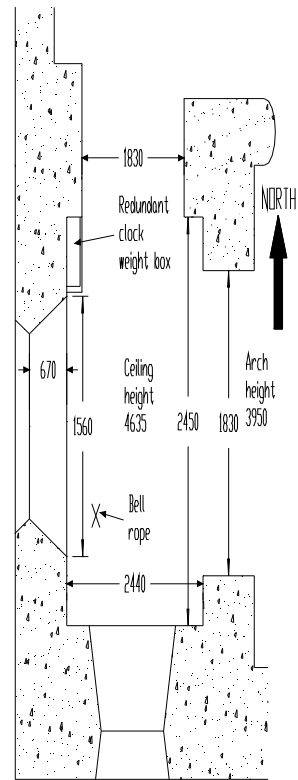
FIGURE 1 - GROUND FLOOR

The area is almost square in section and is used as a storage area for chairs and books. These do not interfere with the ringing of the bell by the rope, which is located in the South West corner. The area is open to the main body of the church by arches on the East and North sides. The redundant clock weight box is still affixed to the West wall. The mechanism for withdrawing the clock hammer from striking the bell whilst being rung full circle is adjacent to this casing. Access to the clock room floor is gained by climbing the vertical wooden ladder which is fitted to the South wall. The ladder, although not captive at floor level, is fixed by metal bracing straps to the wall part way up and is firmly clamped at the trapdoor level. The trapdoor, of good construction, is hinged and when open rests against a wooden support.

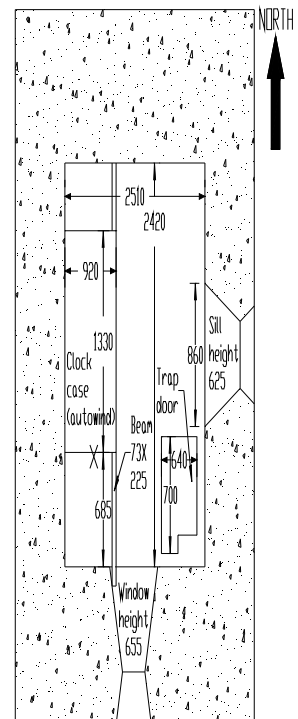
FIGURE 2 - CLOCK ROOM FLOOR

Clear of any rubbish the area is well served by natural light coming through the windows on the South and West walls. More natural light from the louvres higher up make the use of any artificial light unnecessary during the daytime, although a single incandescent light bulb is fitted on the East wall. The clock case is fitted to the West wall and at some time an electric autowind system has been fitted making the weight box that is affixed to the west wall on the ground floor redundant. The floor is of wooden construction and when the trapdoor is shut the noise level at the bell ringer's ear would be acceptable. The bell rope's natural fall brings it very close to the side of the case but this in no way impairs the ringing of the bell. The only other piece of equipment in this area is an old, but serviceable, unfixed wooden ladder that can be positioned to gain access to the top of the clockcase or to one of the sills of a louvre.

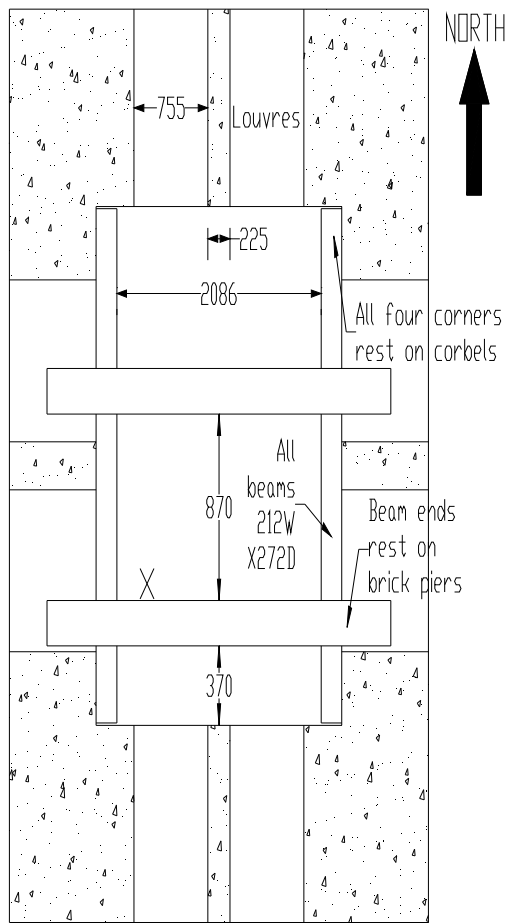
FIGURE 3 - FOUNDATION BEAMS

These timbers run east/west and rest on timbers running north/south, all four corners rest on stone corbels. There was no sign of any woodworm or rot. Wooden wedges have been driven in at the ends of the beams to 'lock' them in place. The large louvres have obviously given some cause for concern in the past because additional piers, made of engineering bricks, have been fitted to all the louvres in which steel reinforcing bars running parallel to the outside wall are bedded. These columns in the East and West louvres are butted up to the foundation beams thus minimising any ability of these to move.

The louvres are well covered by plastic mesh (around 20mm hole size) and panes of glass have been fitted which cover the louvres from sill level to approximately one-quarter the full height. Unfortunately most of these panes are now cracked and /or broken. The plastic mesh keeps out birds but not wind driven rain and we would recommend that 'Galebreaker' is fitted (see 8.2).

8.2 Fit 'Galebreaker' to all the louvres at the frame level. This is a strong PVC coated, woven polyester sheet with tiny closely spaced holes that allow circulation of air through the tower but exclude wind driven rain. Wind driven rain hastens deterioration of the bell frame and fittings. (The Derby Diocesan Association of Church Bell Ringers has bought a roll of this material and can supply any reasonable amount at a cost of £15,65 per metre).

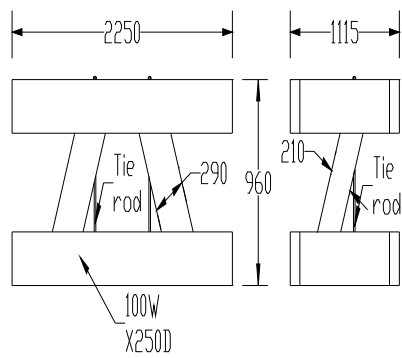
FIGURE 4
FRAME
LAYOUT

The wooden frame is secured to the foundation beams by six tie rods. Two each on the beams running east-west and one each on the cross beams. During the inspection it was discovered that the tie rods on the main beam running east- west by the south louvre were slack. This allowed the frame to lift on this side when the bell was being rung full circle and the movement was visible to the naked eye. All the tie rods show excessive corrosion and no tightening was attempted for fear of shearing one of the rods. The timbers themselves all appear in good condition with no sign of rot or woodworm. The clock hammer is fitted to strike the bell on the North side. All the fixings, supports and actual mechanism appeared to be in good condition, easily operated and well lubricated.

The frame itself is mounted above the sill level of the louvres where the tower is naturally weakened. It is thought that this may very well have contributed to the need for extra piers being installed in recent years.

8.1 Replace the six tie bars holding the frame to the foundation beams, all metal support straps holding the bell to the headstock, and slider pivot.
