<b>Derby Diocesan Association of Church Bellringers Consultant's Report</b>	<b>Report No. DDACB 01/05</b>
<b>Inspection of Bell Installation at St. Andrews, Radbourne</b>	<b>Issue Date 28/01/05</b>

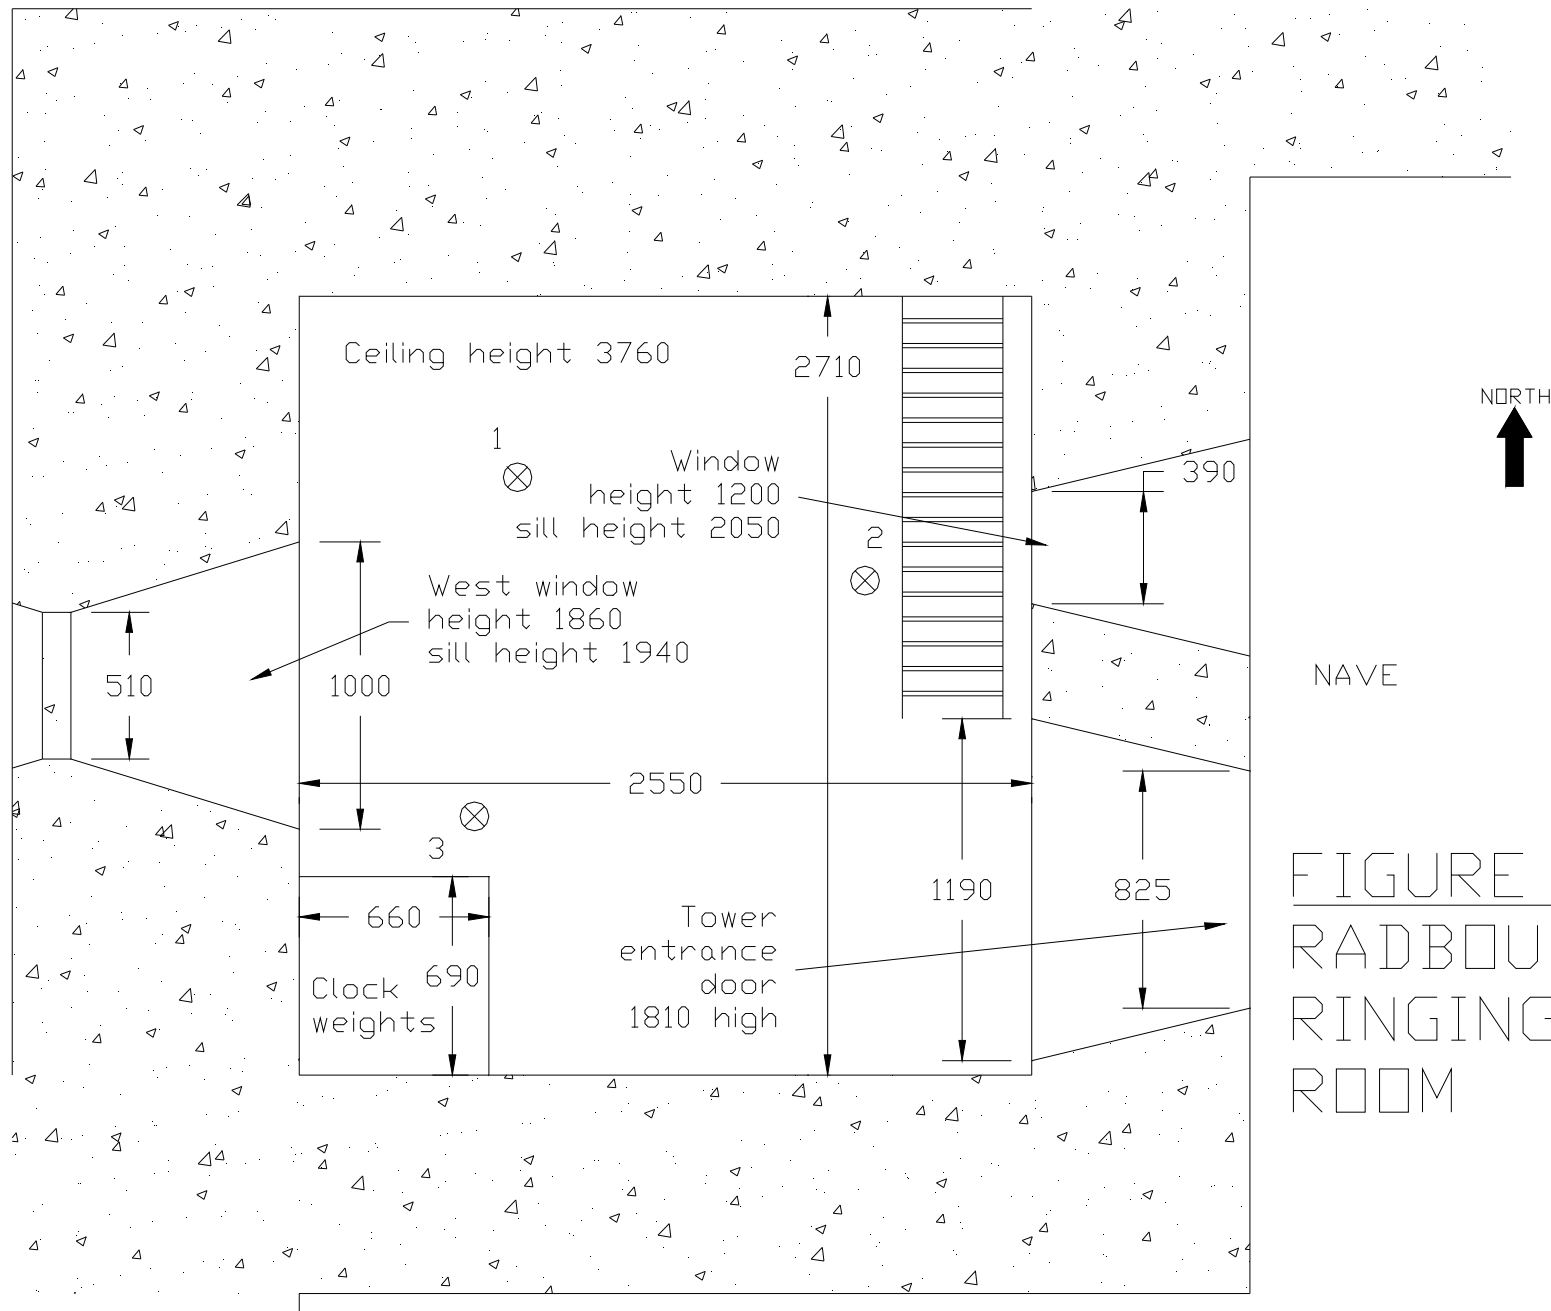
FIGURE 1  
RADBOURNE  
RINGING  
ROOM

Entrance is gained from the main body of the church through a door which is normally closed and locked. The room measures 2.55 metres (East-West) and 2.71 metres (North-South) with a ceiling height of 3.76 metres. There is a small window in the East Wall and a larger window recessed back into the West Wall. A single bulb supplies artificial light to the room. The ceiling, supported on eight beams running East -West, is wooden boarded with a trap door opening in the North East corner. The floor of the room is stone flagged. The electrical intake is on the West Wall and it appears that the tower, and possibly the whole church was rewired in the late 1990's. The ropes fall in a good circle but due to the clock weight box fitted in the South West corner the ringing of Bell No 3 would be difficult for a novice ringer and the free standing ladder, which is used for access to the clock room, presents a similar problem for ringing Bell No 2. There are two free standing cupboards, one on the North Wall and the other in the South East corner behind the door when it is open. The area has also been used to store electric convector heaters used in the church.

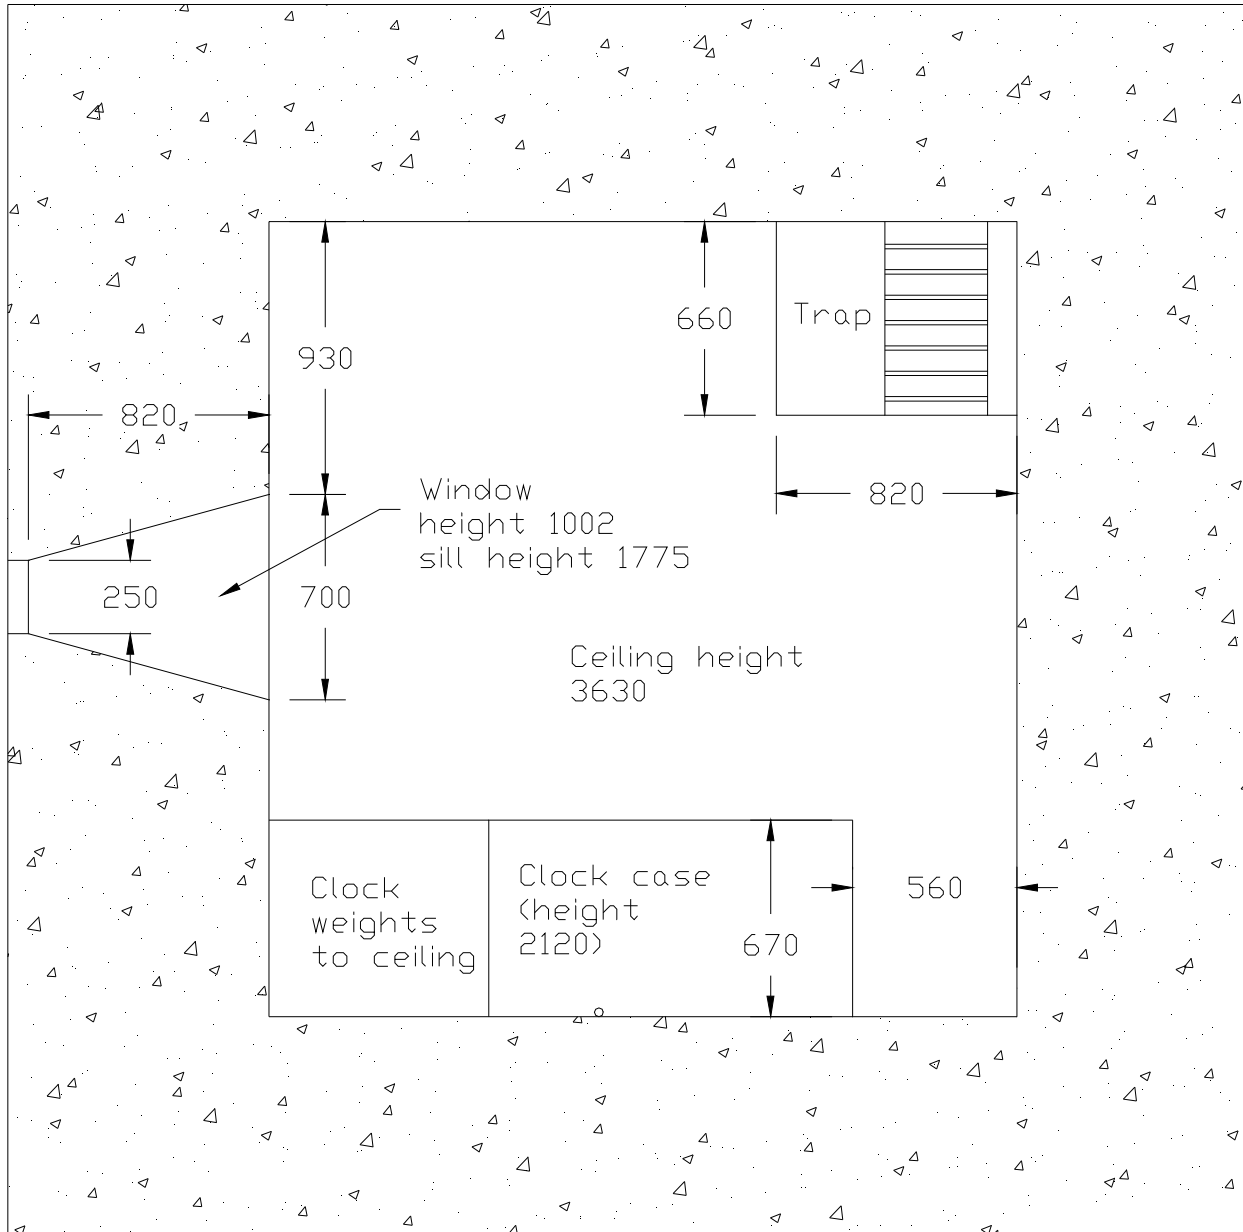
FIGURE 2  
 RADBOURNE  
 CLOCK  
 ROOM

The clock room is reached by climbing the metal free standing ladder which protrudes through the trap doorway. The area is of similar size to the ringing room and the floor is of sound wooden construction. The area is clean apart from

some metal stands. There is evidence of a chimney having been fitted in the North West corner (probably removed when the bells were rehung in 1898).

The clock mechanism mounted on an armchair frame is fitted in a case on the South Wall and appeared to be in excellent condition. The clock drive rod (approximately half inch diameter) to the single clock face, fitted on the South Wall, is supported in simple guides up the wall and through the ceiling. The clock weight box continues up to the ceiling. Natural light enters through a window in the West Wall and artificial light is supplied by a single electric bulb. The height to the ceiling/bell room floor is 3.63 metres below which are four main beams running East- West. The lowside wooden bell frame is secured through these beams by eight tie bars. These foundation beams are resting on two wooden beams running North - South. At the Eastern end the beam is supported on four equidistantly spaced corbels and at the Western end the beam is supported on the tower offset.

Access to the Bell Chamber is via a trap door which is located under Bell No.3. There is a free standing ladder in the clock room which has to be repositioned taking care to avoid the clock face drive rod.

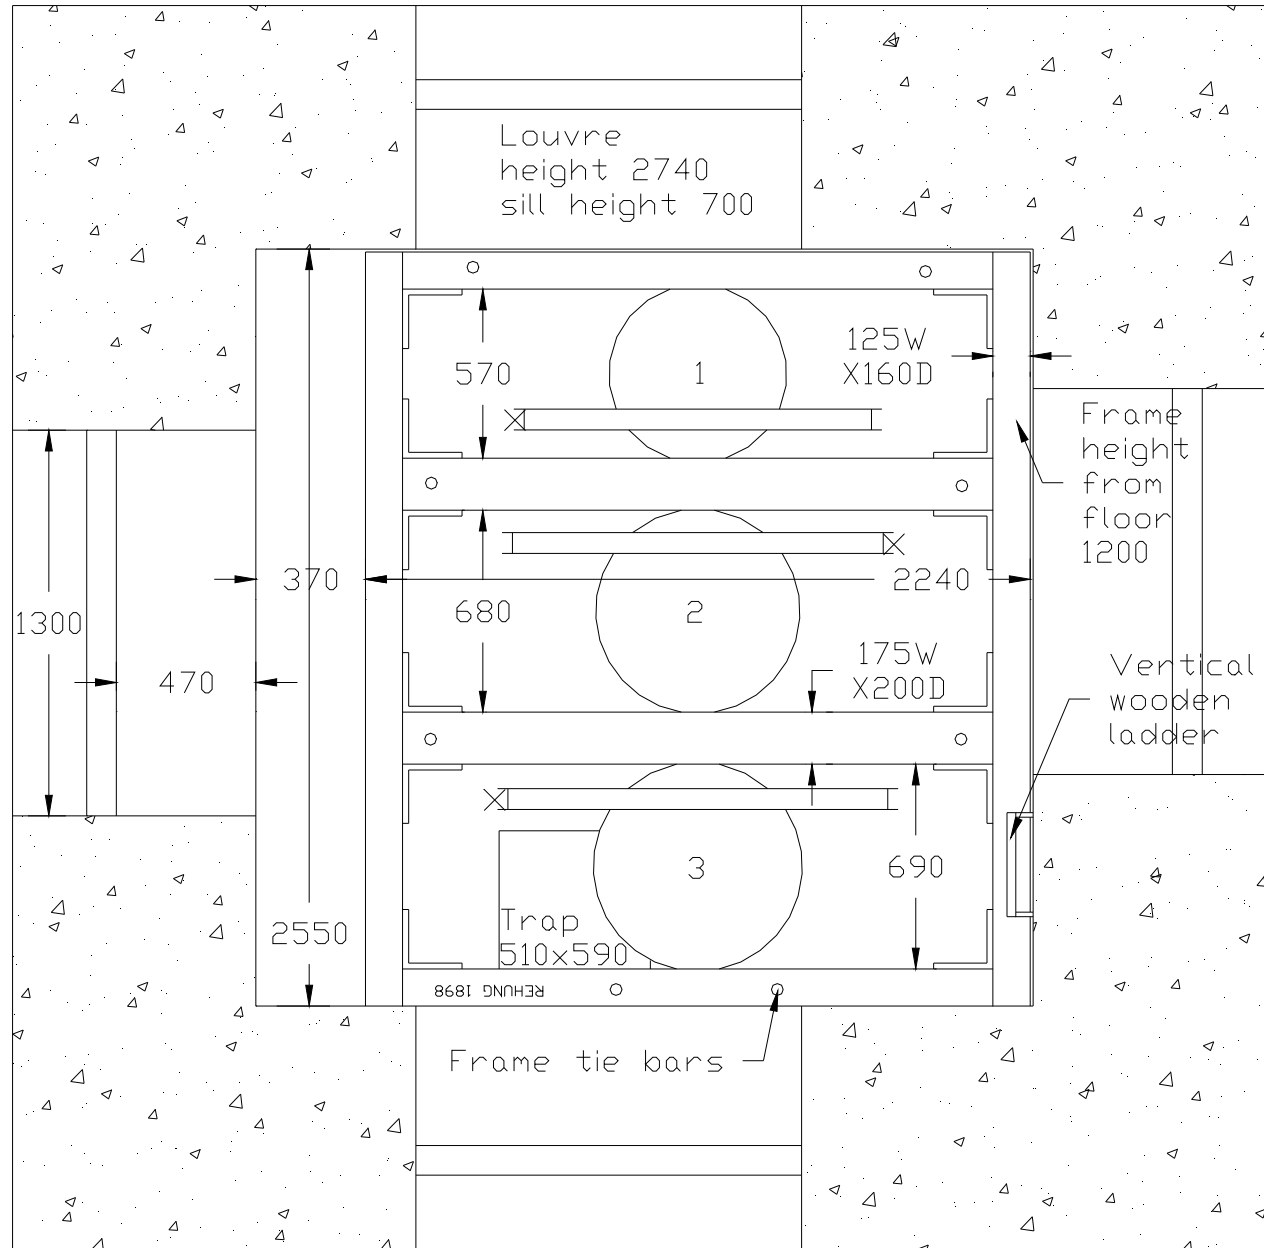
FIGURE 3  
RADBOURNE  
BELL  
CHAMBER

The chamber is almost square in section. The large louvres on all four aspects are covered by plastic sheet which was well fitted and in excellent condition. Although being fitted with larger 'holes' than "galebreaker" there was no evidence of bird ingress and/ or leaves in the chamber. One advantage the larger' hole' mesh has over "galebreaker" is that more natural light enters the chamber. In the South-East corner a fixed vertical ladder gives access to a wooden platform 920mm. wide running East-West fixed 1.4m. above the bell frame. From here a further fixed wooden ladder leads up to the roof trap. The roof appeared to be in good repair with no evidence of water ingress.

The single clock face is fitted below the louvre in the South wall. The drive mechanism is secured to the wooden frame with the gears being open to any ingress of dirt.

Although the bell wheels could probably be removed/refitted using the existing trap doors, removal of any of the bells would have to be via one of the louvres.
