INSPECTION OF THE BELLS AT SAINT MARY'S CHURCH AT TISSINGTON ON 29 JULY 1999

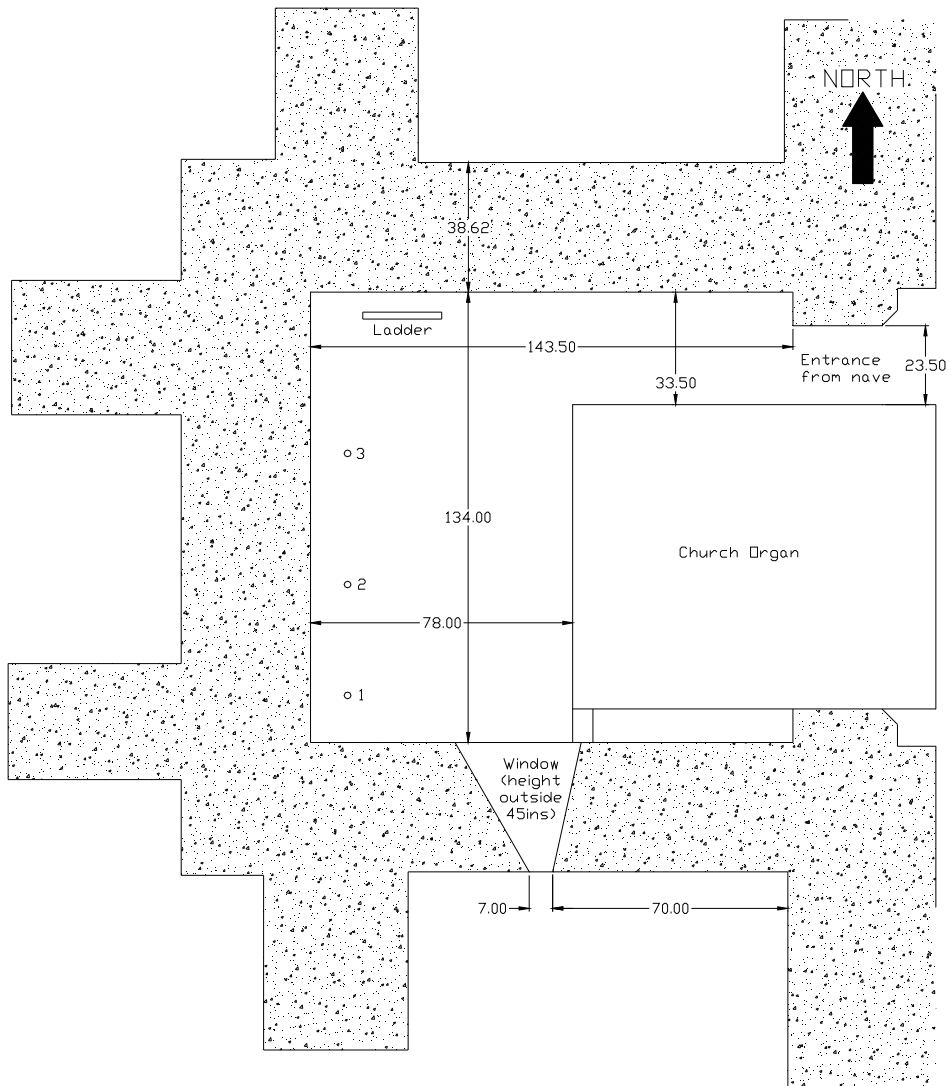
FIGURE 1 Groundfloor Ringing Chamber Layout

Figure 1 shows the layout of the ground floor ringing area. The church organ takes up a significant part of the tower ground floor and access to the ringing area is via a space to the right of the organ. Remaining floor space in the ringing area is further diminished by its part use for storage.

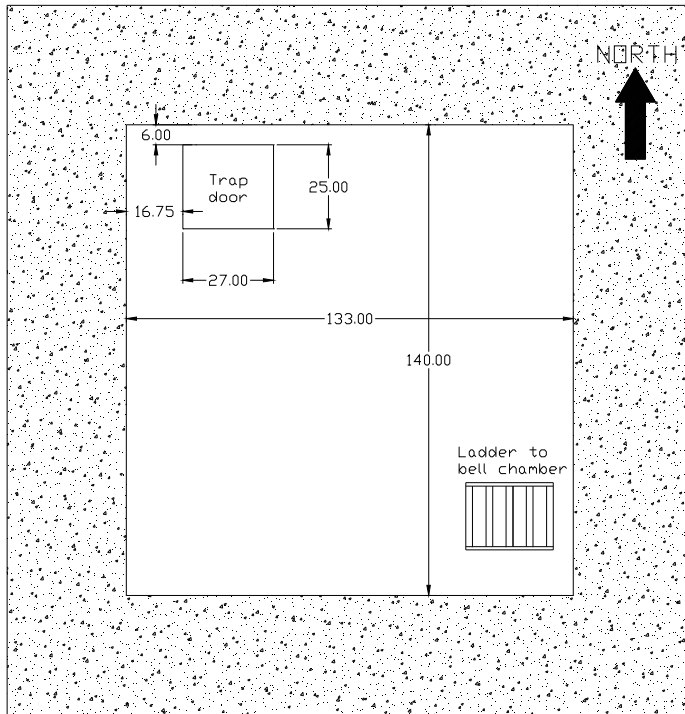
FIGURE 2 Intermediate Room

Figure 2 shows the intermediate room, which has no windows and is unlit. Electric lighting should be installed for safe access to the bells.

The west wall has internal cracks.

The bell chamber floor comprises boarding on top of six joists (5.5 X 5 ins) running east/west and supported on two beams (6.25 X 6.5 ins and 7 X 7 ins) running north/south. There is considerable woodworm in the east beam and it flexes noticeably under the weight of personnel walking in the bell chamber above. This beam should be replaced.

Three of the joists have been patched and one replaced.

- 1) Ceiling / belfry floor supported on two N/S beams (6.25X6.5 and 7X7ins) which in turn carry six E/W joists (5.5X5ins) with belfry floorboards above.
- 2) There is considerable woodworm in one of the N/S beams.
- 3) Three of the E/W beams have been patched and one replaced.
- 4) Ceiling height is 73ins.

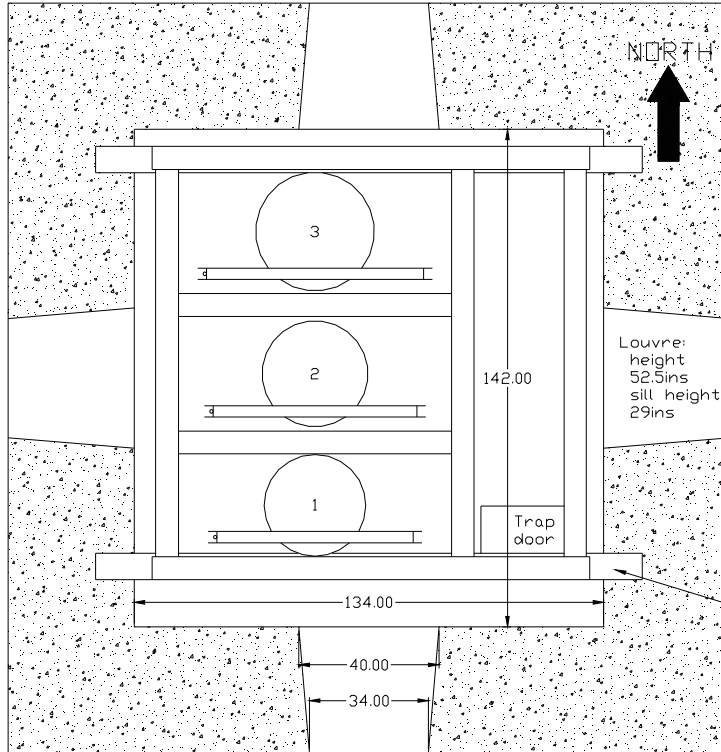
FIGURE 3 Bell Chamber

Figure 3 shows the layout of the bell chamber. Entry is gained through a trap door in the southeast corner. The roof has been recently repaired and its apex stands 123 ins above the floor. The bell chamber is free from birds there being plastic netting on three louvres

and the fourth (east) louvre having a fully glazed opening window. A sheet of Plexiglas also covers the north louvre. There is debris on the floor and it is recommended that this be cleaned.

Three frame tie rods, as yet unfitted, were found on the floor.

Support of the frame within the tower is achieved through extensions to the “truss C” sills which locate in the east and west walls. The south truss rests on a very rusty 6 X 7ins steel beam set into the wall at both ends.
