Derby Diocesan Association of Church Bellringers Consultant's Report	Report no. DDACB 01/003
Inspection of Bell Installation at St. Lawrence, Walton on Trent	Issue date: 11/01/003

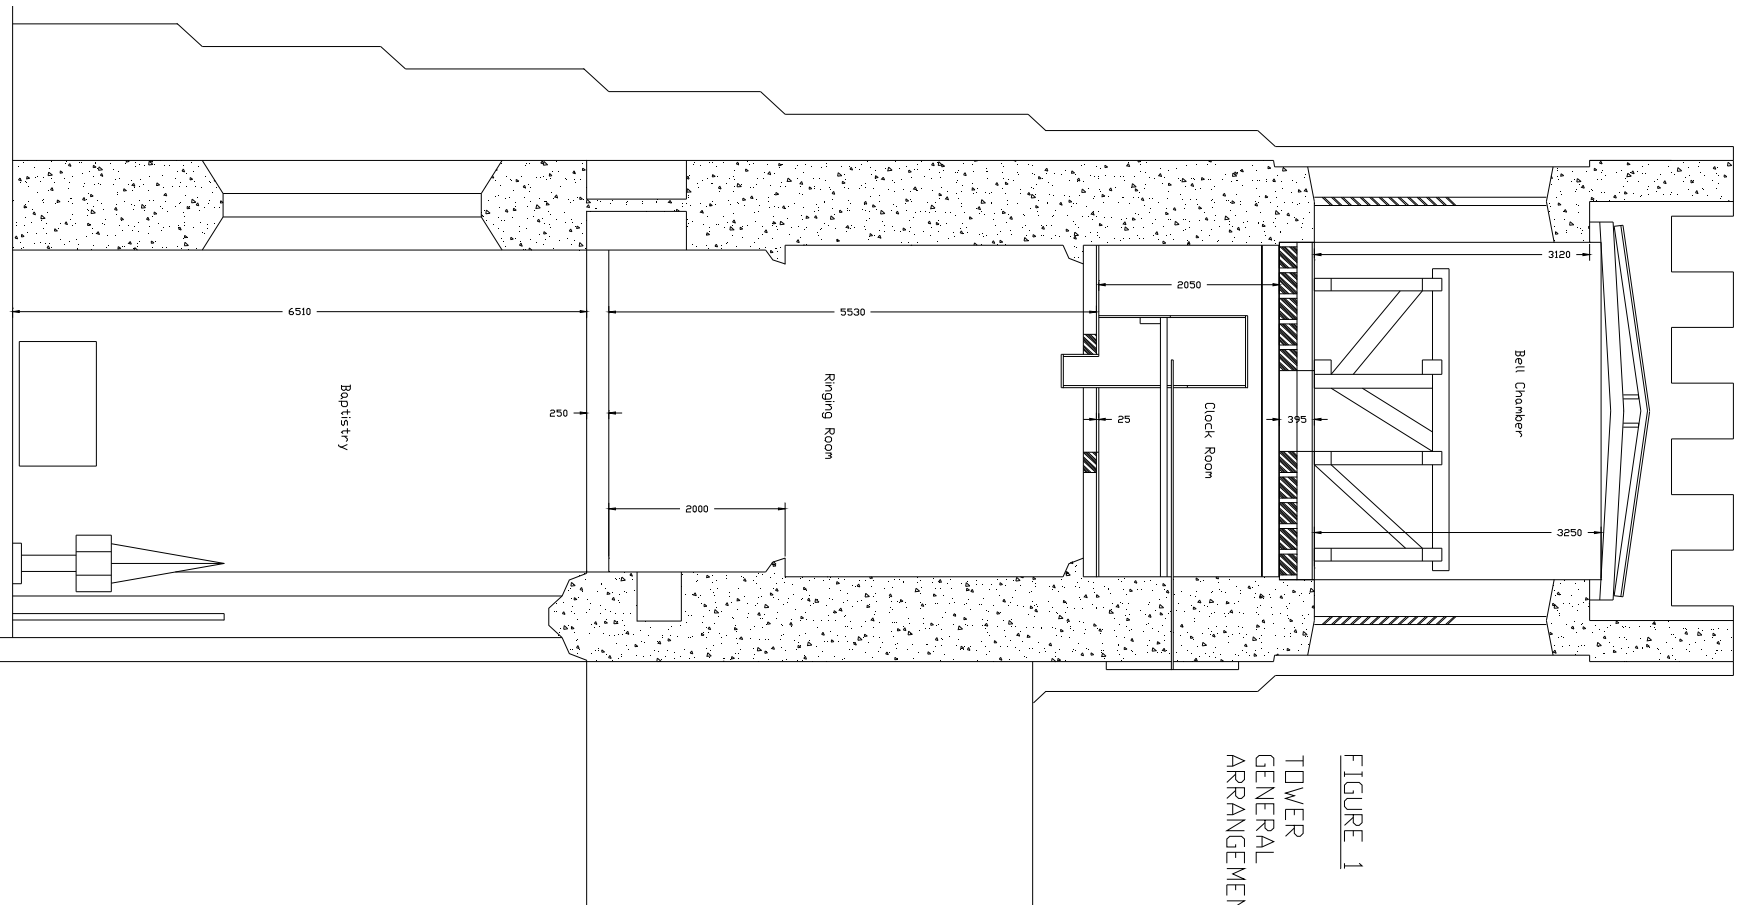
FIGURE 1
 TOWER
 GENERAL
 ARRANGEMENT

The tower is located at the west end of the church, it has diagonal buttresses and contains three bells hung for full circle ringing in a wooden frame.

There is a spiral staircase set in the south west corner. Although the treads are in good condition, the stairs are very steep and of uneven rise and so do not provide easy or safe access up and down the tower. They are lit as far as the ringing room by electric lights, but these should now be extended right up to the bell chamber.

There are iron strengthening tie bars set into the wall at intervals up the stairwell and there is a wrought iron tie bar in the ringing room connecting the east and west walls.

The tower roof appears to have been repaired recently and short brick piers set on top of the tower walls provide additional support for the wall plates.

8.1 Extend the stairway lighting up to the bell chamber.

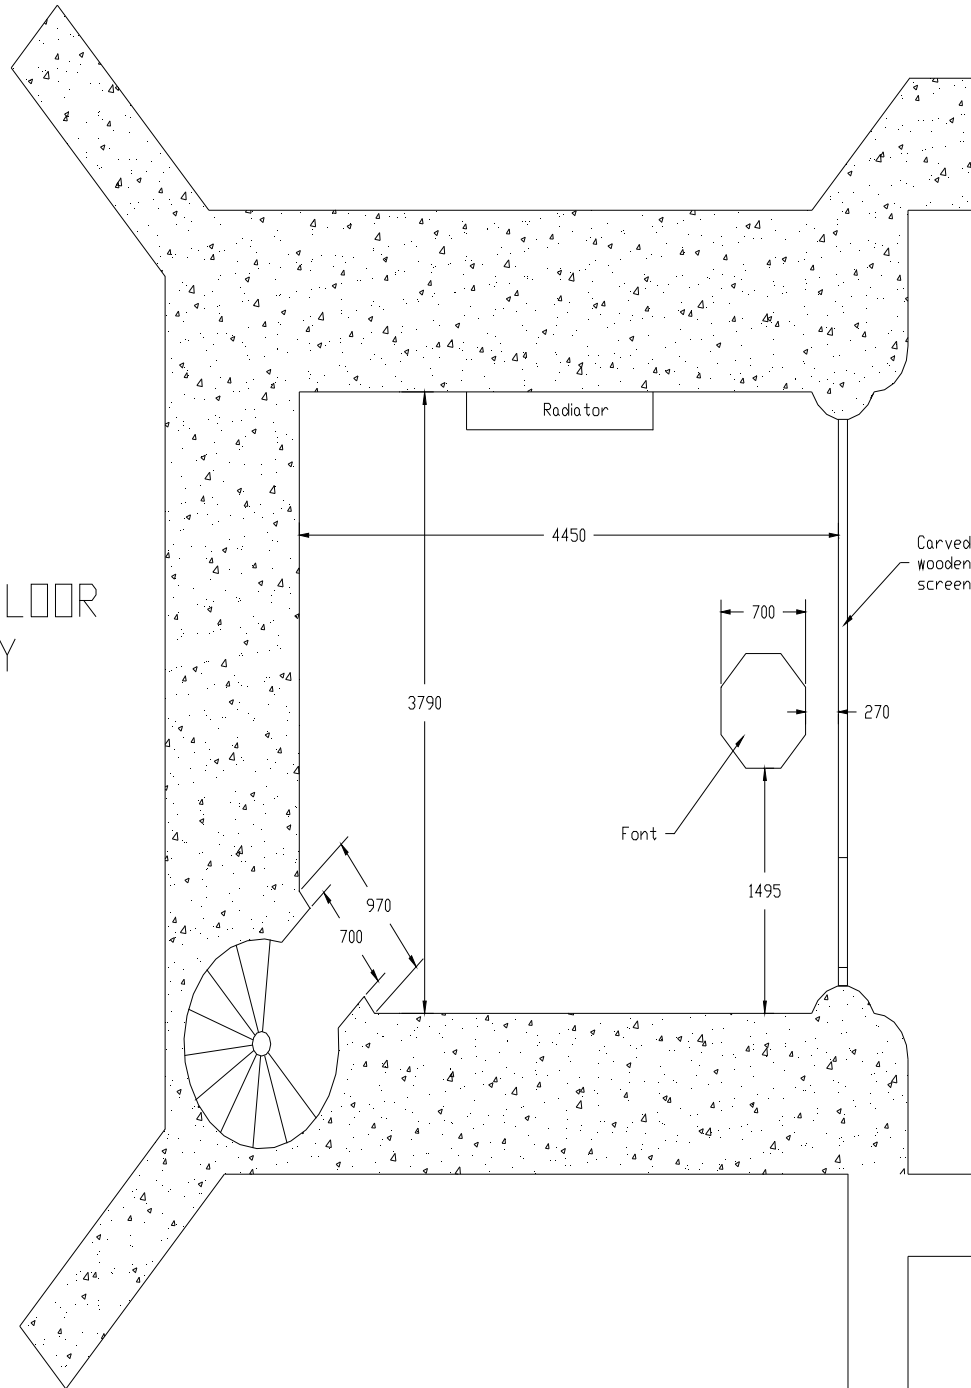
FIGURE 3

The floor appears to have been rebuilt at a lower level at some time. The new entrance has been formed by a considerable excavation of the stonework some 2 metres below the threshold of the original doorway forming a very tall opening and making the adjacent section of spiral stairway even more precarious for users. The original floor level can be judged by the position of its supporting corbels running around each of the walls at a height above the existing floor of 2.0 metres.

There appears to be a trap door in the floor but its dimensions are unknown because the floor is covered by carpet and debris which has yet to be cleared away.

There is a blocked window opening at the current floor level in the west wall which, on the outside of the tower, forms a niche containing a statue of St Lawrence. A further blocked opening in the east wall once communicated with the nave. The counterbalance system for the font cover is set on the east wall.

There is a small window (protected by a metal grill) set 1.4 metres above the corbels in the south wall providing a degree of natural light and ventilation.

The tower is strengthened by a wrought iron tie rod set along the south wall and tying the east and west walls.

The three bell ropes fall in a good circle.

The ceiling is set at a height of 5.53 metres which is safe in event of a ringer being carried upwards following breakage of a stay. The ceiling / clock room floor appears to be very old and is supported by three principle beams and a fourth lesser beam. These beams and associated wall plates rest on corbels set in all four walls.

8.2 Clear the remainder of the debris from the ringing room – this is in hand by the volunteer team.

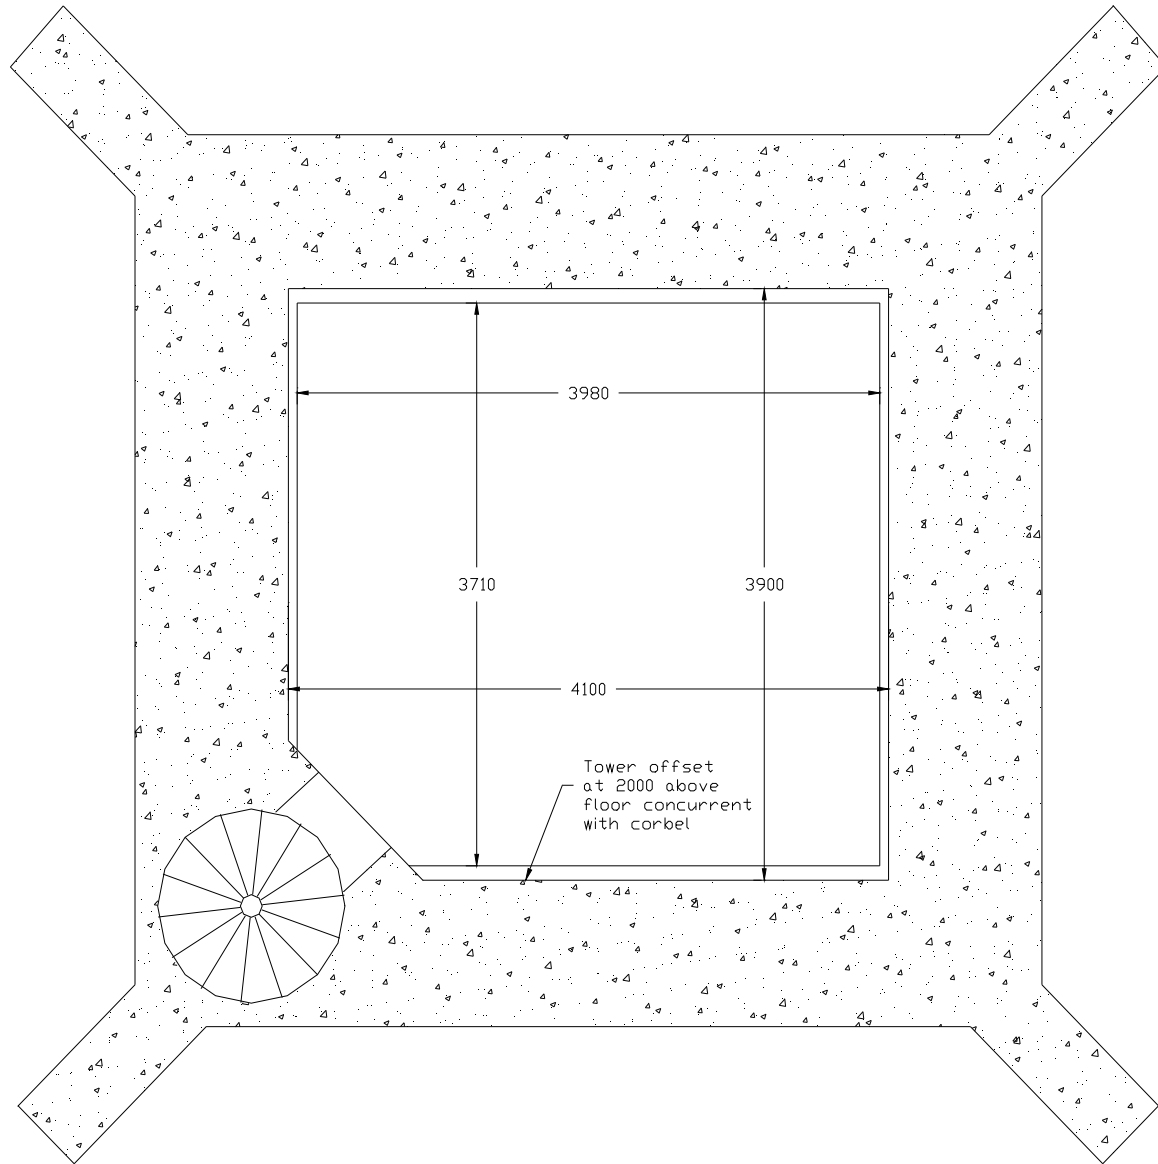
FIGURE 4

The clock room is reached by a further 19 steps. Due to the angular position of the spiral staircase, entry is through a short passage in the south wall. The room is clean and well lit by electric lighting.

There is a 1.21 X 1.2 metre trap door in the floor of sufficient size to allow the bells to be removed.

The clock drives dials on the south and east sides of the tower and has recently been fitted with an autowind system and strikes the hour on the tenor bell. It is housed in a wooden case with glazed doors and the pendulum swings in a case protruding through the trap opening into the ringing room below.

Set at a height of 2.05 metres, the ceiling comprises two groups of 5 substantial (0.26 X 0.2 metre) beams set across the width of the room and resting on corbels in the north and south walls with a further 4 beams in the centre truncated by a 1.0 X 1.0 metre trap opening to the bell chamber. This opening is sufficiently large to allow the tenor bell to be removed.

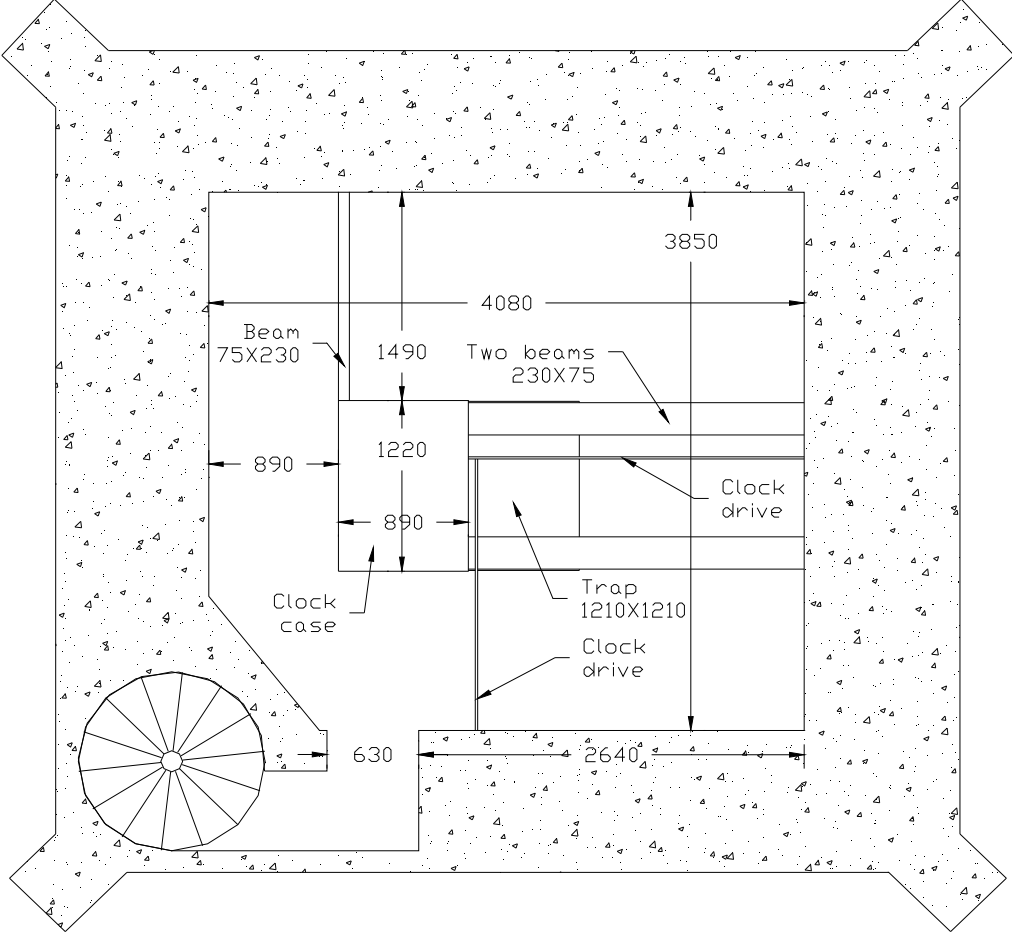
FIGURE 5

The bell chamber is reached by a further 13 steps. Entry is a tight squeeze between the wall and the bell frame.

There are four louvre openings, three of which are protected by Galebreaker material installed by the Derby Diocesan Association of Church Bellringers. Work continues to protect the fourth opening. The wooden louvres are in excellent condition.

The whole area is clean and free from birds and there is excellent artificial lighting. The roof appears to be in good condition.

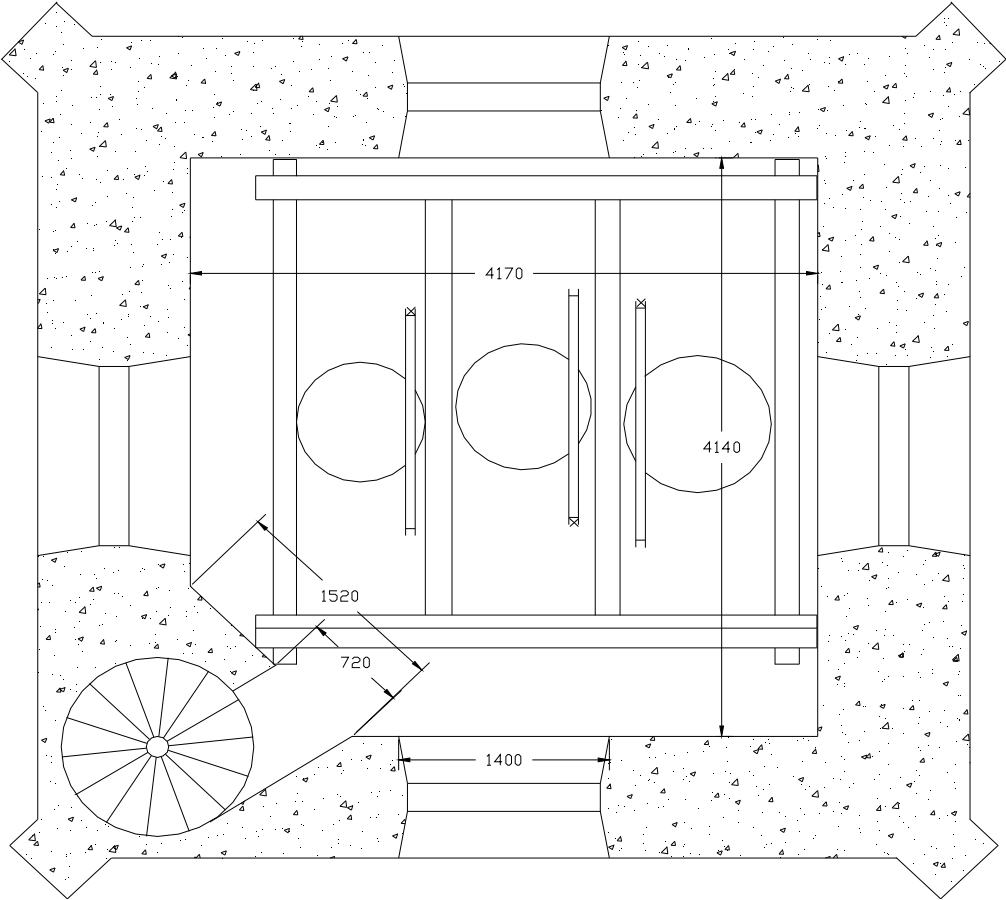
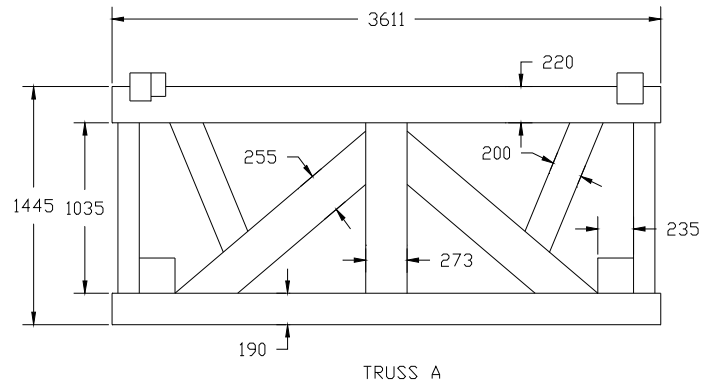
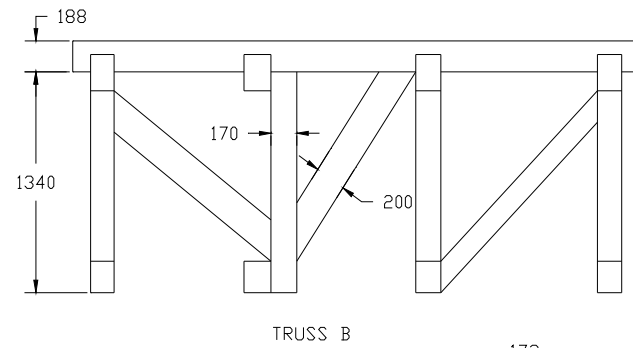
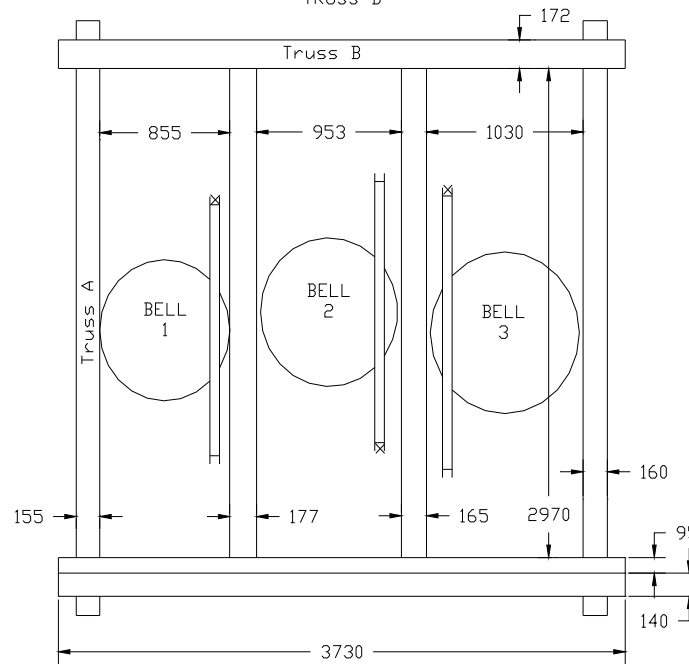
FIGURE 6

The bells hang in an old wooden frame (Pickford type 6.B dating from medieval times or later) which is listed on the Diocese of Derby schedule for preservation. This means that any attempt to significantly alter (or scrap) the frame will be strongly resisted by English Heritage.

Some of the old timbers in the frame show strong evidence of their age through loss of material due to rot. The resulting structural weakening has been offset by the addition of both wooden and steel stiffening members within the frame, complemented by the installation of two steel "I" section joists under the foundation beams in the clock room below. These modifications appear to have been effective since when frame movement (relative to the north wall) was measured during this inspection, the following very small displacements were recorded using a dial gauge:

Bell 1 rung full circle	frame movement +/- 0.25 mm
Bell 2 rung full circle	frame movement +/- 0.25 mm
Bell 3 rung full circle	frame movement +/- 0.40 mm

It is worth recording that these measurements were made during a very damp spell of weather which would cause the wood to swell and so tighten the joints. It might be worth rechecking the frame during a long spell of warm and dry weather.

The wooden frame is very old and its once considerable reserves of strength have been eroded by rotting away of parts of the timbers. This has been offset, over time, by the introduction of additional wooden bracing and steel reinforcements which collectively maintain the stiffness of the frame at a safe level. It is difficult to say how much longer this will continue to be the case and for this reason if ringing is reintroduced the frame condition should be regularly monitored.

8.9 Recheck frame movement in the summer.

8.10 Consider replacement of the wooden frame by a steel 6 bell frame which will carry the existing three bells plus three additional bells.
