Derby Diocesan Association of Church Bellringers Consultant's Report	Report No. DDACB 06/05
Inspection Of Bell Installation at St James' Church, Whitfield Parish, GLOSSOP	Issue Date 10/06/05

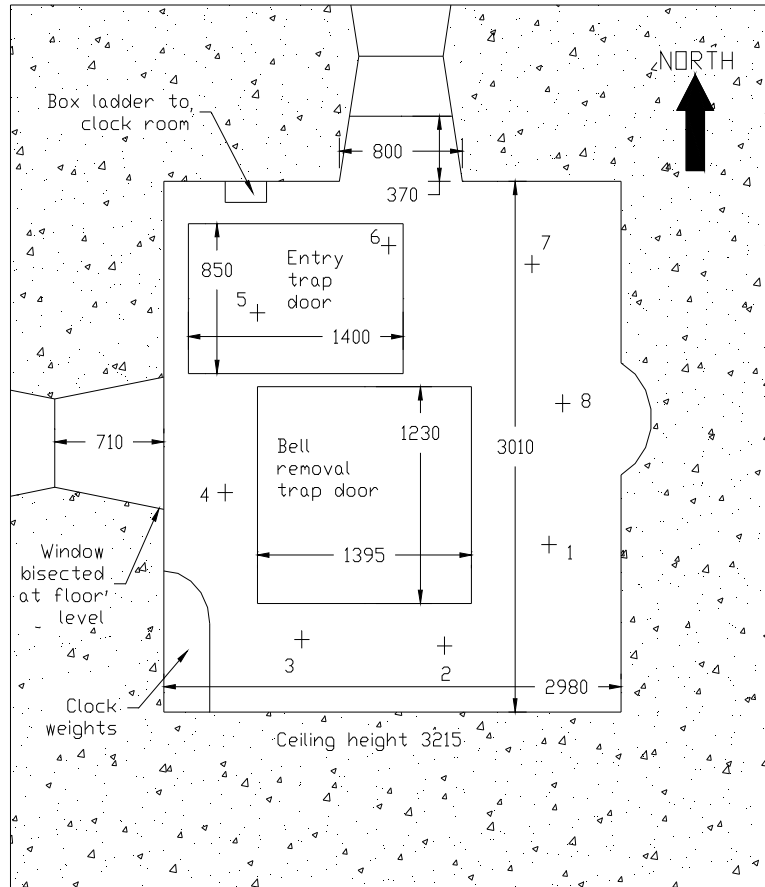
FIGURE 1
Ringing Room

The ringing room is reached by climbing a wide staircase. At the top of the stone step section is a cabinet containing the Ellacombe chiming mechanism. A set of wooden steps then leads to a large padlocked wooden trapdoor. This is counterbalanced and held open by a simple catch which is attached to one side of the vertical wooden ladder.

The room is almost square in section with plastered walls and there is plenty natural light from the floor level windows fitted into the North and West walls. The ringing floor bisects these windows and whilst the floor has been extended into the North facing window recess this is not the case with the west facing window and a gap of 750mm X 710mm is present. Further natural light is supplied by windows on the North, East, and West aspects which are bisected by the clock room floor.

The eight ropes fall in a good circle with the normal ringing position for both Bell No. 5 and Bell No. 6 being on the closed trapdoor position. The eight ropes for operating the Ellacombe chimes are neatly arranged in the North East corner adjacent to the ringing position for Bell No 7.

Almost centrally placed in the wooden floor is a large bell removal trapdoor.

A 48mm diameter steel strut to support the clock mechanism is fixed into the North Wall which in no way interferes with the ringing of any of the bells. The ceiling is supported on two Reinforced Steel Joists (RSJ) running North - South and two RSJ's close to the South wall running East - West. It is 3.215 metres from the floor which is safe in the event of a ringer being carried up following the breakage of a stay. A rectangular box containing the clock pendulum hangs down from the ceiling to which a single light is fitted. The clock weights are enclosed in a wooden cabinet located in the South West corner.

1. Replace the single filament bulbs fitted in the ringing room and the clock room by double fluorescent fittings. It is suggested that two double fluorescent fittings are fitted in the bell chamber. One to illuminate the area where the lower bells are hung and another to illuminate the higher level.
2. Bell No. 1 - slacken off crown staple nut and retighten making sure that the clapper is striking the sound bow in the centre of the worn section.
3. Bell No. 2 - a. tighten both bolts holding stay in place.
b. grease spindle on double pulley. (bell chamber)
Note If any stays have to be replaced after breakage then use stays made out of ash.
4. Bell No. 3 - grease spindle on pulley. (bell chamber)
5. Bell No. 4 - a. replace double pulley with new unit. (bell chamber)
b. fit new grease caps to bearings.

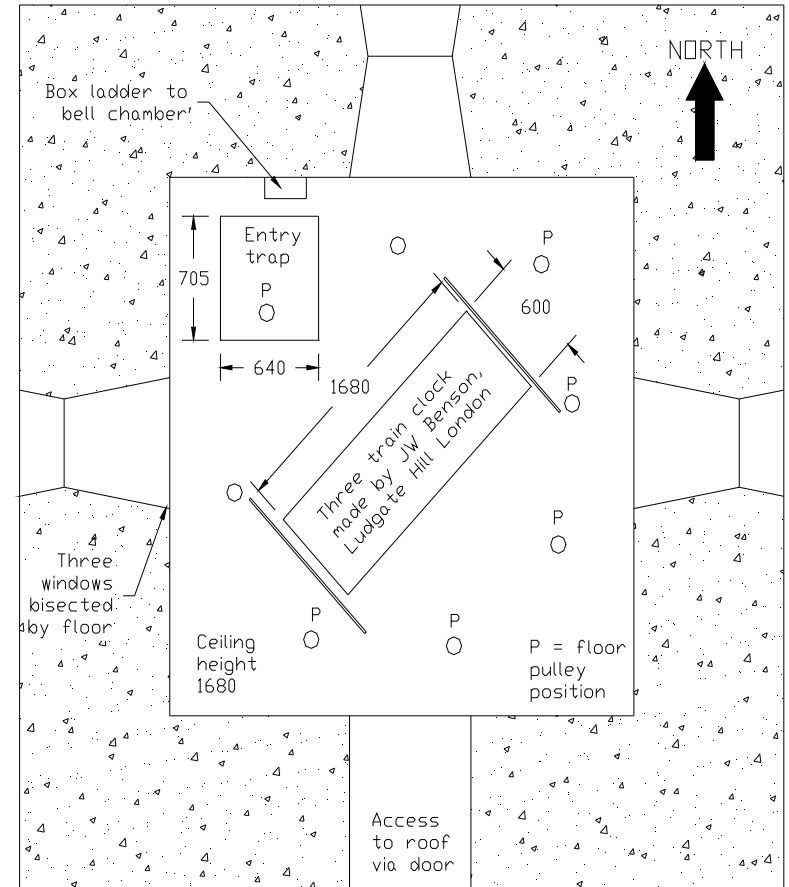
FIGURE 2
Clock Room

The clock room is reached by climbing the vertical box section ladder and opening the counterbalanced trapdoor which rests back against the wall. On the clock room side of this trapdoor is fitted a single pulley through which runs the rope for Bell No 5.

Note no attempt should be made to open the trapdoor when Bell No. 5 is in the raised position.

The walls are natural stone and the size is slightly larger than the ringing room. There are windows on the North, East, and West walls which bisect the floor and on the South side a door gives access to the church roof.

The area is dominated by the clock mechanism which is mounted centrally on a wooden frame running North East - South West. It was manufactured by J.W. Benson of Ludgate Hill, London and the manual winding positions are located on the South East side which is furthest away from the trapdoor. At present the clock is not operational and it's position completely blocks any exit route for removal of the bells internally within the tower. The floor is of wooden plank construction approximately three inches thick. The low ceiling (1.68 metres) to which are fitted several bell cranks for the clock chiming, is of tongue and grooved wooden construction. In the South West corner of which, there were serious signs of wet rot. There is a single light fitted to the West Wall and the area was clean and bird free. The ropes pass through the room all in boxes or flapper boards apart from the fifth. Pulleys are fitted at both floor and ceiling level on Bell No's 1,2,3,5,7,& 8.

The condition of these pulleys is as follows -

No 1 rope - floor pulley OK. ceiling pulley OK.

No 2 rope - floor pulley fitted on ball bearings OK. Ceiling pulley on ball bearings OK.

No 3 rope - floor pulley slightly grooved but free running on ball bearings. Ceiling pulley slightly grooved but OK.

No 5 rope - floor pulley slightly grooved but free running. Ceiling pulley - slightly grooved but free running.

No 7 rope - needs greasing but serviceable.

Ceiling pulley - grooved and needs greasing and new grease cap. Serviceable.

No 8 floor pulley - fitted with ball bearings and OK. Ceiling pulley - OK

10. Monitor wheel segments at six monthly intervals.
11. Bell No. 7 - a. grease spindle on both floor and ceiling mounted pulleys. (clock room)
b. fit new grease cap.

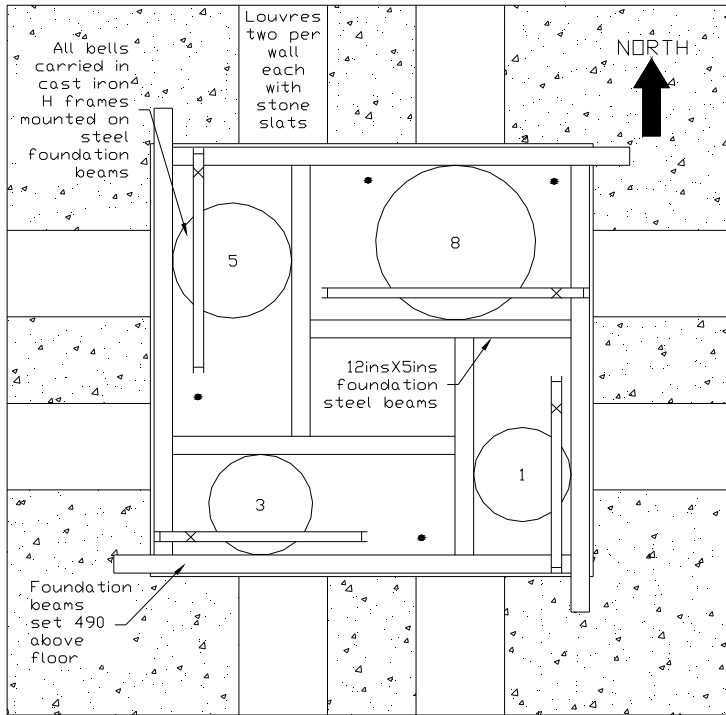
FIGURE 3
Bell Chamber
Lower Bell Frame

Access is gained by climbing the vertical box section ladder and pushing the light construction hatch to one side. The louvres are all covered in wire netting which has been externally fitted and the West louvre has been blocked up by wood to keep the weather out. Although the floor area was in need of a good sweeping there were no signs of bird debris. Apart from the limited natural daylight there is a single light bulb fitted to the West Wall. Moving around within the confines of the chamber is not easy due to the various ropes and pulleys at ground level and there is no recognised route to the bells at the higher level.

Bells 1,3,5, and 8 are carried in a cast iron H frame which is mounted on four steel foundation beams which are keyed into the wall as shown in figure 3. The foundation beam running along the North wall is further supported by 3 stone corbels. The foundation beams (12 ins x 5 ins) are mounted 490mm above the wooden floor which makes moving around under the bells possible but one has to take care in avoiding the extra ropes and metal rods associated with operating the Ellacombe and clock chiming.

Although of adequate size and showing little sign of corrosion it is recommended that the beams should be either wire brushed by hand, and for particularly bad areas an angle grinder fitted with a wire cup brush should be used. The use of eye and ear protection is essential when undertaking this task. Also a watchful eye should be kept out for the fire hazard. Where bare metal is reached a three coat paint application should be applied as follows -

- Red Oxide primer
- Grey undercoat
- Gloss top coat

If only surface rust is removed then a good undercoating followed by the gloss coat will suffice.

The H type cast iron frame (2metres) high, mounted on the foundation beams, should be treated as per the foundation beams with particular attention being paid to the fixing bolts.

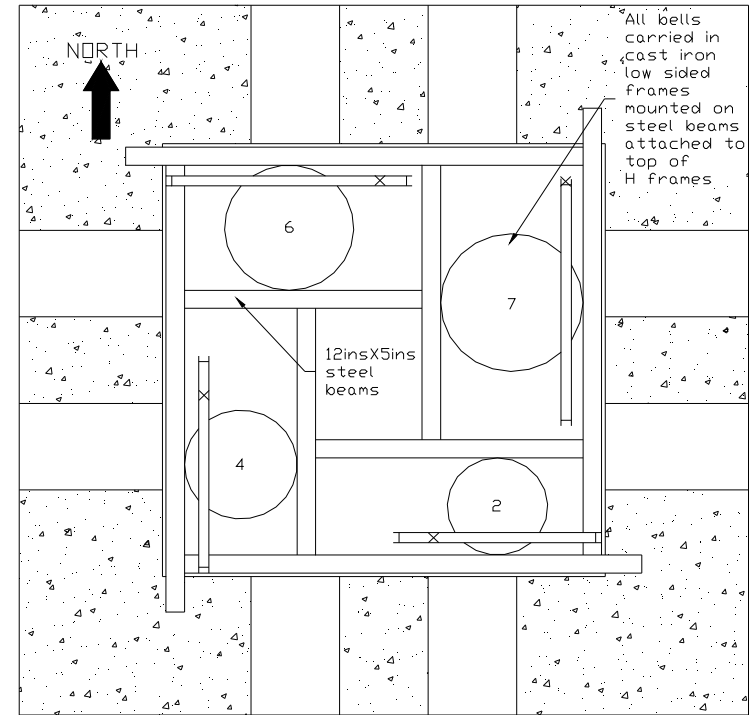
FIGURE 4
Bell Chamber
Upper Bell Frame

Bells 2,4,6, & 7 are carried in the upper frame which is mounted on four reinforced steel joists which are keyed into the wall as shown in figure 4 and supported at each corner by a stone corbel. These joists are bolted to the top of the H frame making a very solid and stable configuration. Inspecting and undertaking any repairs to these bells and fittings is extremely difficult and great care must be taken, not only in reaching the upper level but also when working there. The foundation beams and lowside frame, although of substantial dimensions, showed signs of neglect and the rust removal and paint treatment as specified for the lower level should be carried out with particular attention being paid to the holding bolts.

b. replace missing 'dingler'.
9. All the metalwork in the bell chamber should be wire brushed, bolts checked for tightness, and then painted with red oxide paint followed by an undercoat and gloss topcoat.
