Derby Diocesan Association of Church Bellringers	Report DDACB 11/05
Inspection of Bell Installation at the Church of All Saints Wingerworth	Issue Date 24/10/05

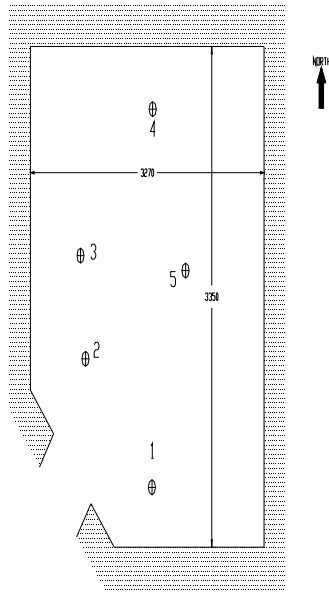
FIGURE 4 PINGING ROOM

Reached by a spiral staircase (24 steps) the room is almost square in section allowing for the built in spiral staircase. The area is carpeted and illuminated by a single fluorescent light. The height of the wooden ceiling is quite low (2.97m.) and the noise of the bells in the chamber, although not measured, is reported to be louder than the ideal. There also appeared to be signs of water

ingress at ceiling level. The ringing circle is awkward (see Figure 4) and ringing bells 2 & 3 could be a problem for inexperienced ringers.

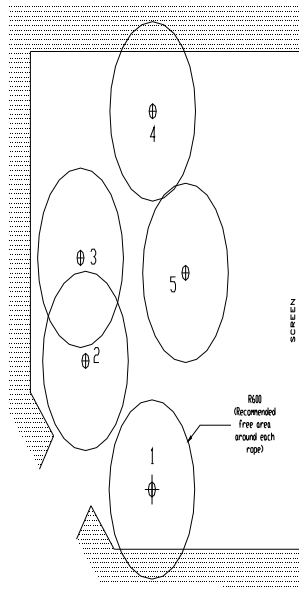
FIGURE 5 GROUND FLOOR Existing rope circle transposed to ground floor

Figure 5 shows the ringing circle if there was no change to the pulley positions or 'draws' on Bells 2 & 4 and the ropes were extended down to ground floor level.

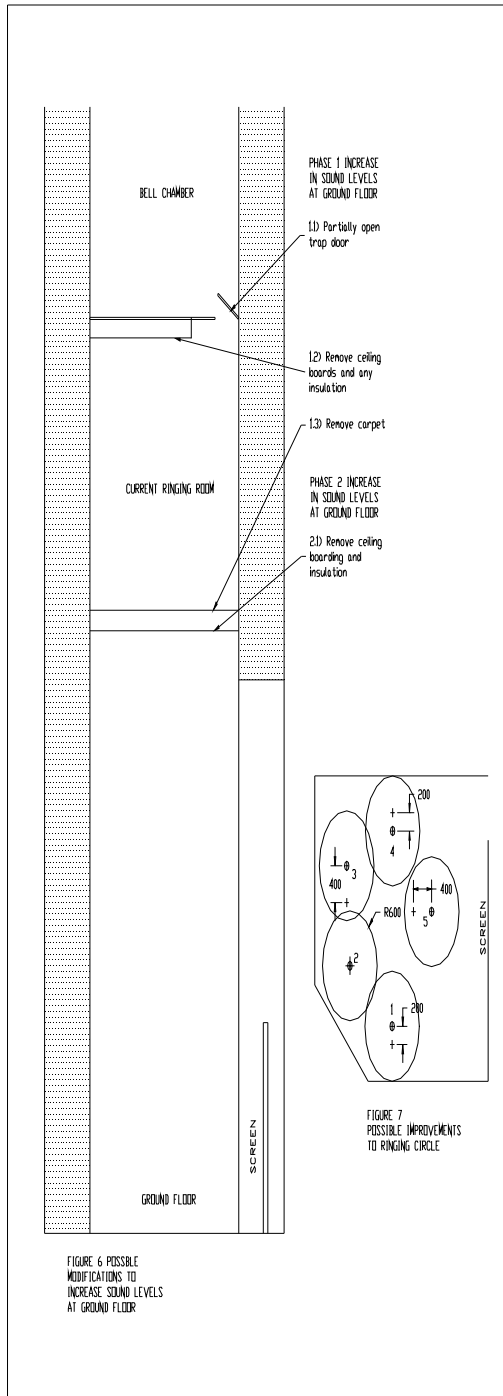
FIGURE 7 POSSIBLE IMPROVEMENTS TO RINGING CIRCLE

Figure 6 shows the improvements to the ringing circle that could be made by altering the pulley and 'draw' positions.

- 10.7 Alterations to the ringing circle mentioned by John McCartney in his letter of 19th. September should be carried out.
Figure 7 shows the rope circle that could be obtained assuming that the beams in the present ringing room floor do not interfere with any of the new location holes required for the ropes to pass through. Serious thought should be given to fitting rope guides under the existing ringing room floor as the lateral movement as mentioned by John McCartney in his letter will increase.
- 10.8 Due to the extra distance from the ringing position to the wheels it is thought that the existing ropes will not be long enough. There are three options
 1. Purchase new ropes.
 2. Make enquiries into obtaining second hand ropes.
 3. Splice an extra length onto the existing ropes.
